PNNL-35364

**Mitigating Corrosion in Mg Sheet in
Conjunction with a Sheet-Joining Method
that Satisfies Structural Requirements
within Sub-assemblies**

CRADA 392

April 2023

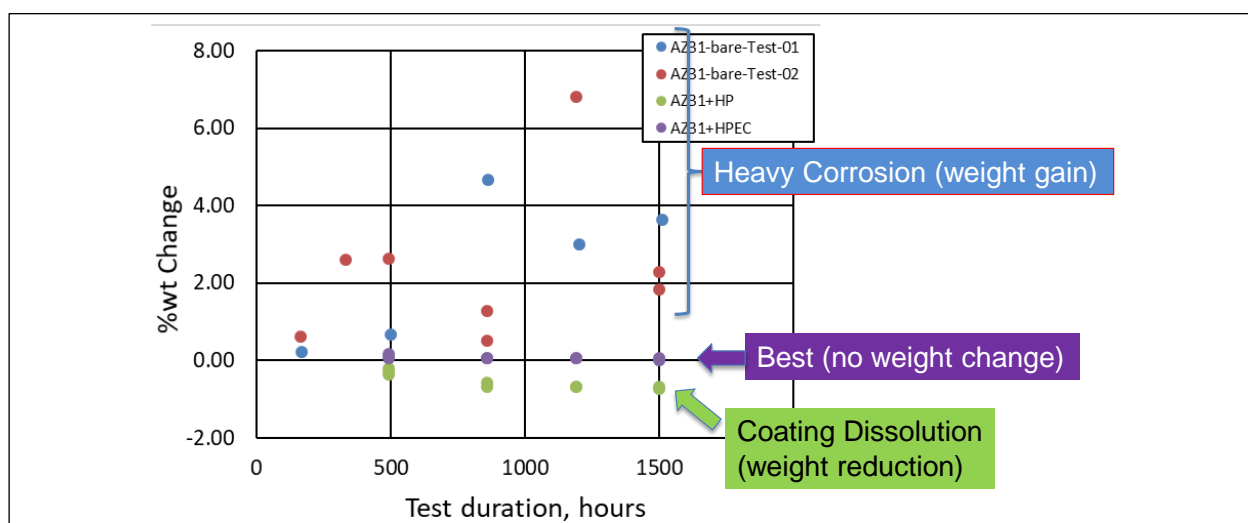
Figure 4: Change in individual AZ31 coupon weight vs. test duration following ASTM B117 testing: (a) bare AZ31; (b) HP (package #A); and (c) HPEC (package #B).

- 4.1 Base Material Corrosion Behavior: Figure 3 shows pictures of base AZ31 coupons in bare (uncoated), and with corrosion protection packages (#A, #B, #D and #E) in the as-received untested state and following corrosion testing per the ASTM B117 method for the durations listed. Figure 4 shows the plots of change in weight of the three types of coupons (i.e., bare untested AZ31, HP (package #A), and HPEC (package #B)) as a function of corrosion test duration.

- 4.2 Base Material Microstructural Characterization: Figure 5 shows a SEM image of the transverse cross-section of a bare untreated AZ31 coupon after corrosion testing for 500 hours. Build-up of $Mg(OH)_2$ on the coupon surface and inward growth into the AZ31 matrix through pitting is noted in the lower-magnification of Figure 5b. Further, the corrosion film contains several cracks which is evident in the adjoining higher magnification image (see image of section in Figure 5a). At a macro-level, **presence of numerous such cracks provides easy paths for the corrosive media to contact the underlying base metal, and thus, continue the corrosion process and corresponding weight gain** (Fig. 4).

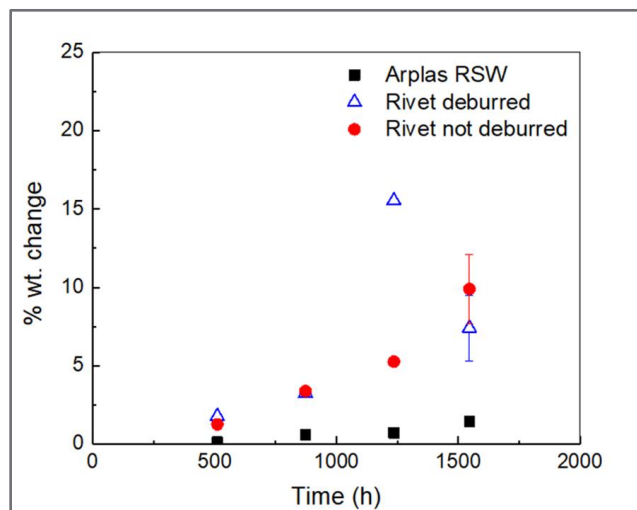
Figure 11: Relative change in weight of joint coupons as a function of time during ASTM B117 corrosion test method. Arplas RSW (HPEC) experiences minimal corrosion attack as compared to Al riveted joints (coating package #C).

The formation of corrosion debris around the resistance spot weld mark could be noticed on the front face of the Arplas RSW joints, which is marked by a yellow circle as shown in Figure 10a. In contrast, the back side of the same Arplas RSW joint does not show any such corrosion product build-up. Unlike Arplas RSW joints, the rivet joints (Figures 10c and 10d) show an extensive corrosion attack on the front and back faces of the joints. It was also observed that in most of the rivet joint coupons, a portion of the top E-coat film peeled off during ASTM B117 testing, thus exposing the underlying metal surface to further corrosion attack. The relative change of corrosion coupons as a function of test duration is plotted in Figure 11 and confirms the visual observations above. Figure 11 shows that the rivet joints showed a large weight change (~10%) indicative of significant corrosion whereas the Arplas RSW joints showed only a small weight change (~2%)
