Nondestructive Evaluation of Carbon Fiber Reinforced Polymers

Pacific Northwest National Laboratory
Richland, Washington 99354

**Division of Engineering
Office of Nuclear Regulatory Research
U.S. Nuclear Regulatory Commission
Rockville, MD 20852**

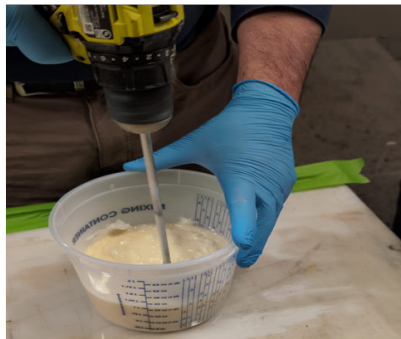
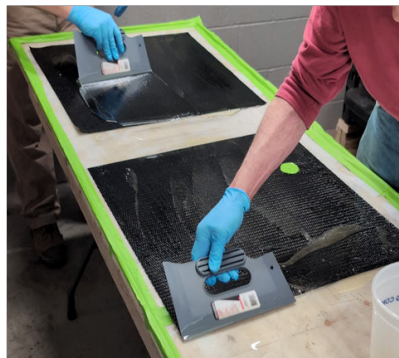
Step 1: Surface Preparation

Step 2: Primer Application

Step 3: Preparation of Putty

Step 4: Putty Application

Step 5: Fabric Saturation

Step 6: Fabric Installation

Step 7: Application of Top Coat and Finish

Figure 7. Mockup preparation steps.

The CFRP repair mockup fabrication process involved the following steps, described below and shown in photographs in Figure 7. Additional information and photographs are provided in Appendix A.

1. Surface preparation – Visual inspection was performed on the steel substrate, and the surface was prepared by sandblasting per the design requirements. For Mockups 7 and 8, one quadrant (Q3) was not sandblasted (as shown in Figure 7), so that effects of improper surface finish could be examined with NDE.

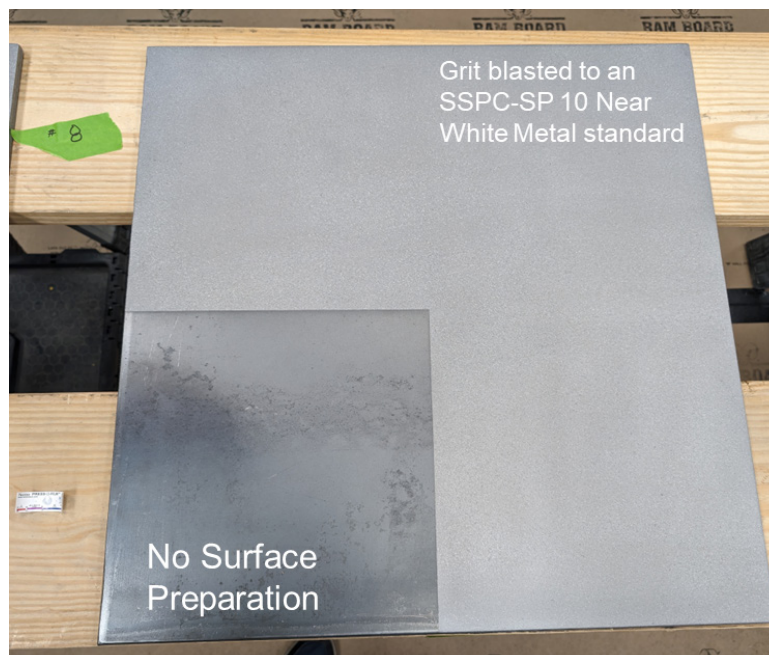
Figure 13. Surface preparation of the substrate of Mockup 8.

Mockups 7 and 8 each had one quadrant of their substrates that was fabricated without sandblasting, as shown in Figure 13. All other mockups had the surface grit blasted to an SSPC-SP 10 Near White Metal standard with a 3+ mil profile.

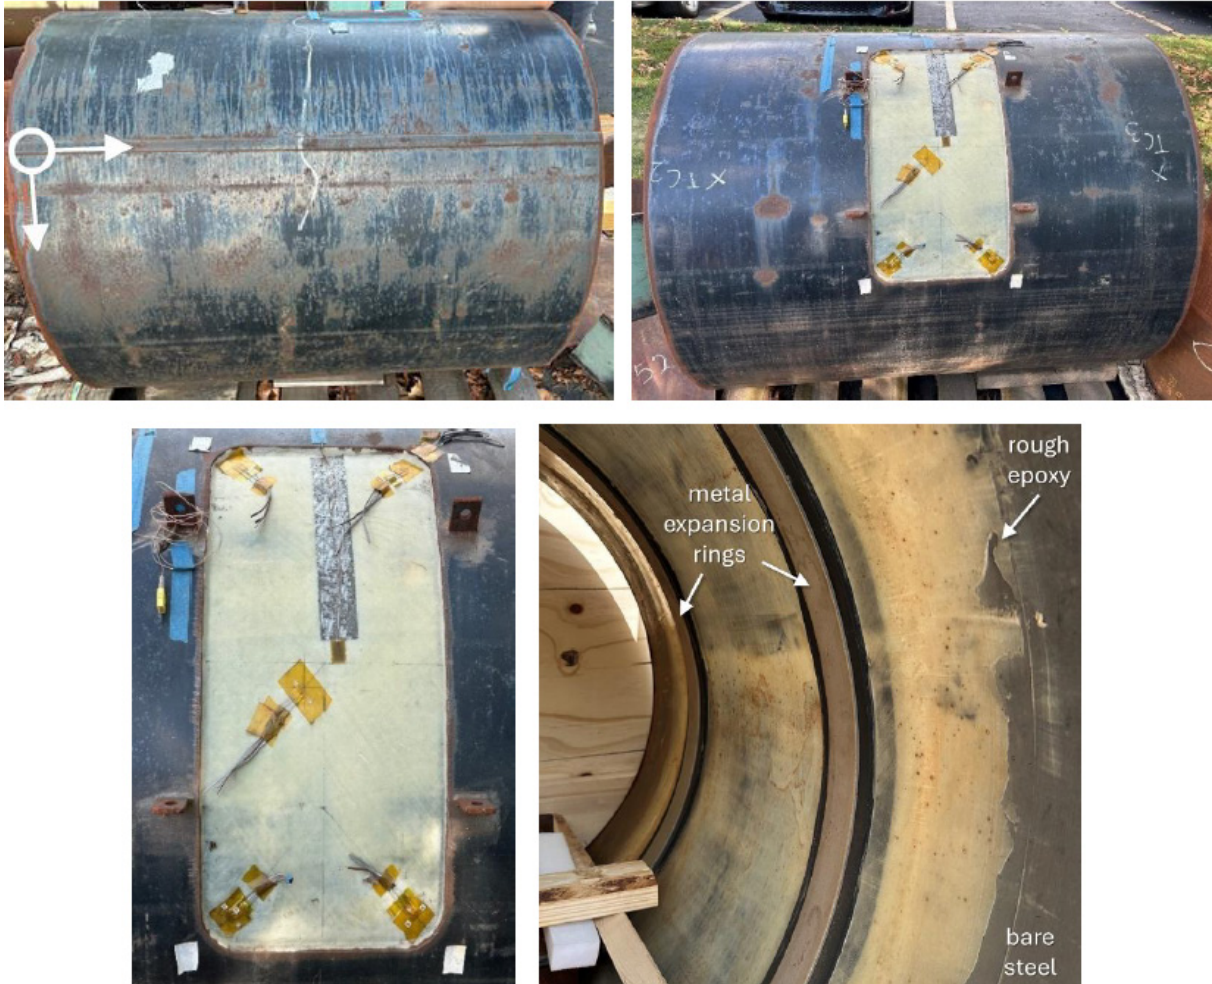
Figure 15. Photographs of the pipe mockup.

PNNL contracted with Sonomatic to inspect the pipe with DRS. Figure 15 shows photographs of the mockup taken by Sonomatic, showing the inspection data on the long seam, the area of the missing steel with CFRP applied internally, and the internal view showing the expansion rings and rough epoxy. Figure 16 shows a CFRP debond from the steel pipe on the outer edge of the CFRP repair pipe mockup. Figure 17 shows the river-like matrix cracking on the CFRP repair pipe mockup after the hydrostatic pressure testing.

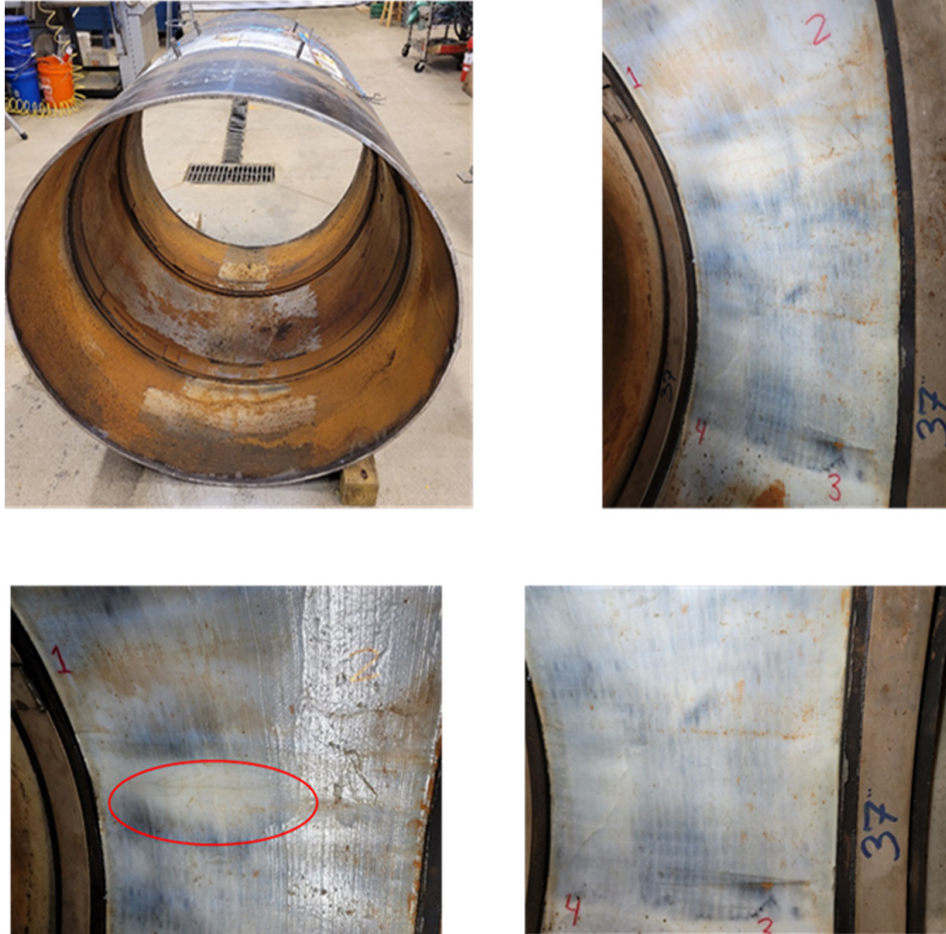
Figure 17. River-like matrix cracking on the CFRP pipe after hydrostatic testing. Images from Hioe et al. (2021).

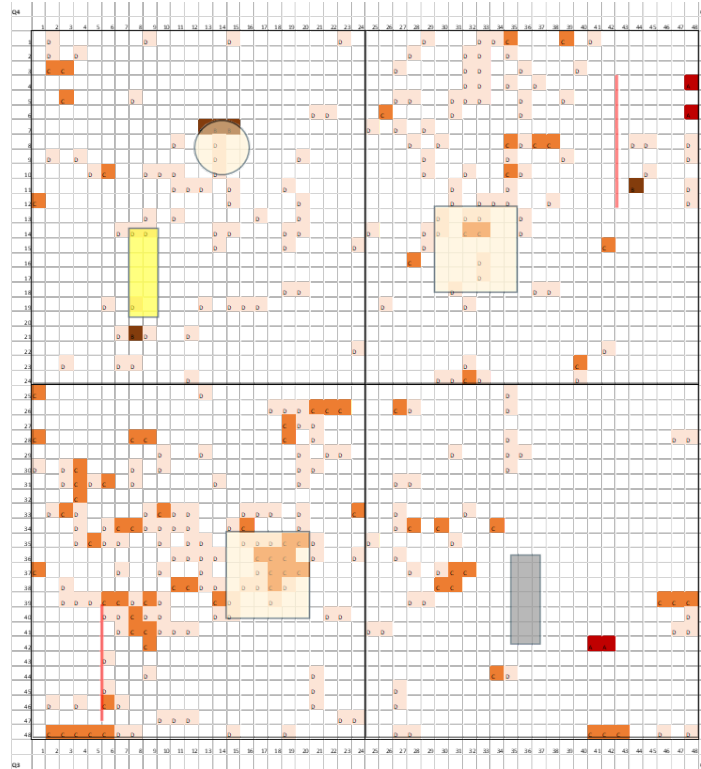
Figure 20. Woodpecker results on Mockup 1 based on the color code shown in Table 6. The intended true state (see Figure 5) is overlaid on the Woodpecker results.

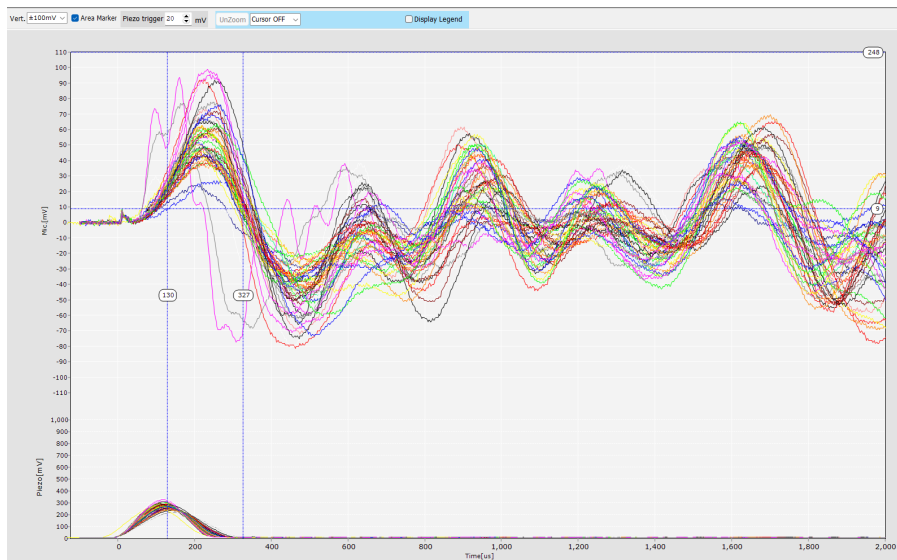
Figure 22. Example EVOTIS signal responses from one grid row.

A second ATT device was borrowed by PNNL from EPRI, an EVOTIS tap tester (see Figure 21). The EVOTIS is intended for use on thick composites. It measures both a piezoelectric and acoustic response and records the data digitally to a computer via a USB connection for real-time visualization. Figure 22 shows an example of recorded waveforms from one row of the grid; location information was recorded manually. These raw data required additional analysis in order to determine whether a defect was present.

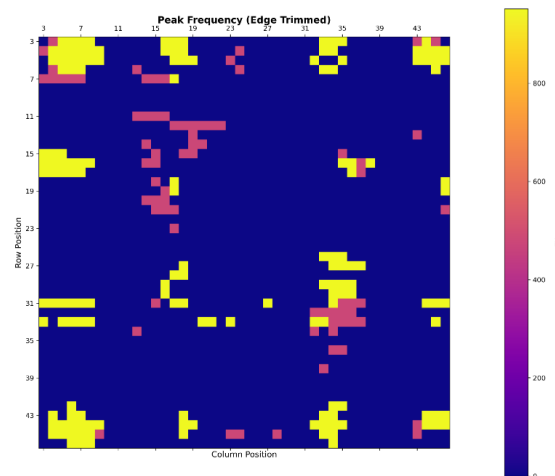
- What it does: Converts time-based signal into frequencies (like a musical note analyzer)
- Key outputs:
 - Peak frequency: The strongest frequency in the signal (like the main musical note)
 - Center frequency: The middle point of the active frequency range
 - Bandwidth: The range of frequencies in the signal (how “broad” the sound is)
- Value: Identifies the main ultrasonic frequencies that interact with the material
- Conclusion: Appears to be as sensitive or more sensitive to the natural resonances of the plate than to the defects

Figure 23. Peak frequency plot of Mockup 1.

1. Basic frequency analysis (Figure 23)

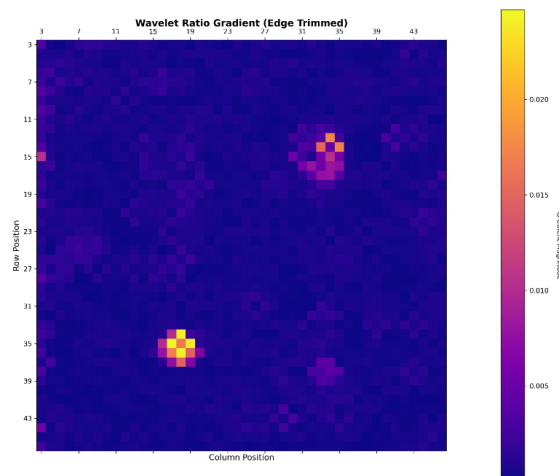
- What it does: Breaks signal into different components (like separating bass, midrange, and treble in music) and compares the ratio of different components or the spatial gradient of the ratio
- Key outputs:
 - Approximation energy: energy in the lowest frequencies
 - Detail 1 energy: energy in the highest frequencies
 - Detail 2 energy: energy in the medium-high frequencies
- Value: Shows which frequency ranges contain most information about the material
- Conclusion: Appears to be sensitive to defects, has a high contrast-to-noise ratio

Figure 25. Wavelet ratio gradient plot of Mockup 1.

PNNL analyzed the EVOTIS data using several methods that were then evaluated to decide which method provided the most sensitivity and most accurate results. These methods included basic frequency analysis, signal quality assessment, multi-scale decomposition (wavelet), audio-inspired features, and correlation analysis. A brief summary of these methods is given below. The value of some analysis methods was readily apparent, whereas others may contain information that is less obvious. To avoid spending too much time digging into analytical minutiae, a high-level analysis determined that the wavelet ratio spatial gradient (Figure 25) had the best performance in identifying the flaws. These data will be shown in this report.

3. Multi-scale decomposition (wavelet) (Figure 25)

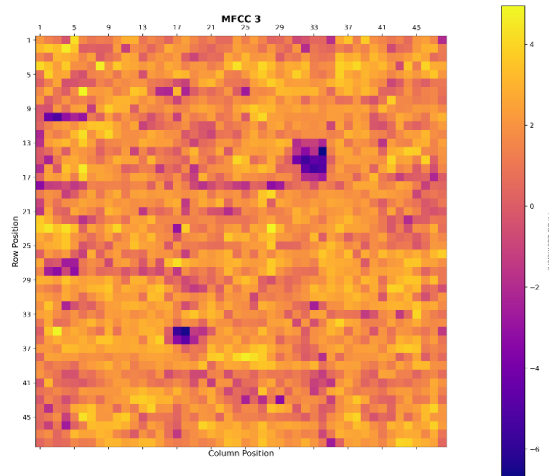
- What it does: Analyzes signal features and audio descriptors, such as “timbre,” using frequency analysis techniques (Abdul and Al-Talabani 2022)

- Key outputs:
 - o MFC coefficients: Numerical values representing spectral patterns
- Value: Captures complex audio patterns that may indicate material properties
- Conclusion: Appears somewhat sensitive to defects but is noisy

Figure 26. MFC coefficient plot of Mockup 1.

4. Mel frequency cepstral (MFC) coefficients (Figure 26)

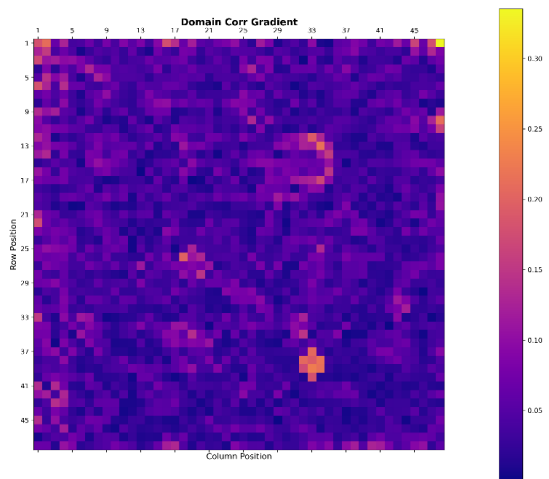
5. Correlation analysis (Figure 27)

- What it does: Compares the microphone and piezo sensor readings
- Key outputs:
 - o Pearson correlation coefficient: How closely the two sensors' readings correlate (-1 to 1, with -1 being perfect negative correlation and +1 being perfect positive correlation)
- Value: Shows how consistently material responds to acoustic testing using two different measurements
- Conclusion: Less sensitive than other methods, some false signals

Figure 27. Pearson correlation analysis of Mockup 1.

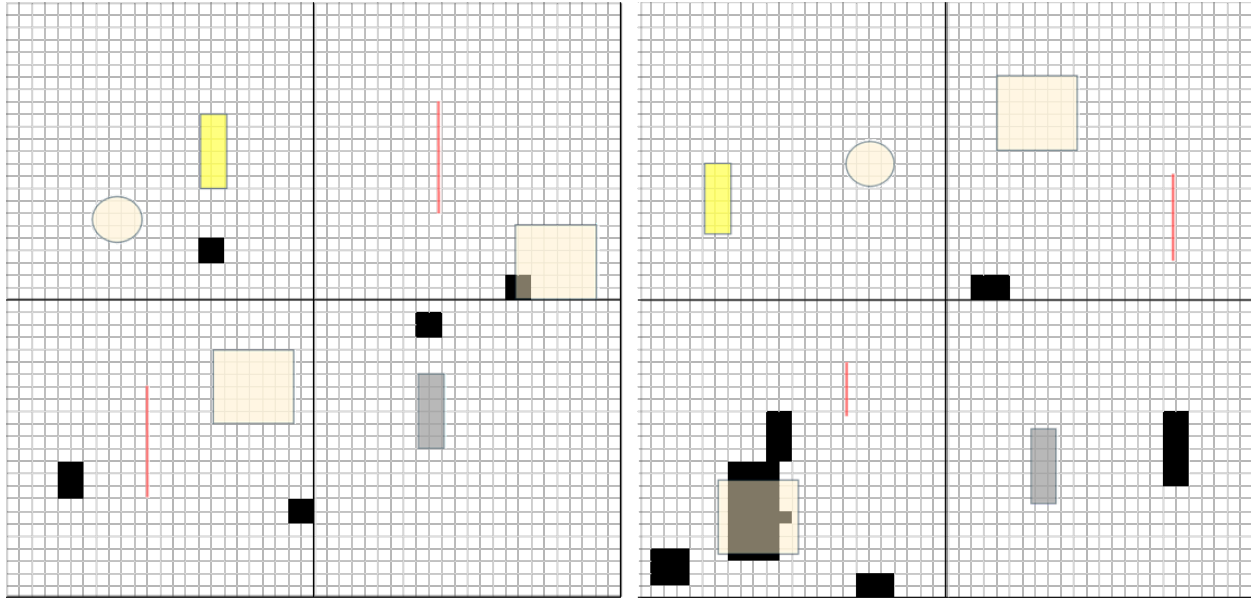
Figure 30 shows results from Mockups 4 and 6, fabricated with the thick putty layers. Both show several false indications, and the sizes of the dry spots that were detected (in Q1 of Mockup 4 and Q3 of Mockup 6) did not agree well with the true-states.

Figure 30. MTT results of Mockup 4 (left) and Mockup 6 (right).

Note that indications in the same location as the indication labeled “6” in Figure 33 were also observed in the ATT and MTT data (see Figure 30 and Figure 32). It is likely an unintended disbond defect.

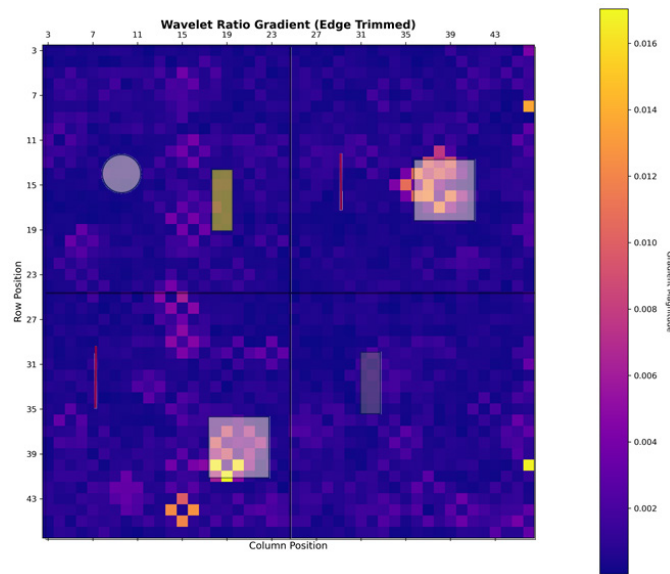
ATT performed nearly identically to MTT; the only exceptions were two dry spots detected with MTT that were not detected with ATT. Figure 31 shows results from Mockup 3. The color scale in the figure indicates the strength of the measured wavelet ratio gradient; stronger indications appear orange and yellow against the purple background. The dry spot in Q4 was missed, and this mockup had a higher than usual amount of background noise.

Figure 31. ATT results of Mockup 3.

effect (cf., Figure 31, which has a couple of small indications along the right edge). The ATT results of Mockup 6 were similar to those of the MTT, with one dry spot detected.

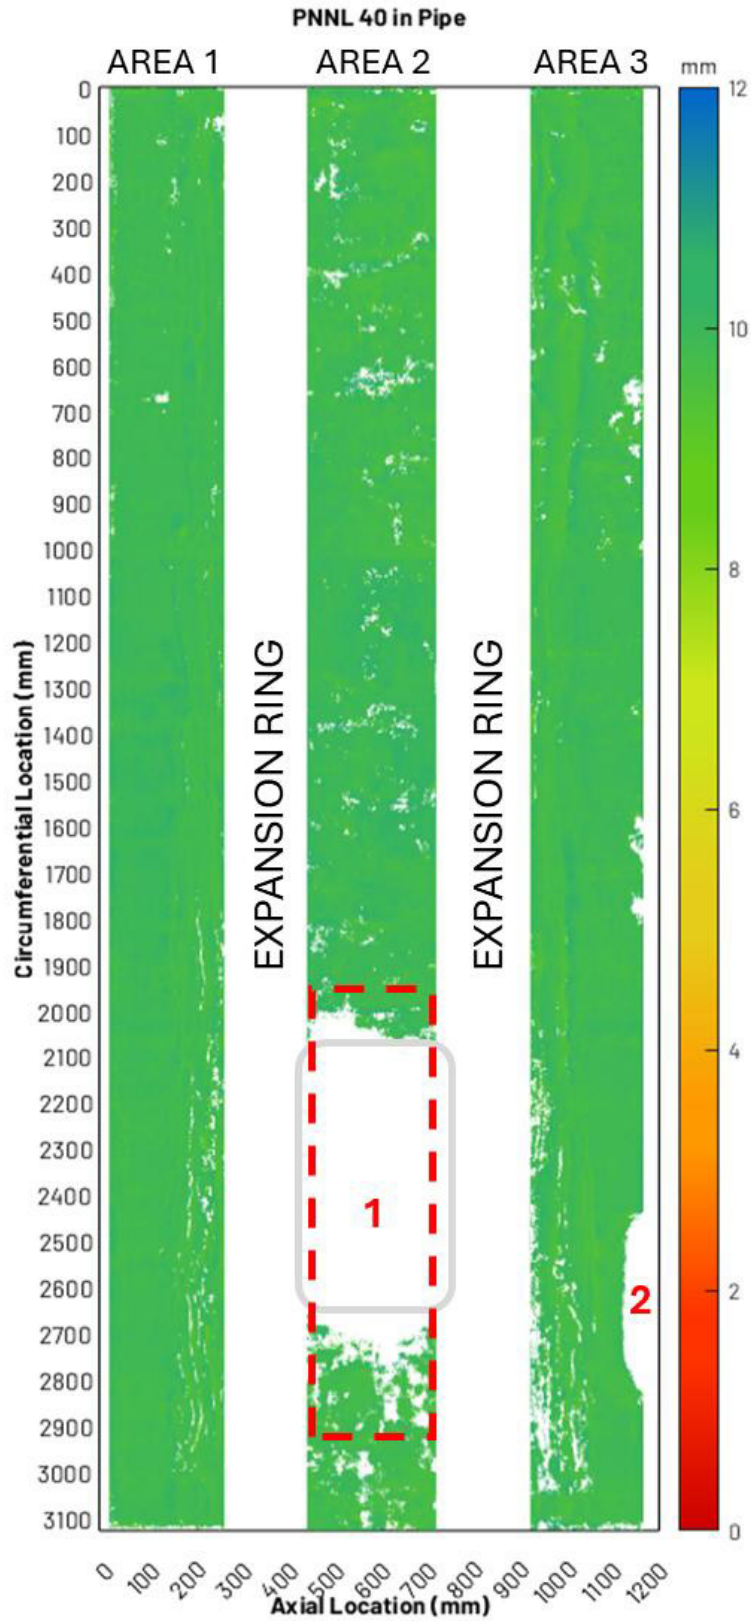
The pipe mockup, described in Section 3.6, was inspected by Sonomatic from the inner surface using DRS. Figure 38 shows the DRS map. Two circumferential regions were not inspected because of the expansion rings, shown in Figure 15. Overall, the DRS results show that the CFRP was well bonded to the steel pipe. Sonomatic expressed that some areas of the epoxy surface were rough enough to prevent good contact with the scanning head, which resulted in some white pixels in the map that were not flagged as indications. Two large indications, labeled 1 and 2 in Figure 38, were identified.

Indication 1 is the missing steel area, but it also extends further in the circumferential direction than the actual defect. This suggests that delamination occurred during the hydrostatic pressure testing, as evidenced by the water leaking during the pressure tests. Indication 2 correlates to the CFRP disbond flaw identified by visual inspection, as shown in Figure 16, extending from 85 mm (3.35 in.) axially, touching the edge of pipe to 410 mm (16.1 in.) circumferentially. Note that the only other confirmed flaw identified in the EMC² report was river-like matrix cracking, as shown in Figure 17. This flaw lies within the area designated as Indication 1, where the metal substrate is absent. Consequently, a limitation of the DRS technique is evident: while it identifies debonding regions, it cannot detect flaws within the CFRP repair itself. This is because the methodology for DRS excites the steel substrate with a range of low ultrasonic frequencies and uses the response to determine thickness and thickness variations, further correlating it to a debond or defect. Hence, without a steel substrate as base, this DRS technology is not valid on the CFRP material alone. It only identifies a region as a flaw if the thickness of the metal substrate is not detected. Furthermore, CC N-871-1 focuses primarily on the terminal end region and requires only visual inspection of the remaining CFRP-repaired area. As a result, inservice defects, such as matrix cracking presented on the CFRP-repaired area (which are not terminal ends), will not be detected under current procedures and standards unless additional NDE techniques are employed.

Figure 38. DRS map of the CFRP pipe mockup inspected internally.

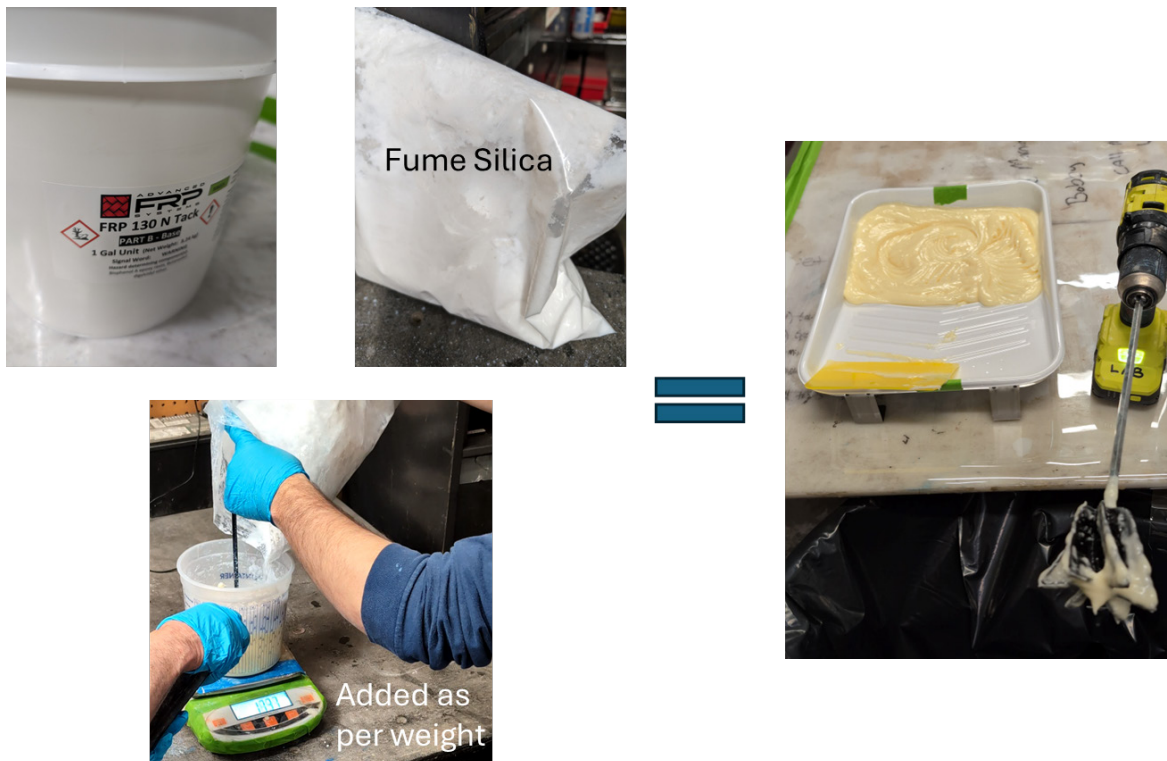
The putty used in the CFRP mockup fabrication process (130N Tack) has 6.3% of fumed silica with other proprietary components. However, the percentage of fumed silica varies between different CFRP manufacturers, and it is also varied depending on the weight of the fabric. In order to have this percentage of fumed silica as a variable, an additional 2% or 4% (by weight) was added to the 130N to achieve 8.3% and 10.3%. The fumed silica was mixed well with the 130N tack coat and stirred thoroughly, as shown in Figure A.1.

Figure A.1. Preparation of thickened epoxy.

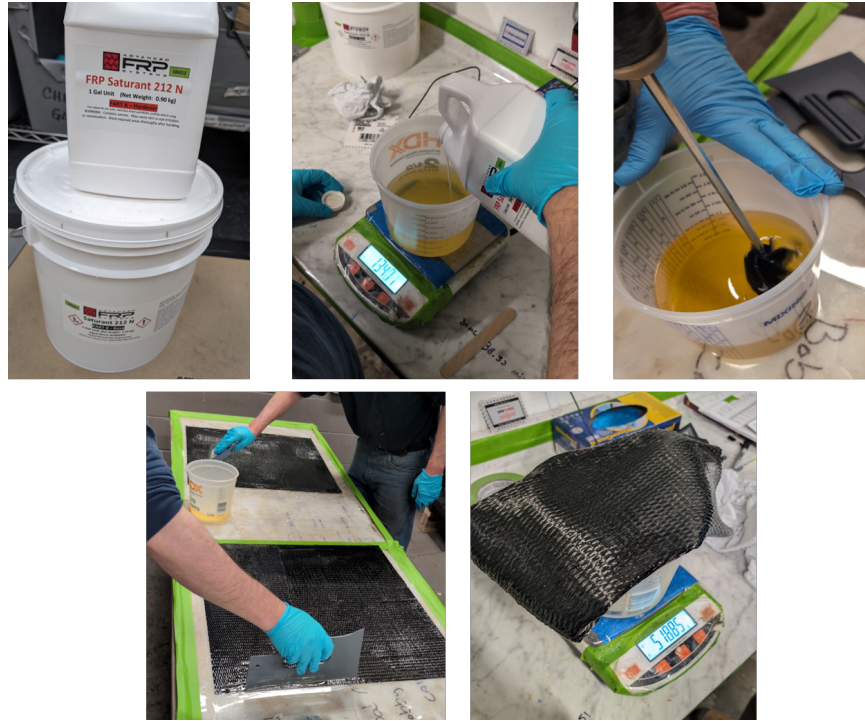
The fabric saturation was achieved by mixing the two-part epoxy and hardener in the appropriate ratio, as specified by the manufacturer and shown in Figure A.2. It was thoroughly mixed and manually applied to the fabric. The fabric was weighed to ensure the fiber-matrix ratio met design criteria and any additional epoxy was removed.

Figure A.2. Manual saturation of fabric.

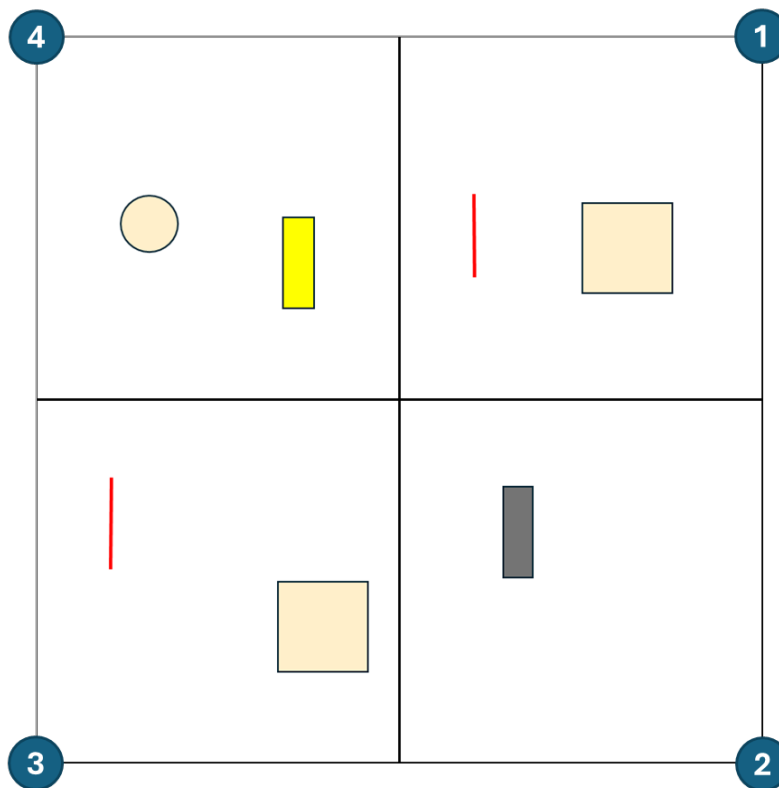
Figure B.3. Plate 3.

130N 10.3% (additional 4% fumed silica) tack coat on primer and between each layer		
1/16" notched trowel for the 130N		
FG Layer	No Defects	
CF1	Q1 – 2 in. to 3 in. wrinkle	14.5 in. right and 5 in. to 7.5 in. down
CF2	Q1 – Dry spot (3 in. x 3 in. square)	18 in. to 21 in. right and 5.5 in. to 8.5 in. down
CF3	Q2 – 3 in. x 1 in. overlap	15.75 in. to 16.75 in. right and 14.75 in. to 17.625 in. down
	Q3 – 2 in. to 3 in. wrinkle	2.5 in. right and 14.5 in. to 17.5 in. down
	Q4 – 3 in. x 1 in. gap	8.375 in. to 9.375 in. right and 6 in. to 9 in. down
CF4	Q3 – Dry spot (3 in. x 3 in. square)	8 in. to 11 in. right and 18 in. to 21 in. down
CF5	Q4 – Dry spot (3 in. ² circle)	4 in. right and 6.25 in. down to center
CF6	No Defects

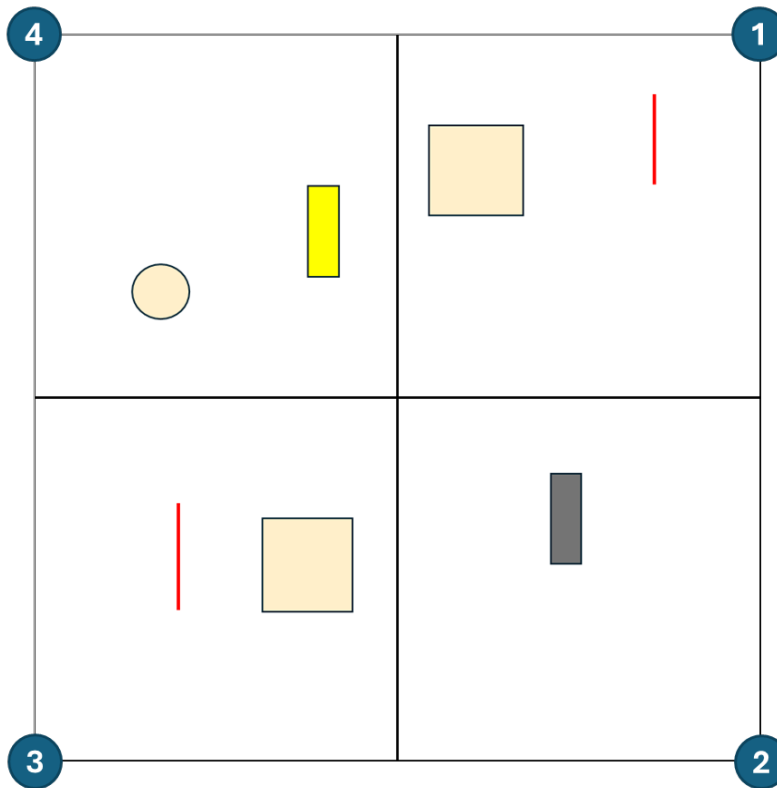
Figure B.5. Plate 5.

130N 8.3% (additional 2% fumed silica) tack coat on primer and between each layer		
1/4" notched trowel for the 130N		
FG Layer	No Defects	
CF1	Q1 – 2 in. to 3 in. wrinkle	20.5 in. right and 2 in. to 5 in. down
CF2	Q1 – Dry spot (3 in. x 3 in. square)	13 in. to 16 in. right and 3 in. to 6 in. down
CF3	Q2 – 3 in. x 1 in. overlap	17 in. to 18.25 in. right and 14.5 in. to 17.5 in. down
	Q3 – 2 in. to 3 in. wrinkle	4.75 in. right and 15.5 in. to 19 in. down
	Q4 – 3 in. x 1 in. gap	9 in. to 10 in. right and 5 in. to 8 in. down
CF4	Q3 – Dry spot (3 in. x 3 in. square)	7.5 in. to 10.5 in. right and 16 in. to 19 in. down
CF5	Q4 – Dry spot (3 in. ² circle)	4.5 in. right 8.5 in. down to center
CF6	No Defects

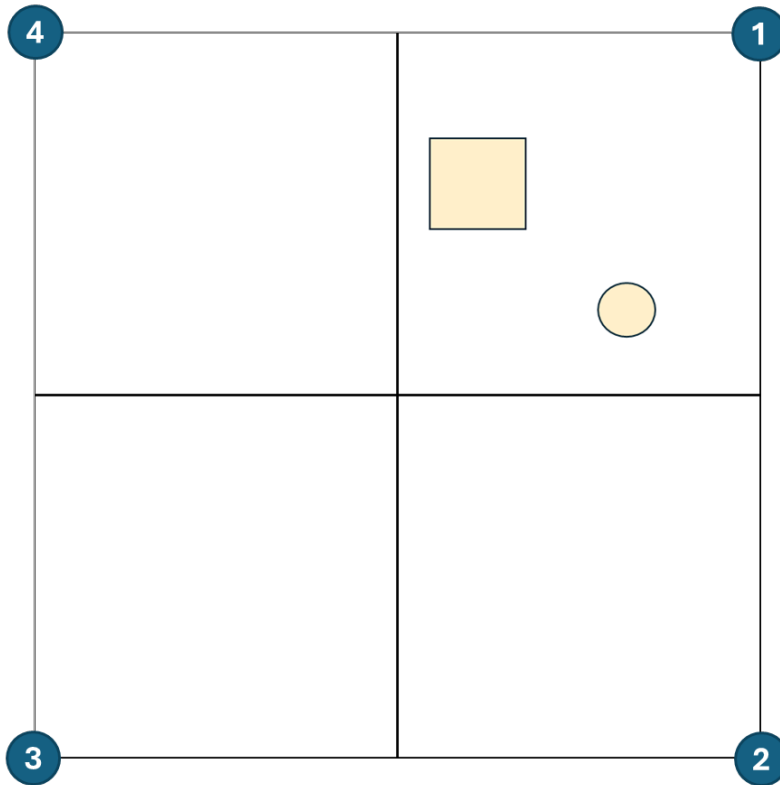
Figure B.8. Plate 8.

Blast 3 quadrants – Leave Q3 unblasted		
130N 8.3% (additional 2% fumed silica) tack coat on primer and between each layer		
1/4" notched trowel for the 130N		
FG Layer	Q1 – Dry spot (3 in. ² circle)	19.5 in. right and 9.25 in. down
	Q1 – Dry spot (3 in. x 3 in. square)	13 in. to 16 in. right and 3.5 in. to 6.5 in. down
	Q2 – Primer partial cure before ply	
	Q3 – Improper surface prep – no blast	
CF1	No Defects	
CF2	No Defects	
CF3	No Defects	
CF4	No Defects	
CF5	No Defects	
CF6	No Defects

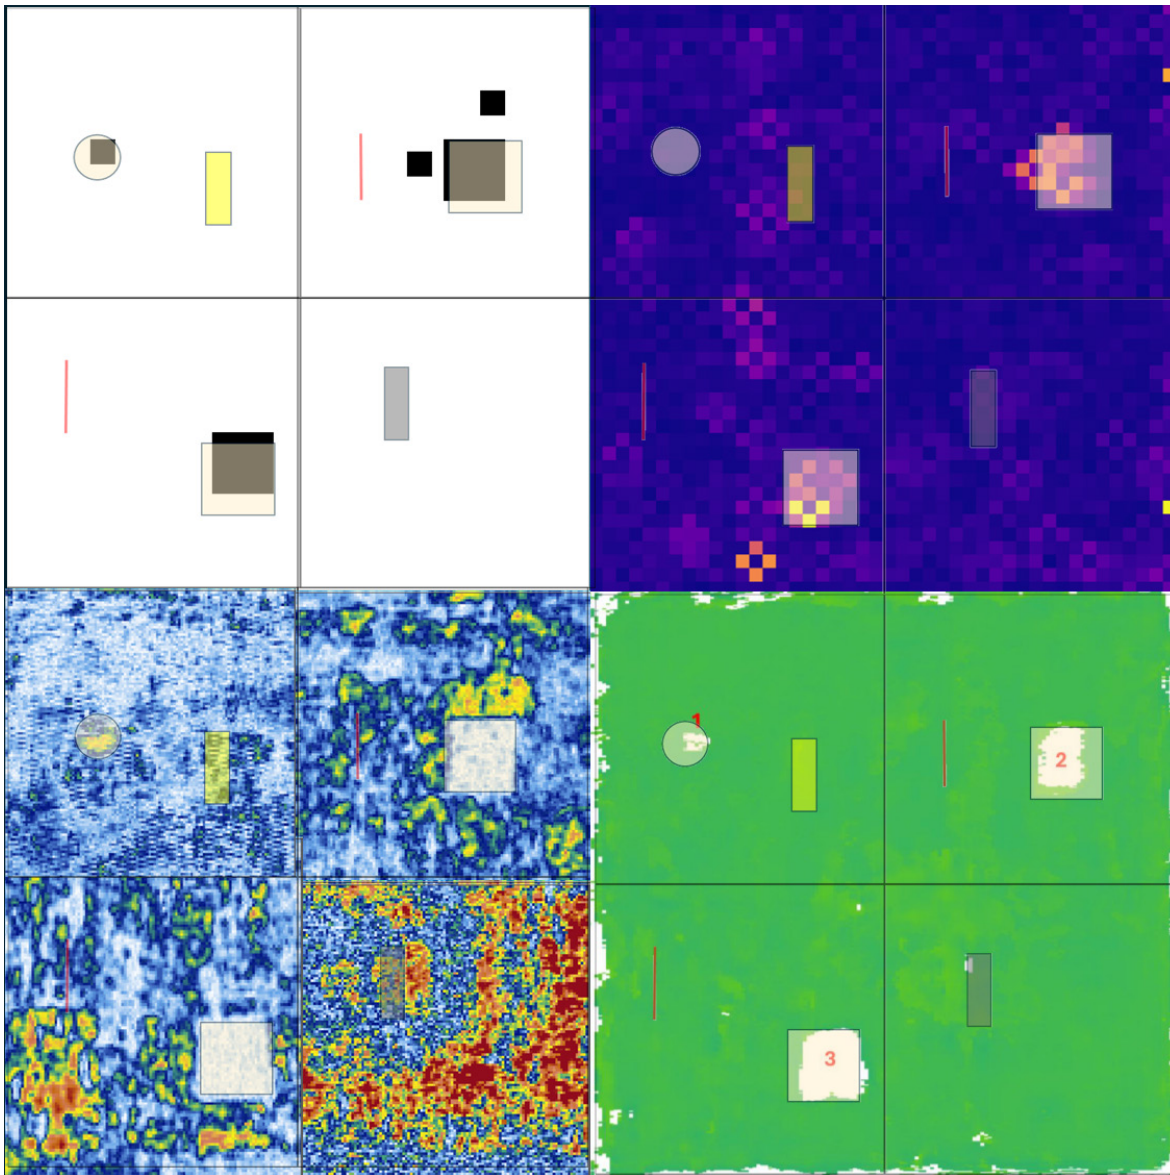
Figure E.4. NDE of CFRP Plate 3.

The NDE results from MTT, ATT, UT, and DRS are compared together in this appendix. The images below are organized as shown in Figure E.1: the top left quadrant is the MTT results, the top right quadrant is the ATT results obtained using EVOTIS, the bottom left quadrant has the 1.0 MHz UT results, and the bottom right quadrant is the DRS results. Plots are overlaid with the true-state maps.

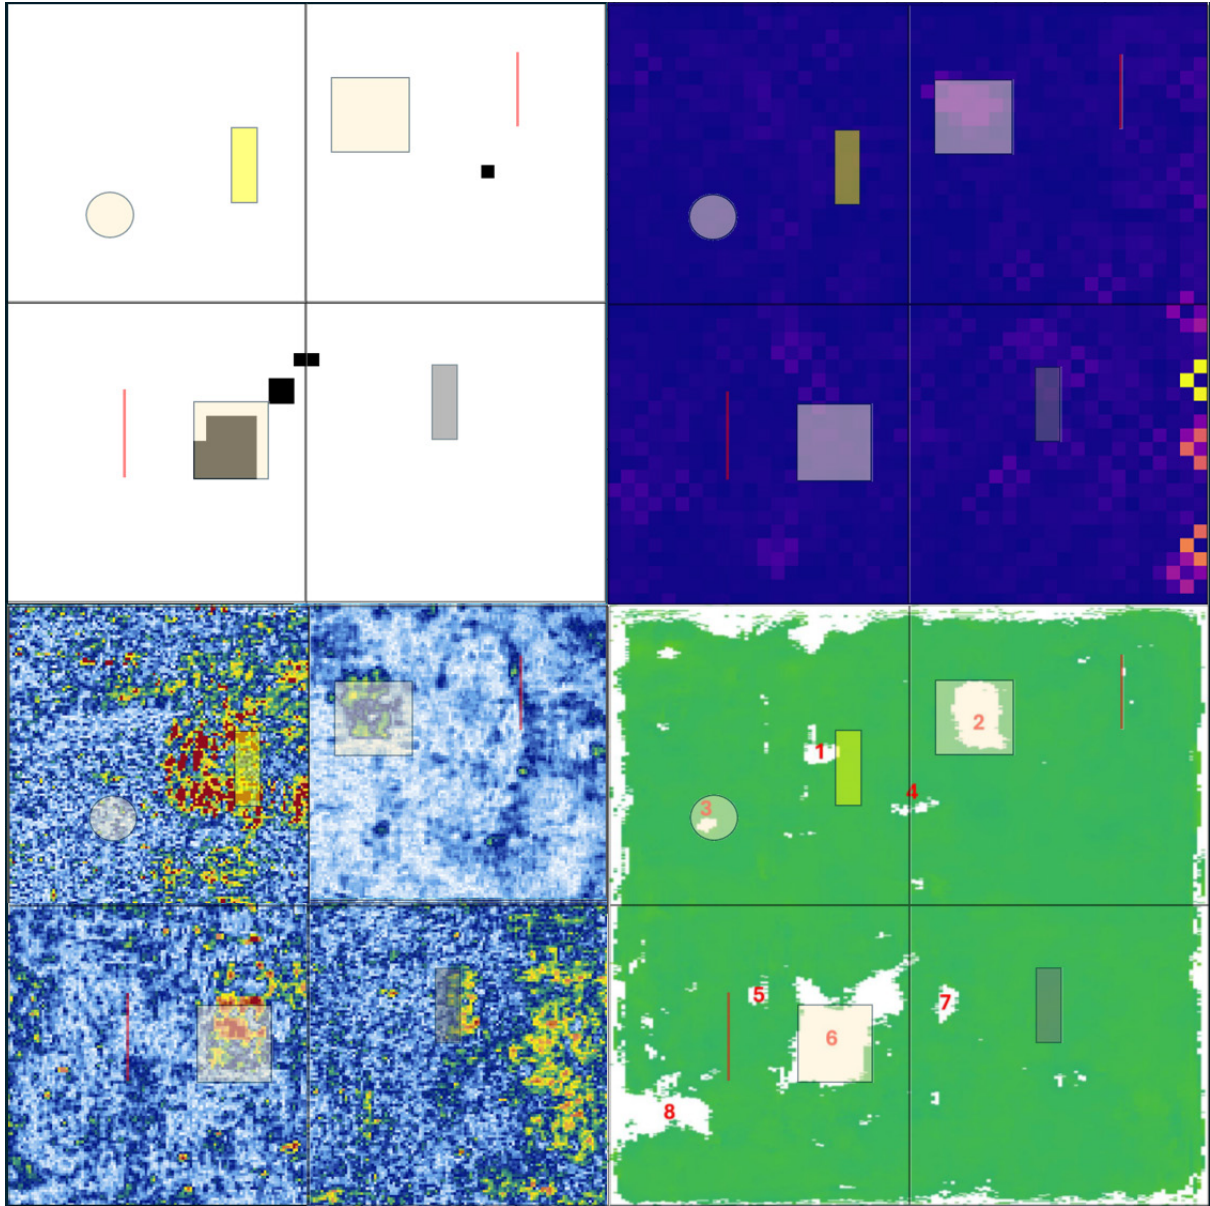
Figure E.6. NDE of CFRP Plate 5.

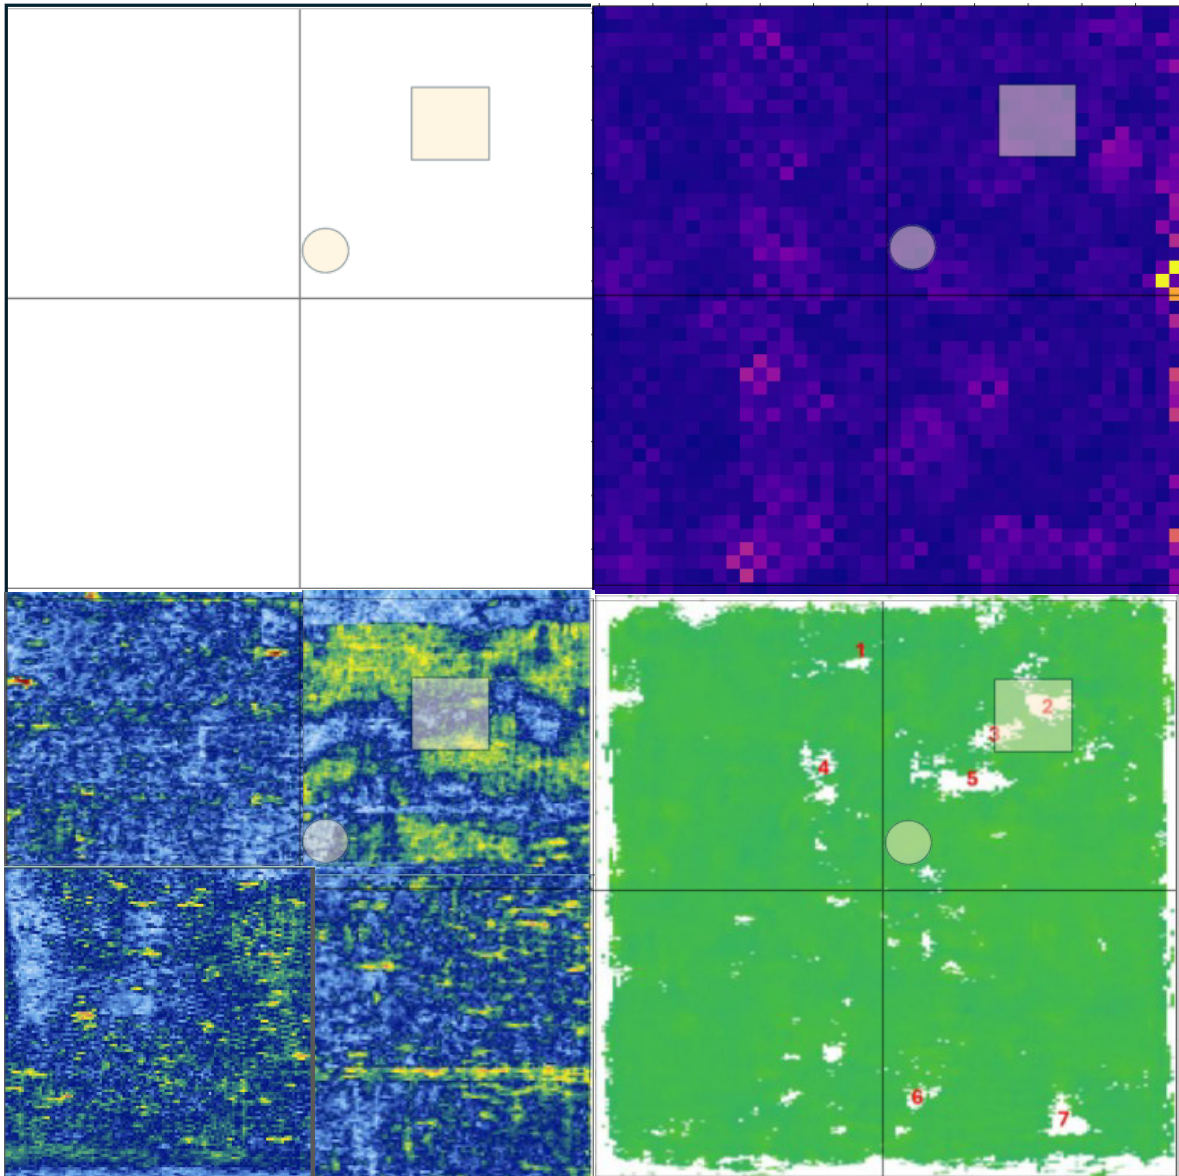
Figure E.8. NDE of CFRP Plate 7.
