Corrosion Fatigue Life Evaluation of 17-4PH in Support of Water Filled Turbine Hubs

Final Report

February 2025

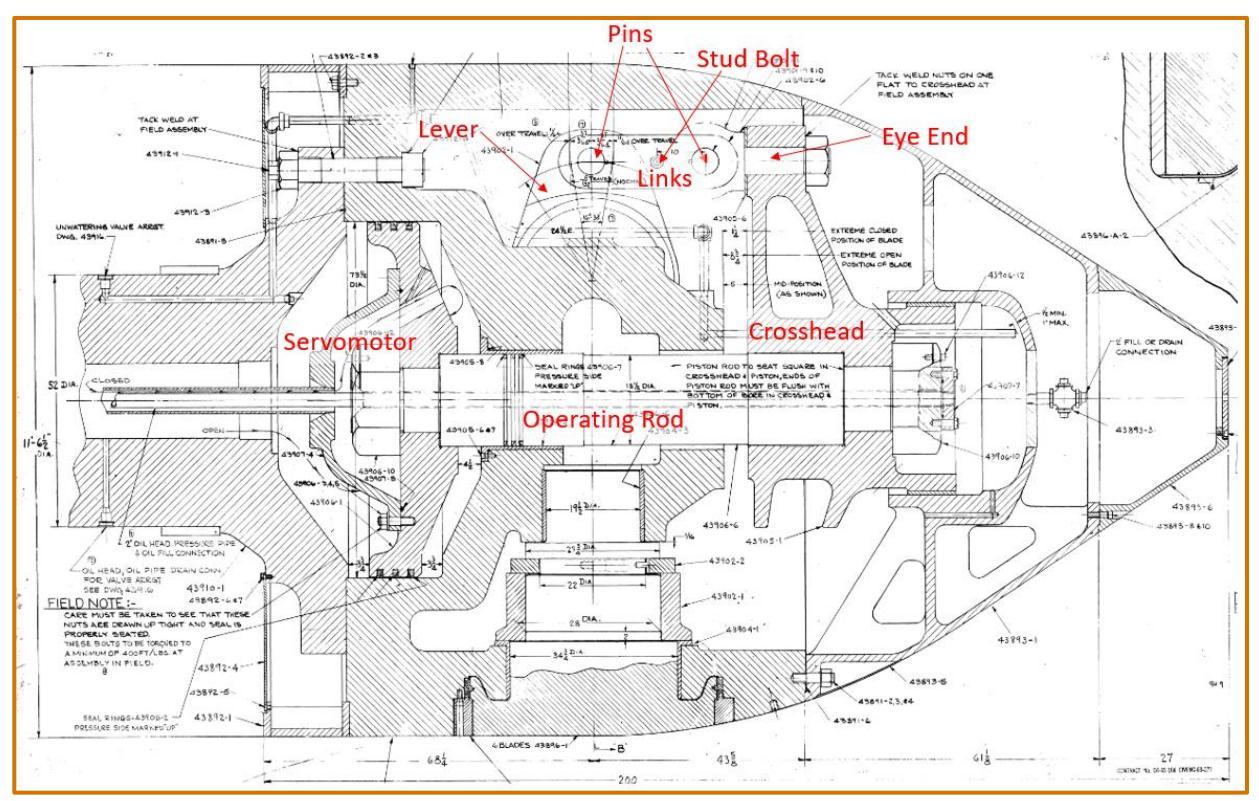
Figure 1. Detail drawing of an example Kaplan runner hub internals used to control blade angle. Blades are not shown in this sketch.

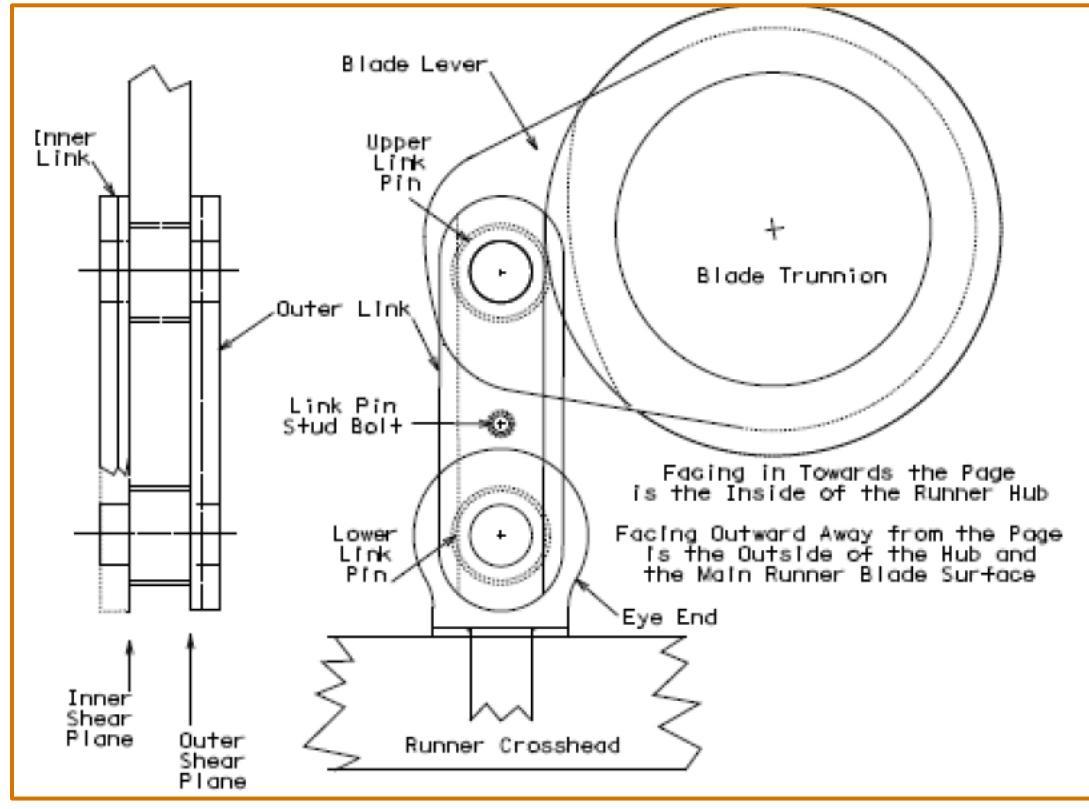
Figure 2. Sketch of BACH provided by the USACE.

The servomotor that controls blade angle is actuated by hydraulic fluid, and a position sensor is used as the feedback mechanism to control fluid pressure. The feedback loop between the crosshead position and pressure control hardware operates at a frequency of ~0.0055 Hz (a period of 3 minutes). As with any feedback-based control system, constant small back-and-forth adjustments to blade angle occur that cause alternating loads on the BACH. In addition to these feedback-driven load variations to the BACH, load changes also arise from directed changes in blade angle in response to river head and flow conditions coupled with the power setting that occurs on a longer time scale. Load changes associated with these two types of blade angle movement are roughly the same, and the overall frequency of the change in stress remains ~0.0055 Hz. The mean force applied by the crosshead is to push on the BACH at low blade angles and pull on the BACH at high blade angles. The most common operating angle for John Day Kaplan turbines is in the regime where the crosshead is exhibiting a mean pulling force on the BACH which resists the hydraulic thrust of the water passing the turbine blades.

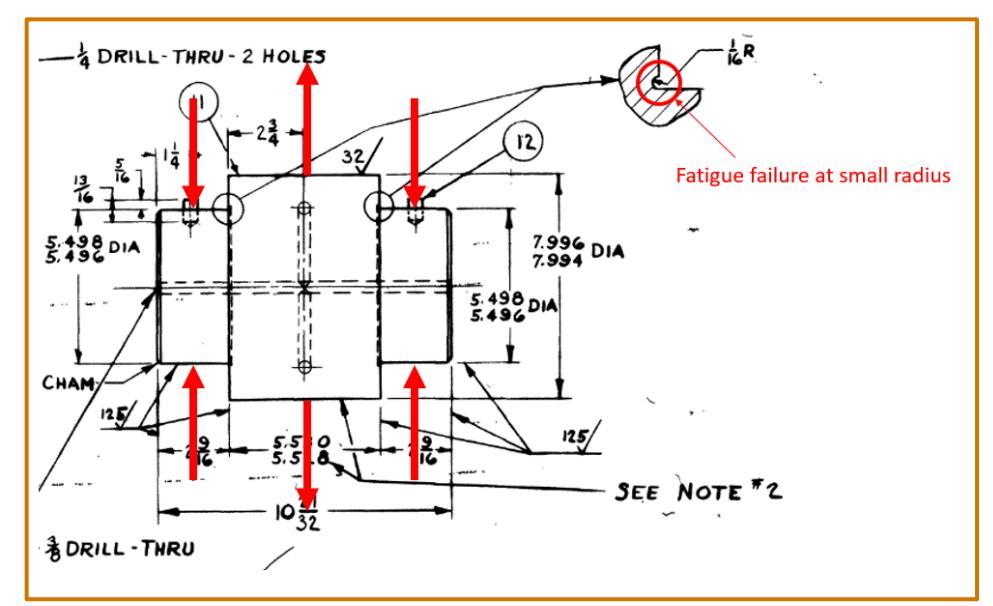
Figure 3. Diagram of a Kaplan runner hub link pin provided by the USACE.

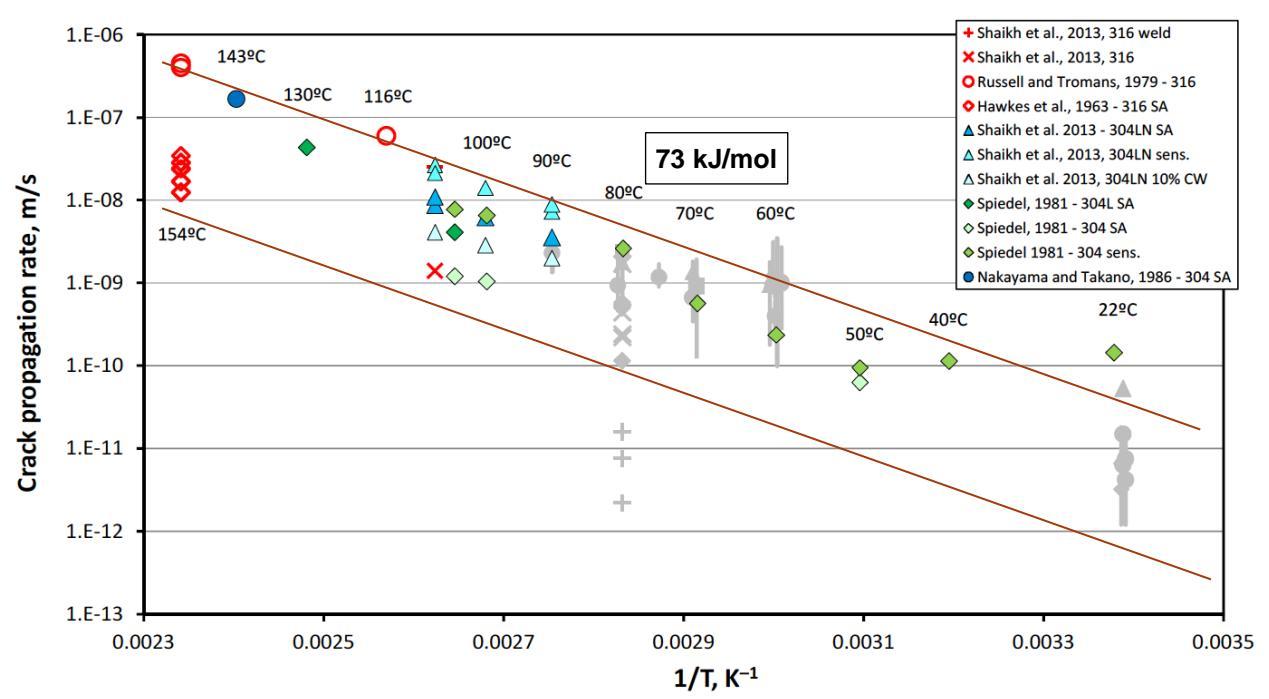
Figure 4. Literature compilation of 300-series stainless steel CISCC growth rate data [Bryan 2016]. Data points in gray are from air evaluations with deliquescent salts while immersed salt brine evaluations are colored.

In many cases, stress corrosion has a strong temperature dependence. An example for 300series stainless steel crack growth in chloride salt solutions and in deliquescent humid air chloride salt conditions is provided in Figure 4 [Bryan 2016, Toloczko 2020]. These are not corrosion fatigue crack growth tests, but rather true stress corrosion crack growth rate (SCCGR) tests conducted at constant load to show only the stress corrosion contribution to crack growth. In this example, a test temperature of 90°C produces an ~200x higher SCCGR than tests conducted at 22°C.

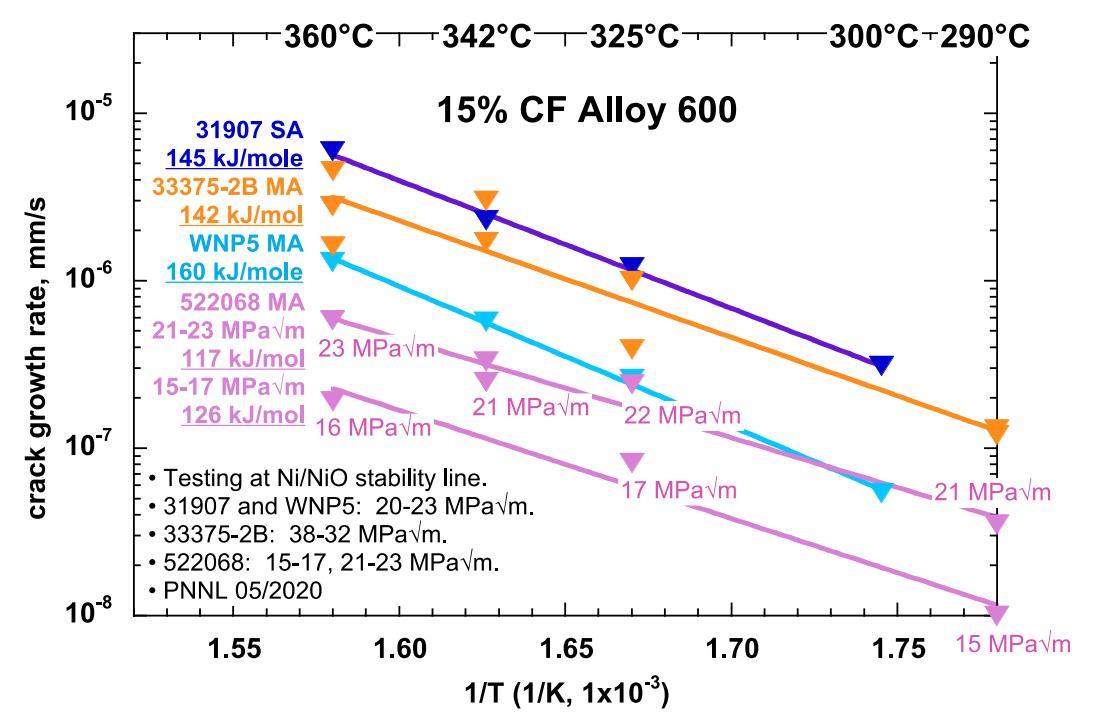
Figure 5. PNNL-measured stress corrosion crack growth rates of Alloy 600 in high temperature water showing an activation energy of 117-160 kJ/mol [Zhai 2020].

Another example of the dependence of SCCGR on temperature is shown in Figure 5 for Alloy 600 (a Ni-base alloy) measurements in high temperature water [Zhai 2020]. A complementary plot for Alloy 600 stress corrosion crack initiation (SCCI) in high temperature water is provided in Figure 6 [Etien 2011]. A strong temperature dependence on stress corrosion can again be seen. Note that the temperature dependence of Alloy 600 SCCI differs from the SCCGR temperature dependence, but the values are not substantially different, showing that, at least for this combination of material and environment, the accelerating effect of temperature is approximately the same for SCCI and SCCGR.

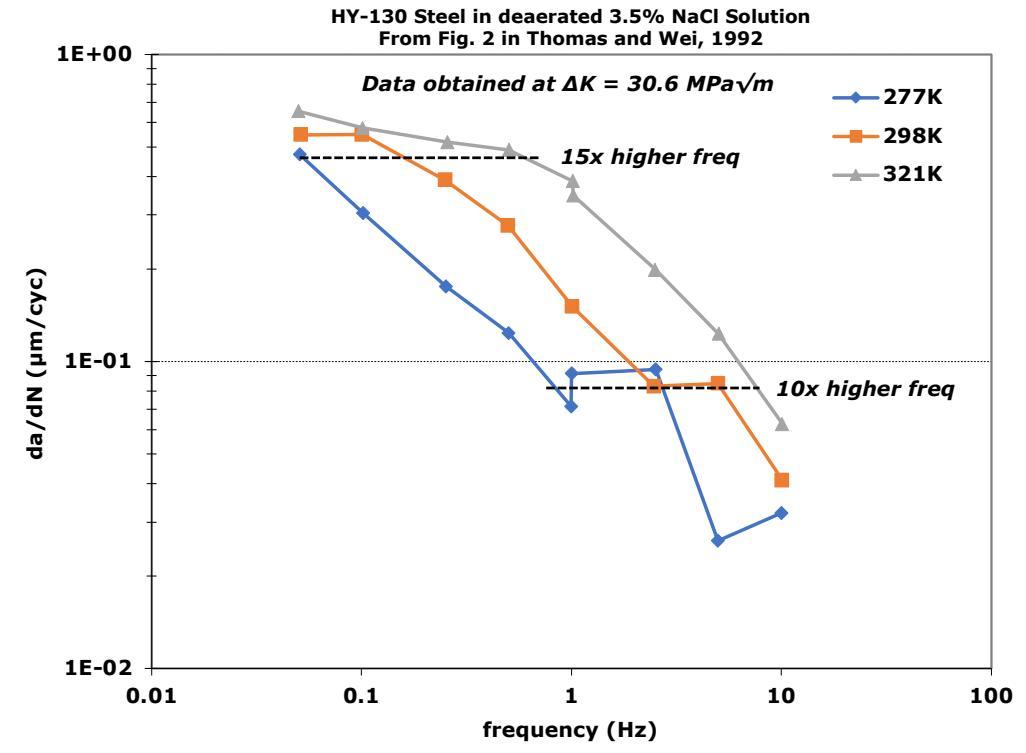
Figure 7. Corrosion fatigue da/dN as a function of frequency for HY-130 steel obtained at $\Delta K = 30.6 \text{ MPa}\sqrt{m}$ [Thomas 1992].

Research published by Thomas and Wei [Thomas 1992] contains data that allow a cursory evaluation of this approach. In this study, Thomas and Wei measured the corrosion fatigue crack growth rate (CGR) and da/dN of HY-130 steel in a sodium chloride solution. HY-130 is a high strength steel with 0.4Cr, 4.7Ni, 0.4Mo, 0.7Mn, and 0.2Si. da/dN data were obtained over a range of temperature, cyclic loading frequency, and stress intensity factor amplitude (ΔK) values. Plots of the da/dN as a function of cyclic loading frequency in Figure 7 (ΔK = 30.6 MPa \sqrt{m}) and Figure 8 (ΔK = 20.9 MPa \sqrt{m}) show that at any given temperature, the crack advance per load cycle (da/dN) decreases with increasing cyclic loading frequency because the time-dependent stress corrosion contribution to crack advance becomes smaller as the cycle period decreases. The plots suggest that for a limited range of frequencies, da/dN can be maintained at increasing frequencies by increasing the temperature. This is represented by horizontal lines of constant da/dN across the data sets. Using the data in Figure 7, if a plantrelevant corrosion fatigue environment is 0.05 Hz at 277K (5°C) where da/dN is ~0.45 µm/cycle, then an accelerated test that maintains that same crack advance per cycle for the same ΔK could be conducted at ~1 Hz (20x higher frequency) when using a test temperature of 321K (48°C). A similar accelerating approach is implied by the Thomas and Wei measurements conducted at $\Delta K = 20.9 \text{ MPa}\sqrt{\text{m}}$ as shown in Figure 8, and in particular, the same ~10x accelerating factor appears to exist between the 277K (5°C) and 321K (48°C) data traces.

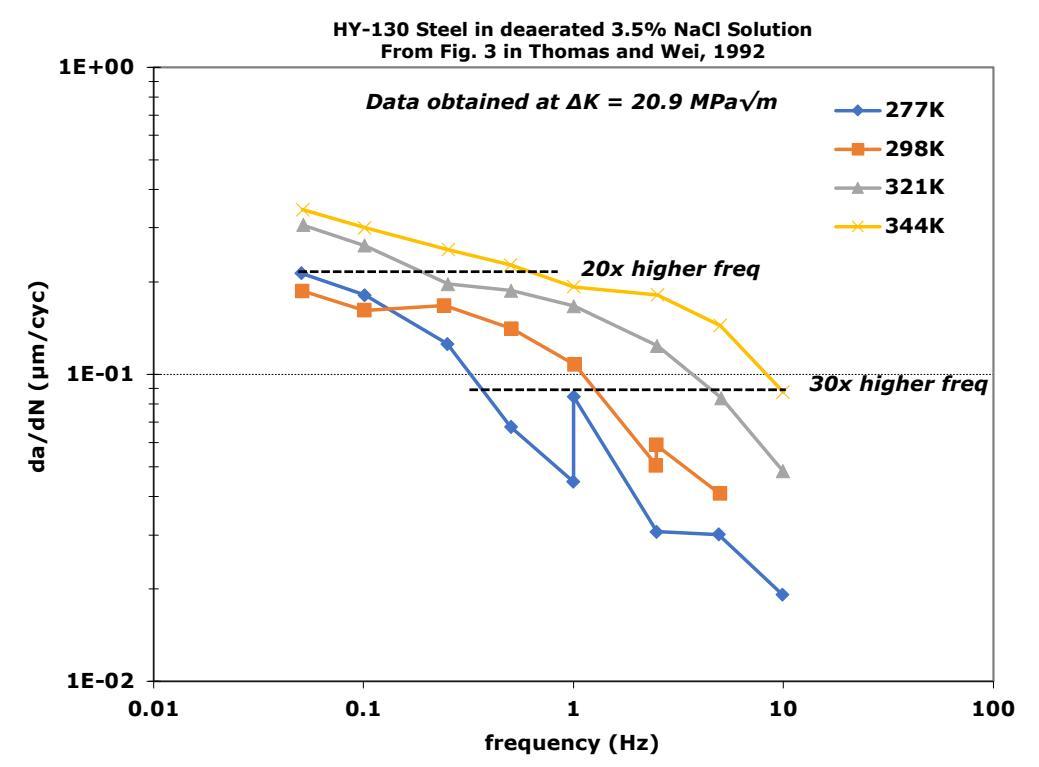
Figure 8. Corrosion fatigue da/dN as a function of frequency for HY-130 steel obtained at $\Delta K = 20.9 \text{ MPa}\sqrt{m}$ [Thomas 1992].

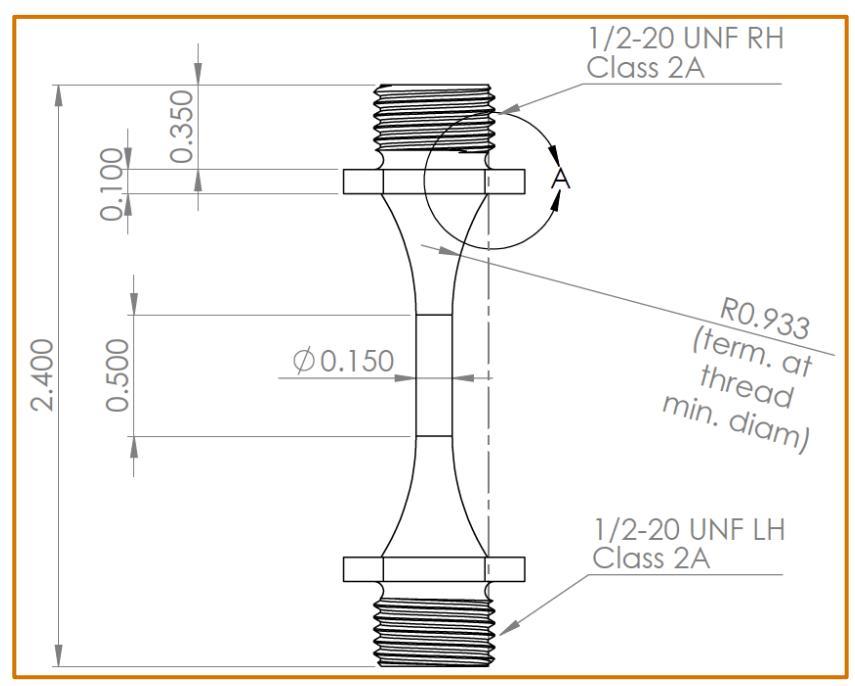
Figure 9. Tensile specimen design used for this project.

High cycle fatigue (HCF) and high cycle corrosion fatigue (HCCF) life testing was conducted using tensile specimens in a tension-tension loading condition. A round tensile specimen with a nominal 0.150 inch (3.8 mm) gauge diameter was designed based on ASTM E466 guidelines [ASTM 2021]. As shown in Figure 9, this specimen has a 0.5 inch (12.7 mm) long gauge, a fillet radius of 0.933 inch (23.7 mm), and a shoulder diameter of ~0.5 inch (12.7 mm). A surface finish of RA32 (root mean square surface height variability ≤32 µinches or ≤0.8 µm) or better was specified for specimen fabrication, and spot checks were performed to verify surface roughness.

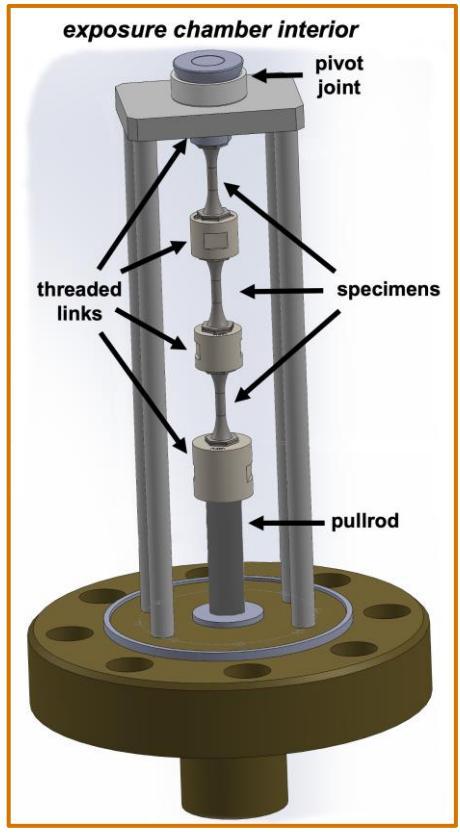
Figure 10. Sketch of multi-specimen corrosion fatigue life testing load train.

An example of a set of specimens installed in a test system is provided in Figure 10. Notable items in this photo are polytetrafluorethylene used for pivot joint lubrication and wiring attached to the specimens that is used to detect the formation of a crack.

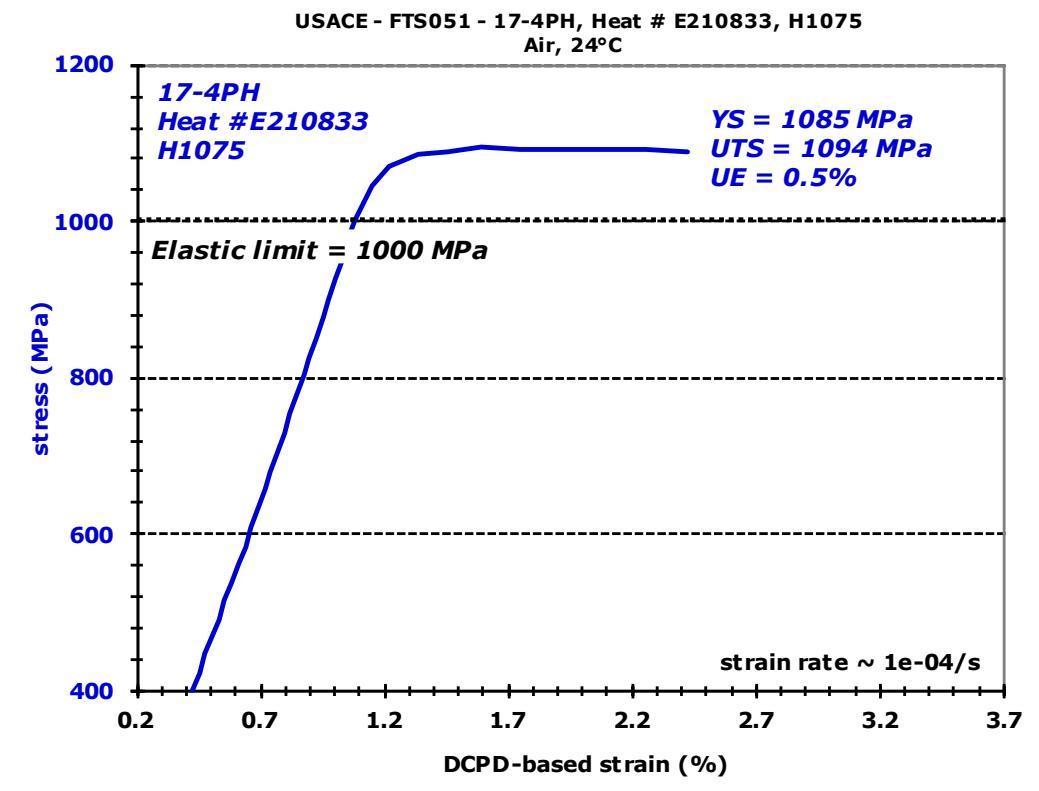
Figure 12. Room temperature tensile test of the 17-4PH used for this research.

To evaluate the tensile properties needed to select the upper limit of the maximum stress for corrosion fatigue testing, a single tensile test was conducted at room temperature (24°C) and 90°C. Tensile curves and tensile properties consisting of YS, ultimate tensile strength (UTS), and uniform elongation (UE) are provided in Figures 12 and 13. As expected, only minor differences in tensile properties were observed between the room temperature and 90°C tests. The differences could be due to the difference in test temperature or material variability.

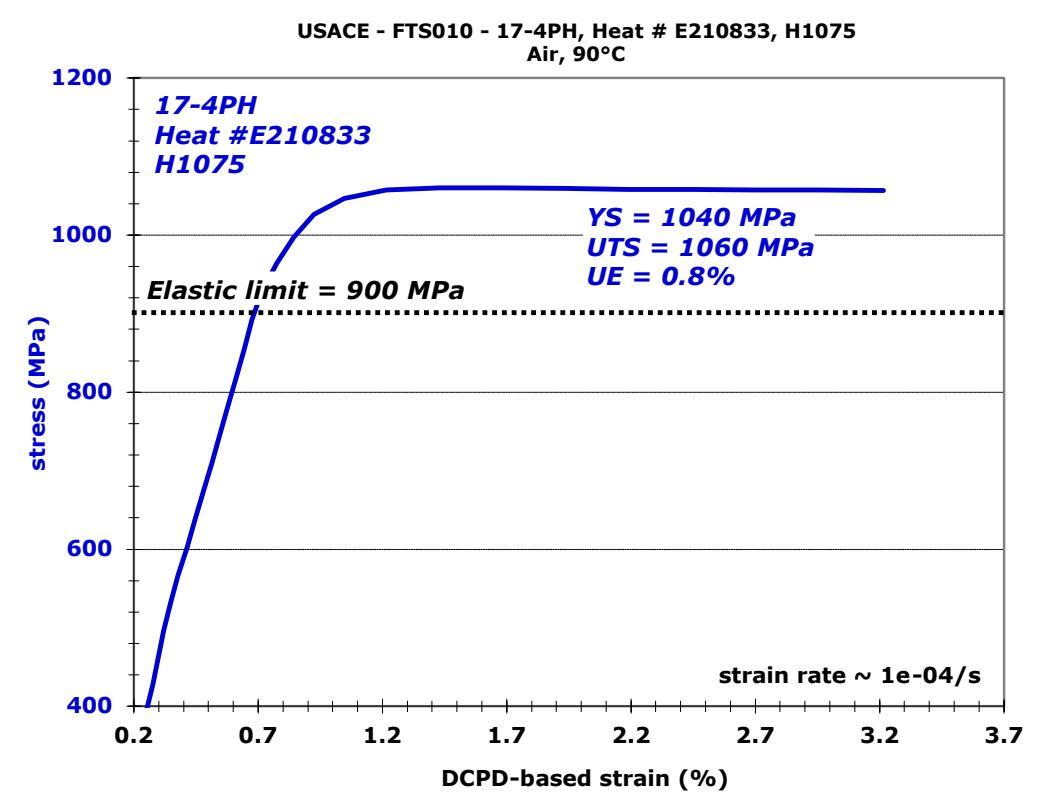
Figure 13. 90°C tensile properties of the 17-4PH used for this research.

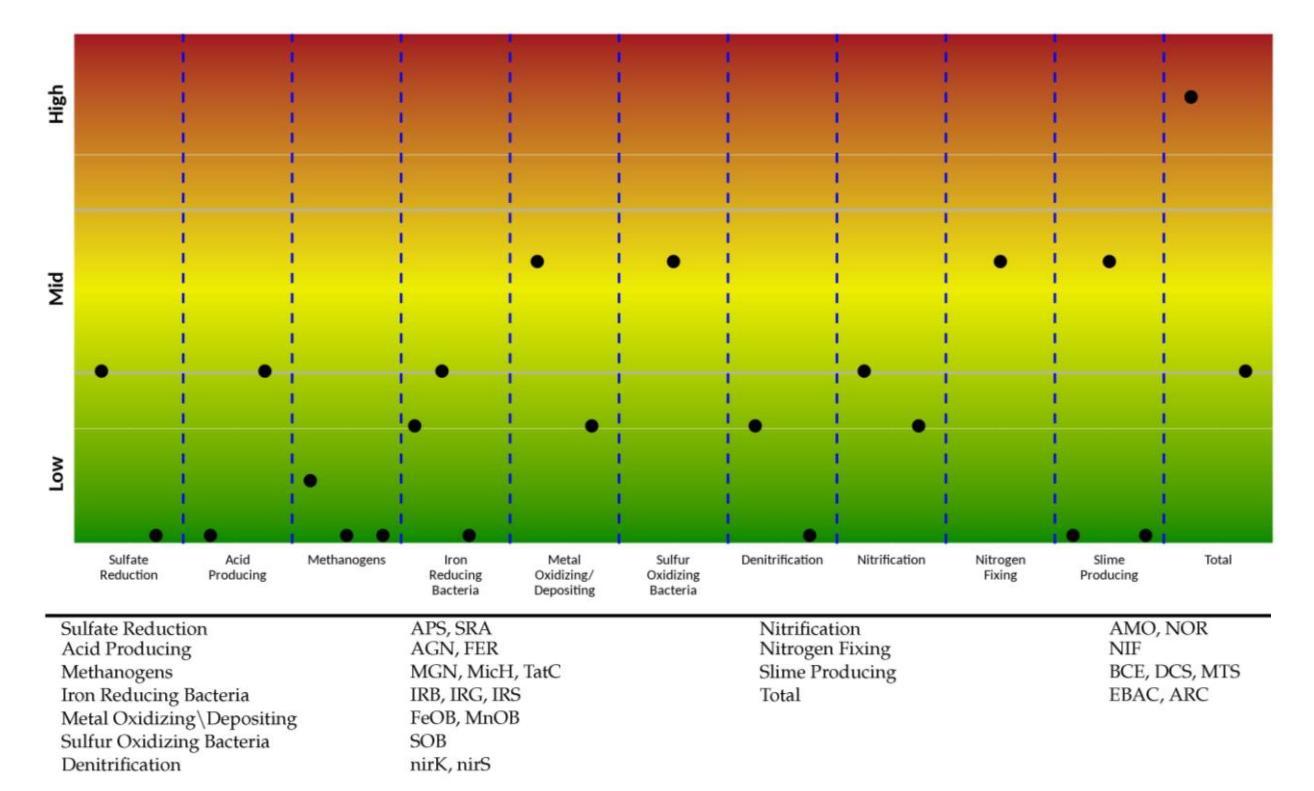
Figure 14. Microbial population summary on water sample retrieved from Columbia River downstream of John Day Dam in November 2022 to aid in evaluating potential MIC mechanisms. The dots in the same category represents the concentration of different microbe species that belong to the same functional group.

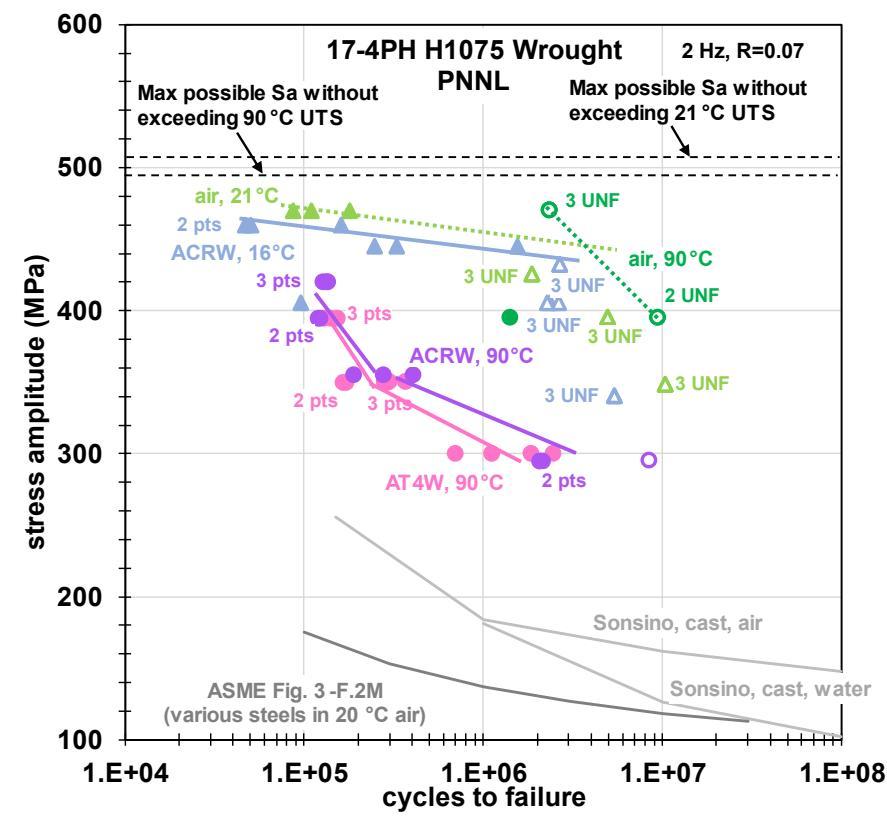
Figure 15. HCF and HCCF life in air and water for tests conducted near room temperature and at 90°C.

The 16°C HCCF performance of the PNNL-tested 17-4PH is approximately 96% of the room temperature HCF performance. It is difficult to compare this aspect of the PNNL test results to the literature because virtually all literature HCCF data on 17-4PH was obtained in water with 3+ orders of magnitude higher chloride content [Zhai 2023]. For such tests, the ratio of HCCF S_a to HCF S_a near 10⁶ cycles-to-failure ranged from 80-90%. For material roughly similar to 17-4PH, comparisons of HCCF and HCF performance for water purity similar to what were used by PNNL are possible. In particular, 410 stainless steel was found to have an HCCF life only slightly below its HCF life when tested in similar purity water used for the PNNL tests [Zhai 2023].

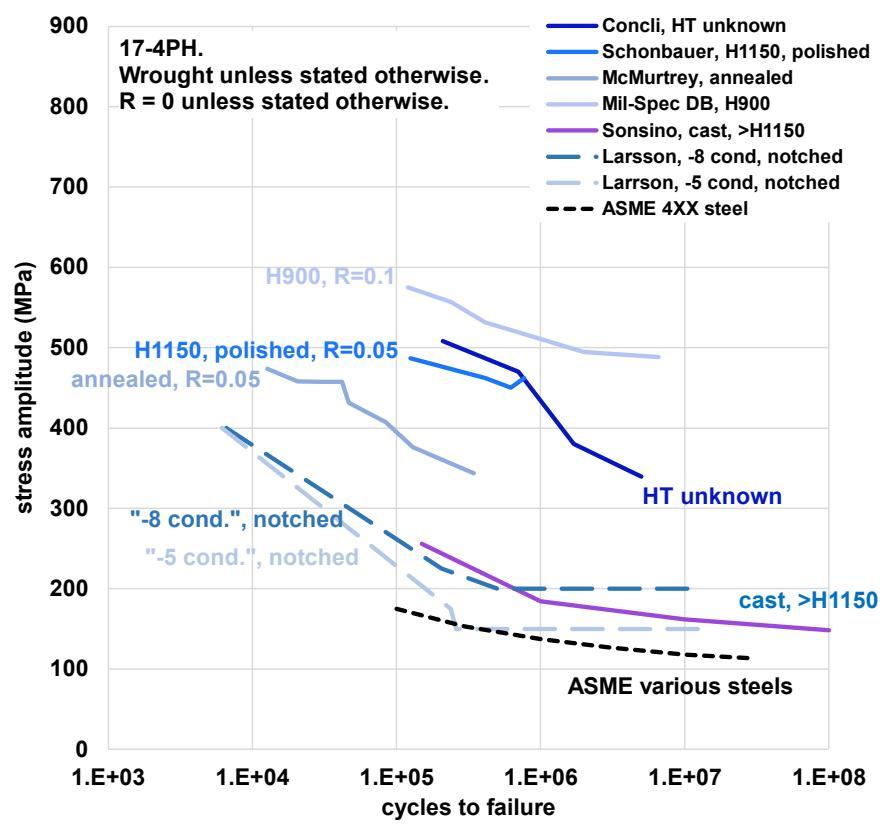
Figure 16. 17-4PH air HCF data from the literature [Zhai 2023].

The RT HCF performance of the 17-4PH material is consistent with the available literature data on wrought 17-4PH with similar heat treat conditions and similar loading conditions (Figure 16).

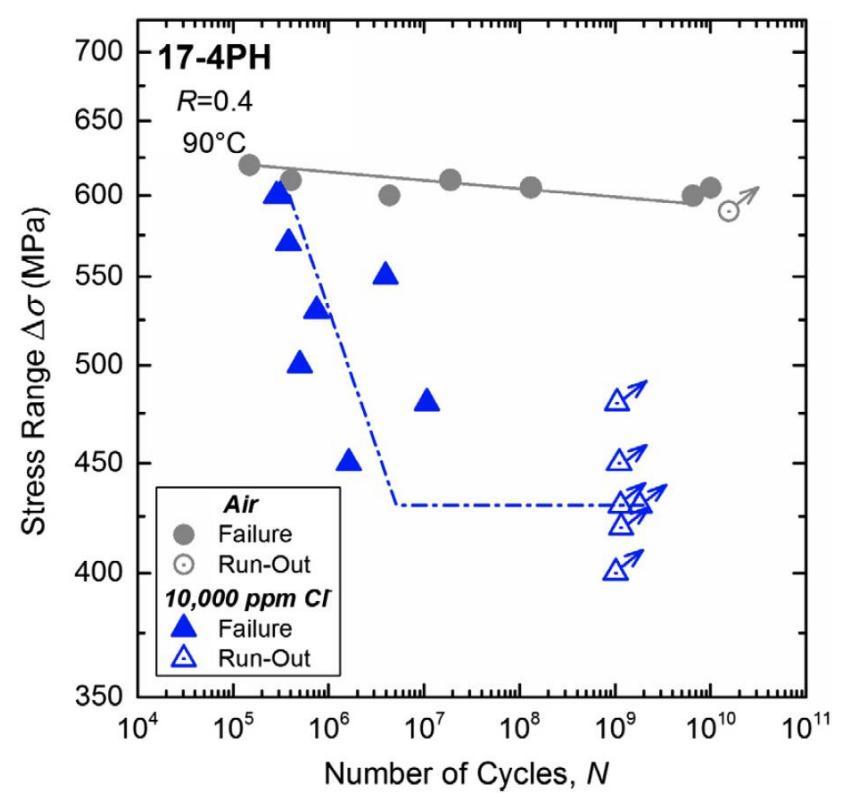
Figure 17. 17-4PH smooth specimens tested in 90°C air and water with 10,000 ppm Cl⁻ from NaCl. Plots taken from [Schönbauer 2015].

producing a DO content of 1.9 wppm. Load cycling was conducted at a very high frequency of 20 kHz. At this load cycling frequency, 10⁷ cycles were attained in 8.3 minutes, nominally giving very little time for corrosion to contribute. Although not discussed in Schönbauer's paper, it is very likely that before load cycling began, a specimen would spend at least one hour in the test environment as the system is brought up to temperature and environmental conditions are established. HCF and HCCF life tests for R=0.4 are presented in Figure 17. Even with this incredibly high load cycling frequency, a strong effect of the environment can be seen, but is not possible to isolate the contribution to the corrosion fatigue life from just the water or just the chloride given the limited data.

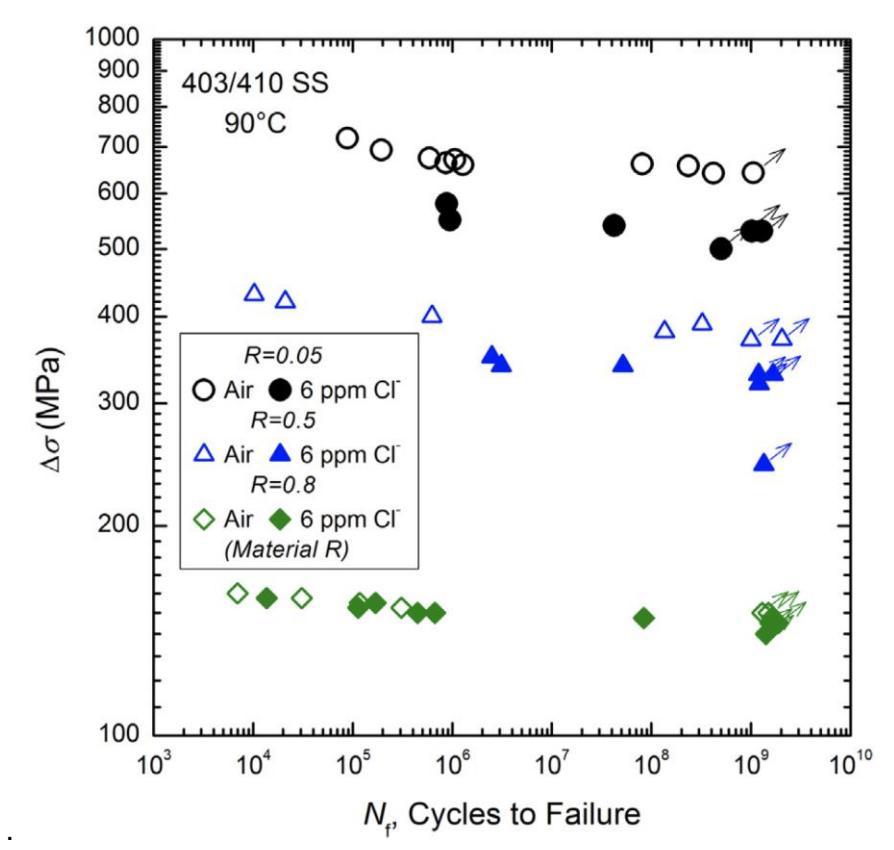
Figure 18. 403/410 SS life in air and chloride water at 90°C at various R values. Plot taken from [Schönbauer 2014].

Schönbauer also conducted HCF and HCCF testing on 403/410 SS [Schönbauer 2014] in a manner similar to his research on other materials. Tensile fatigue load cycling was conducted at 20 kHz at various load ratios in air and a solution of NaCl. For these steels, the chloride content was set to only 6 ppm, most likely because of the significantly reduced corrosion resistance of 403/410 SS. The results of the fatigue life tests are presented in Figure 18, showing the response of this material in air and 6 ppm Cl⁻ water for various load ratios. For R=0.05, the HCCF life of this material in a 6 ppm Cl⁻ solution is 85-90% of the HCF life. This result shows a clear effect of the water environment, but it is not nearly as strong as that observed in the PNNL tests.

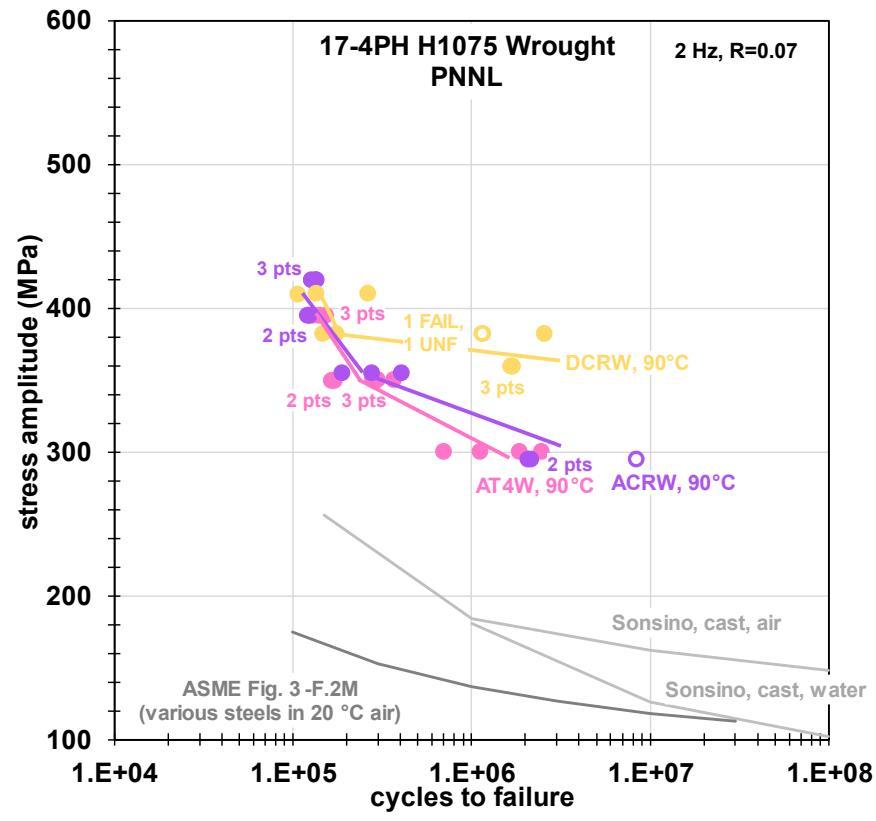
Figure 19. 17-4 PH fatigue life in 90°C CRW and T4W.

The HCCF life results for 90°C tests in ACRW, AT4W, and deaerated CRW (DCRW) are compared in Figure 19. The performance of 17-4PH in ACRW and AT4W are virtually identical. A single runout data point for ACRW at the lowest S_a is the only deviation in performance between the two different waters. Considering that CRW has a low concentration of ions, this is not a surprising result. The performance of 17-4PH in DCRW is identical to ACRW and AT4W at the higher S_a values, but is significantly improved at the lowest S_a value.

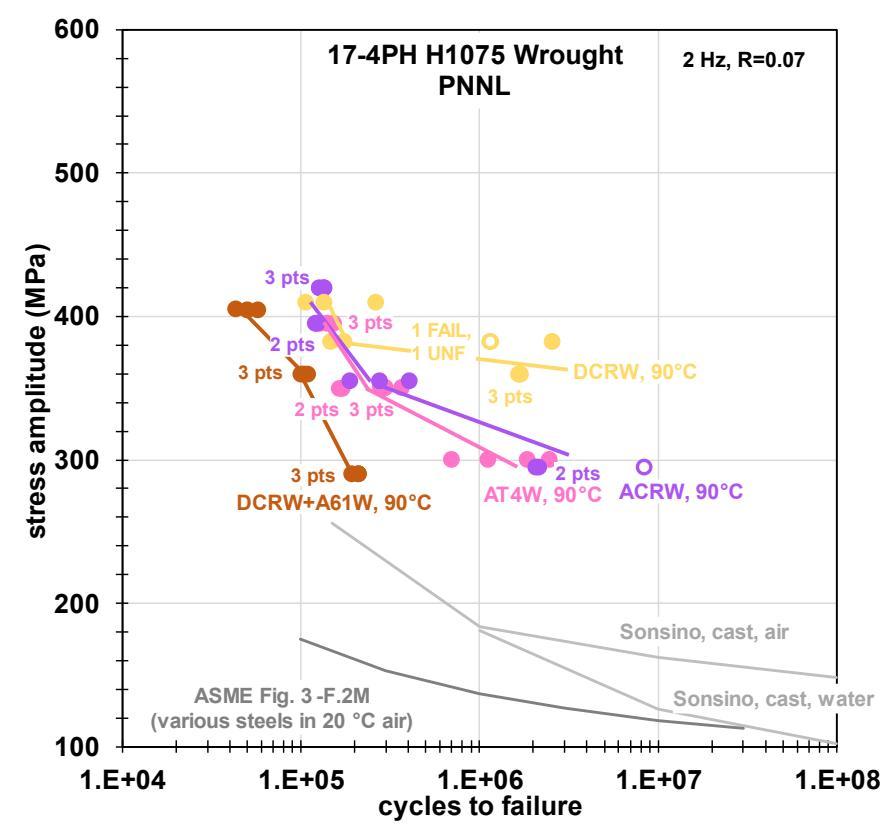
Figure 20. Fatigue life of 17-4PH in aerated CRW with Amersite 61W added.

The effect of Amersite 61W corrosion inhibitor on 90°C HCCF life is presented in Figure 20. Surprisingly, the HCCF life is significantly reduced compared to the other tested water conditions without corrosion inhibitors. Post-test examinations shown in the next section confirm a much higher corrosion fatigue susceptibility of 17-4PH with Amersite 61W added to the water.

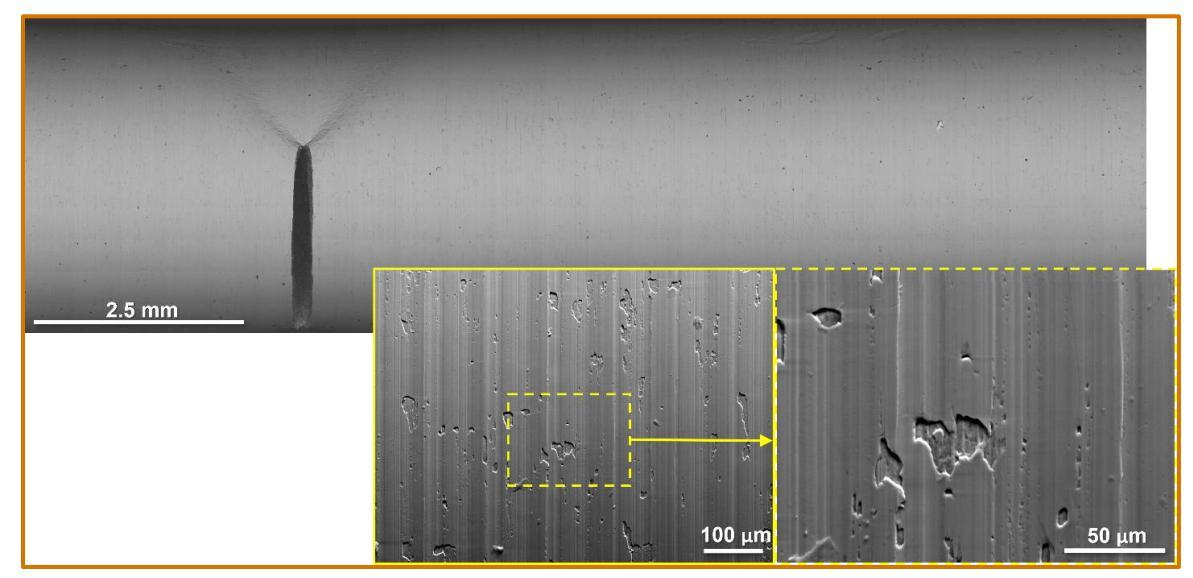
Figure 22. 30 keV SE montage image of the gauge surface of FTS028 with zoom in images of typical surface morphology found on the gauge of this specimen.

The post-test examination started with two specimens tested in room-temperature air, FTS027 and FTS028, as control samples to the specimens tested in water environments. The FTS028 was stopped after crack initiation but prior to specimen failure. As shown in Figure 22, FTS028 had one large crack in the gauge section that was more than 2 mm long and normal to the tensile loading direction. Significant deformation bands can be seen around the end of the crack in the image. No other cracks were observed. The two lower images in the same figure show the representative morphology of the gauge surface. Radial grooves and micrometer-size patches of shallow flaking are common features of the surface finish produced by the lathe machining process used to make these specimens.

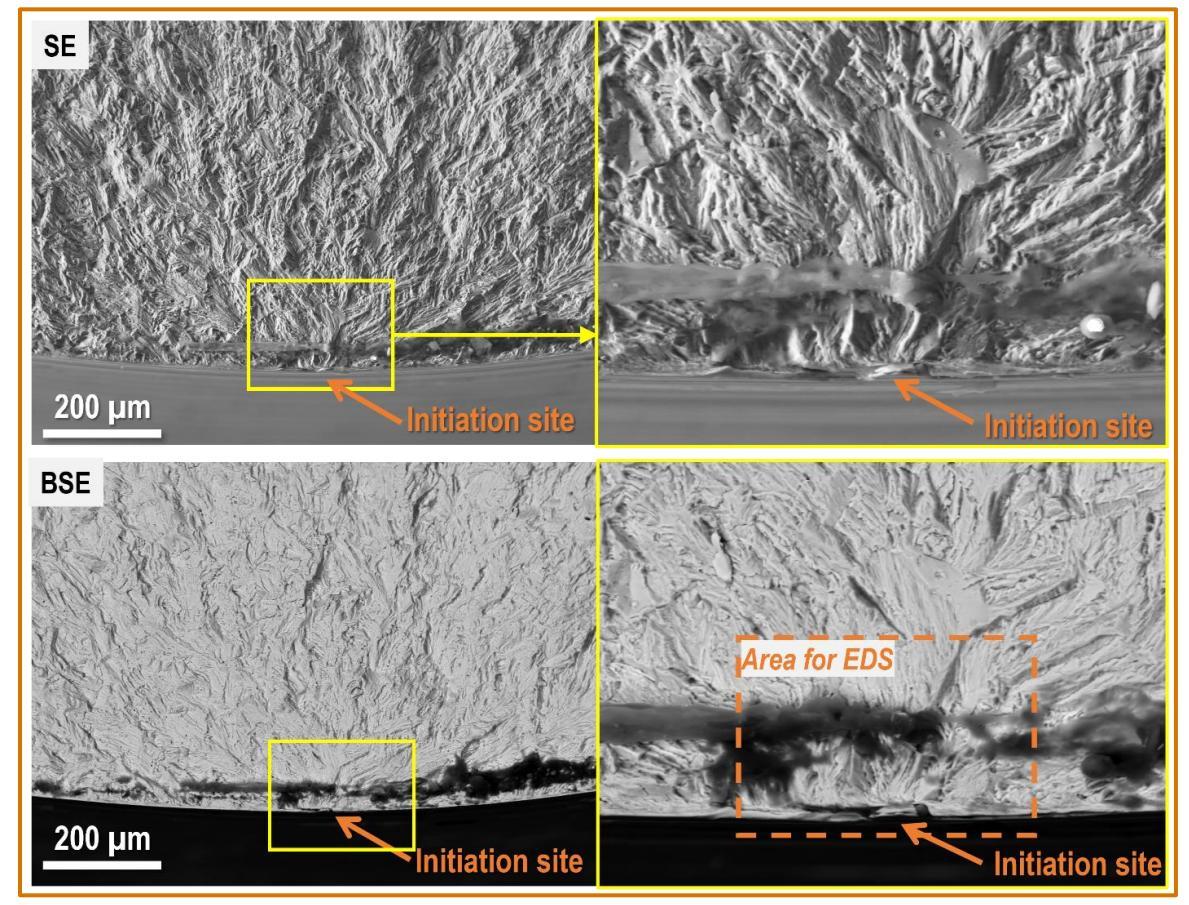
Figure 23. High-keV SE (upper) and low-keV BSE (lower) of the crack surface near the initiation site in FTS027.

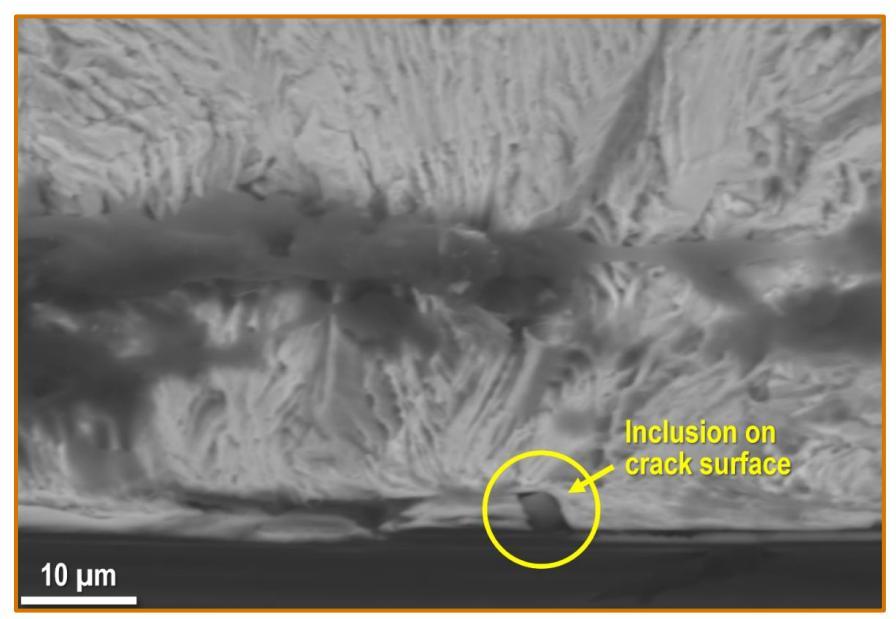
Figure 24. Zoom-in BSE image of the region highlighted in orange in the lower right image in Figure 23 for EDS.

A closer look at the initiation site revealed that the point of initiation occurred at a particle that intersected the surface of the specimen (Figure 24). EDS performed on this area suggests that the particle is an intermetallic material inclusion enriched in aluminum, calcium, silicon, oxygen, and sulfur (Figure 25). Most particles embedded in the matrix, whether second phase precipitates (formed during alloy cooling or heat treating) or inclusions (present before the alloy solidifies) are brittle and can act as a stress riser due to having a different modulus of elasticity and also if it decoheres from the matrix.

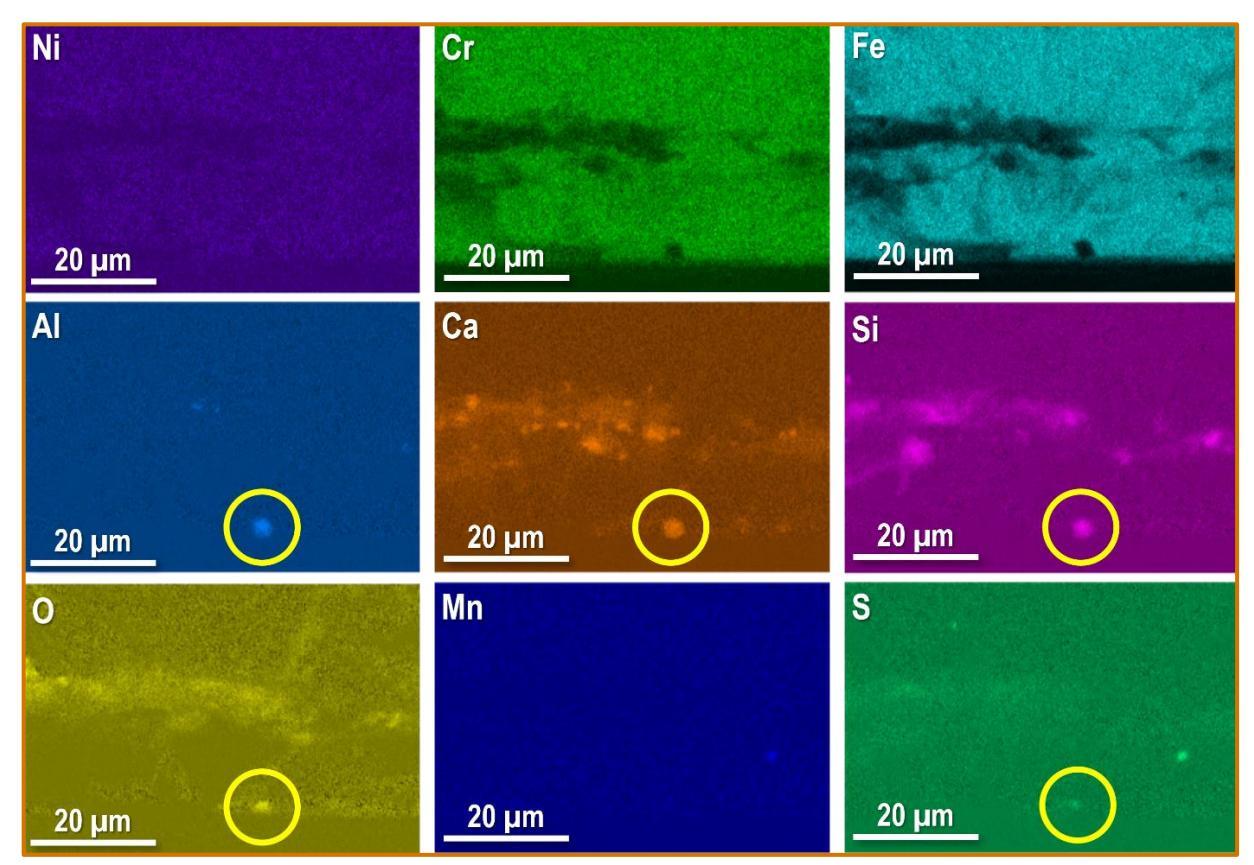
Figure 25. Elemental EDS mapping of the region shown in Figure 24 near the initiation site on the crack surface of FTS027.

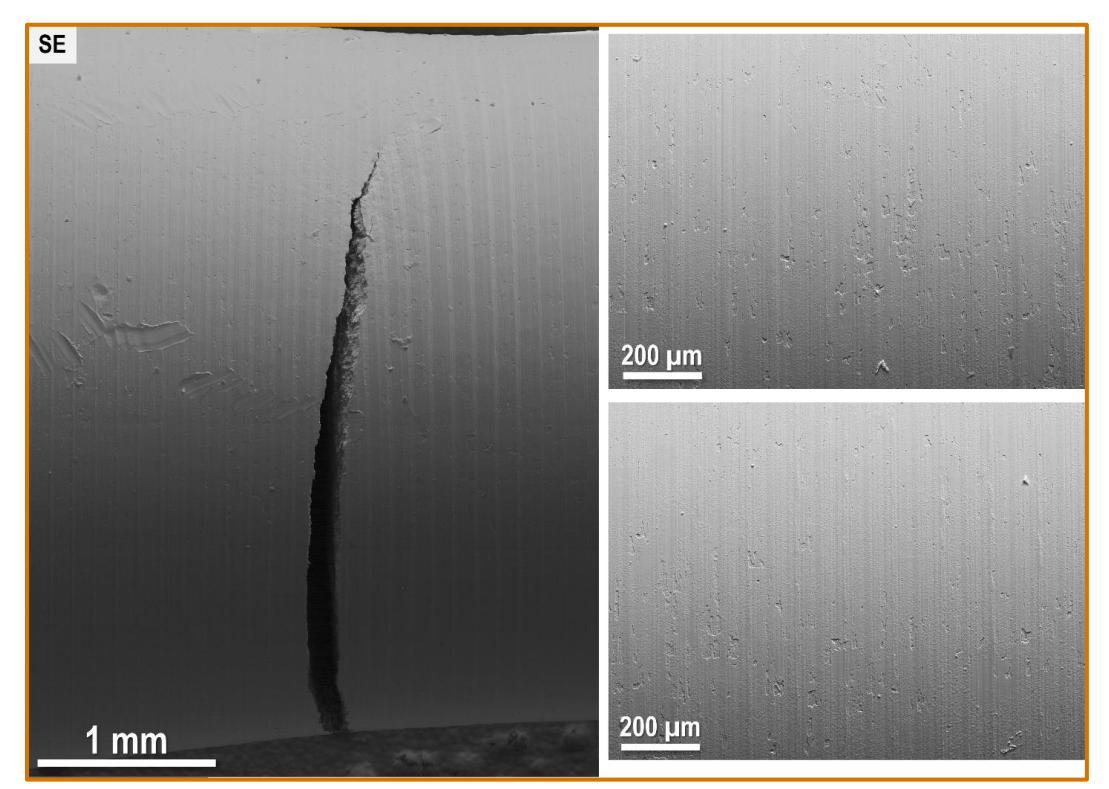
Figure 26. High-keV SE montage image of part of the gauge surface (left) and zoom-in images of the gauge surface morphology (right) of FTS004.

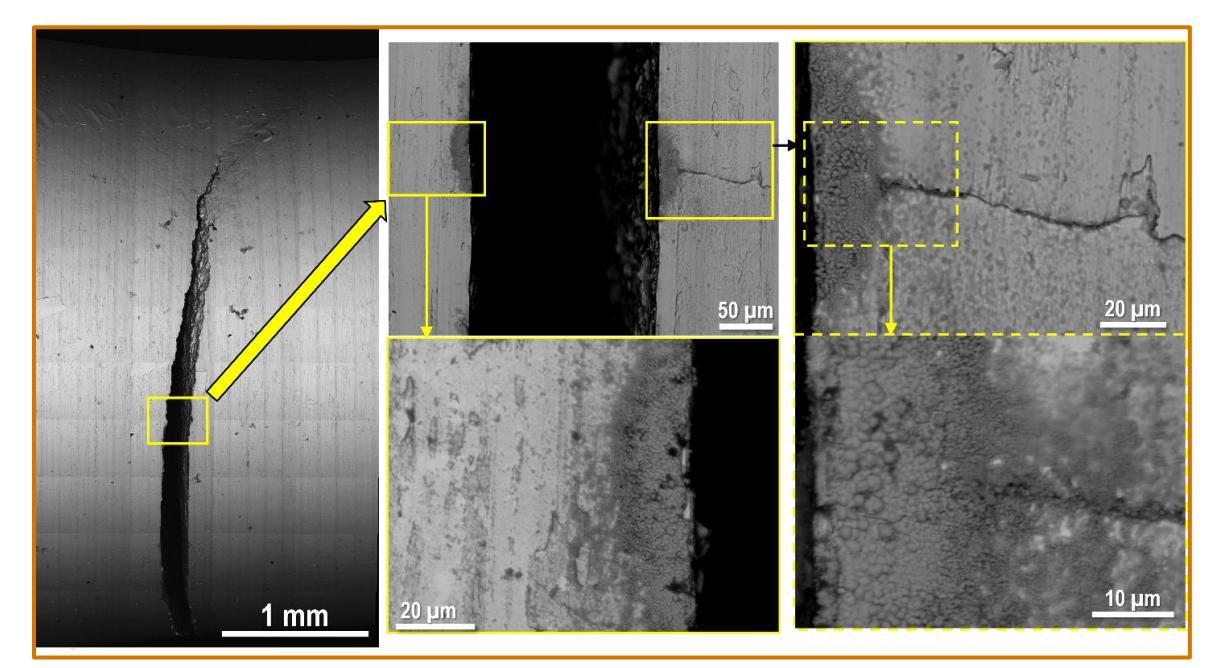
Figure 27. Low-kV BSE image showing the half-moon shaped dark oxides found on both sides near the crack center on the gauge surface of FTS027.
