Corrosion Fatigue Life Evaluation of 17-4PH in Support of Water Filled Turbine Hubs

Final Report

February 2025

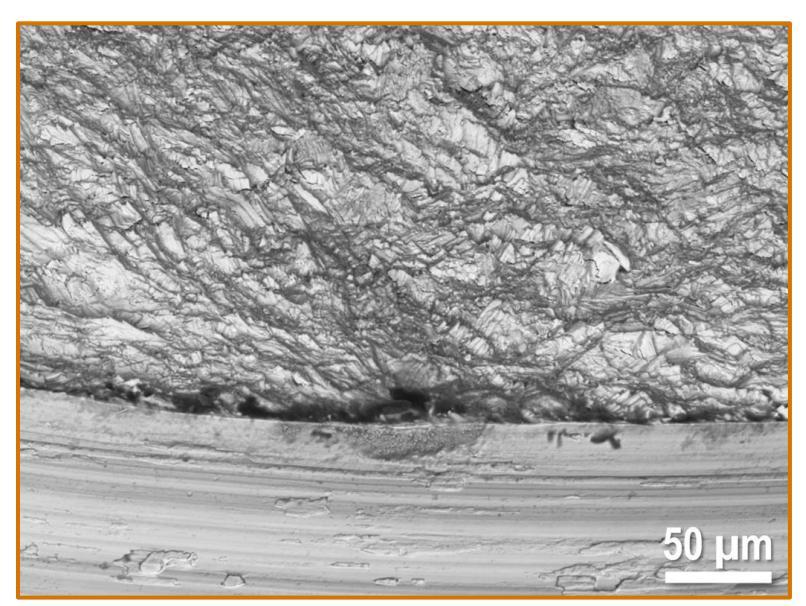
Figure 28. BSE image of a tilted view of one failed half of FTS027 where the half-moon shaped dark oxide on the gauge is found to correspond to the crack initiation site on the crack surface.

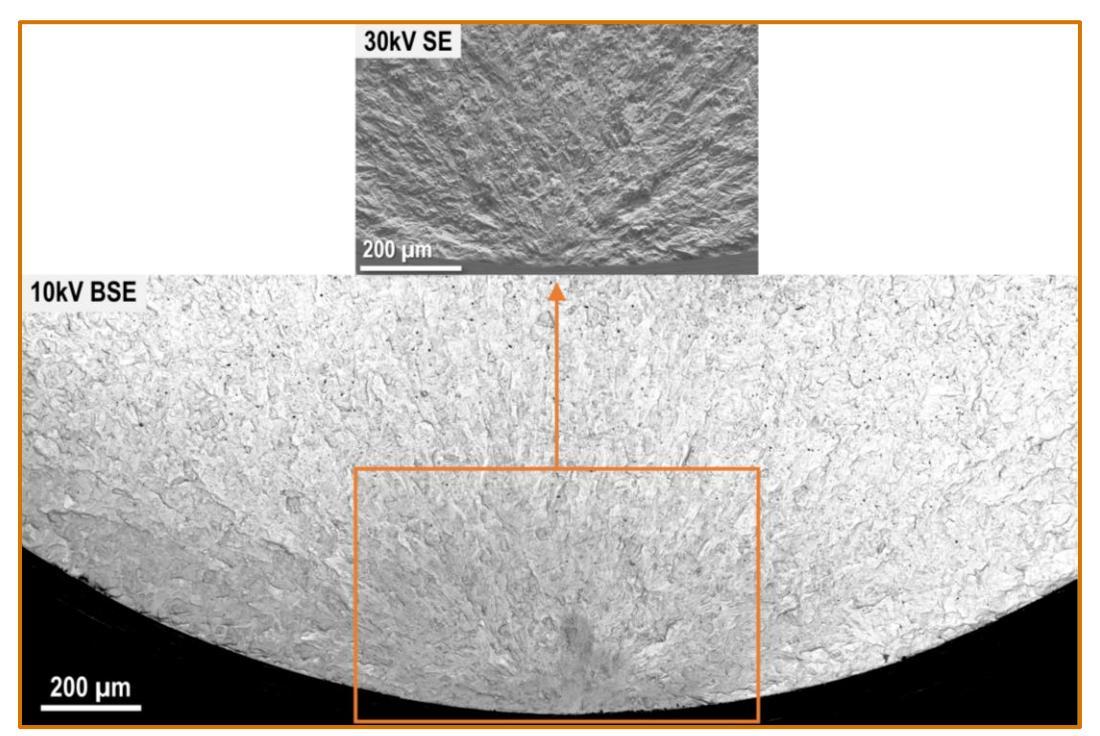
Figure 29. High-keV SE (upper) and low-keV BSE (lower) montage image of the top-down view of the crack surface on one failed half of FTS027.

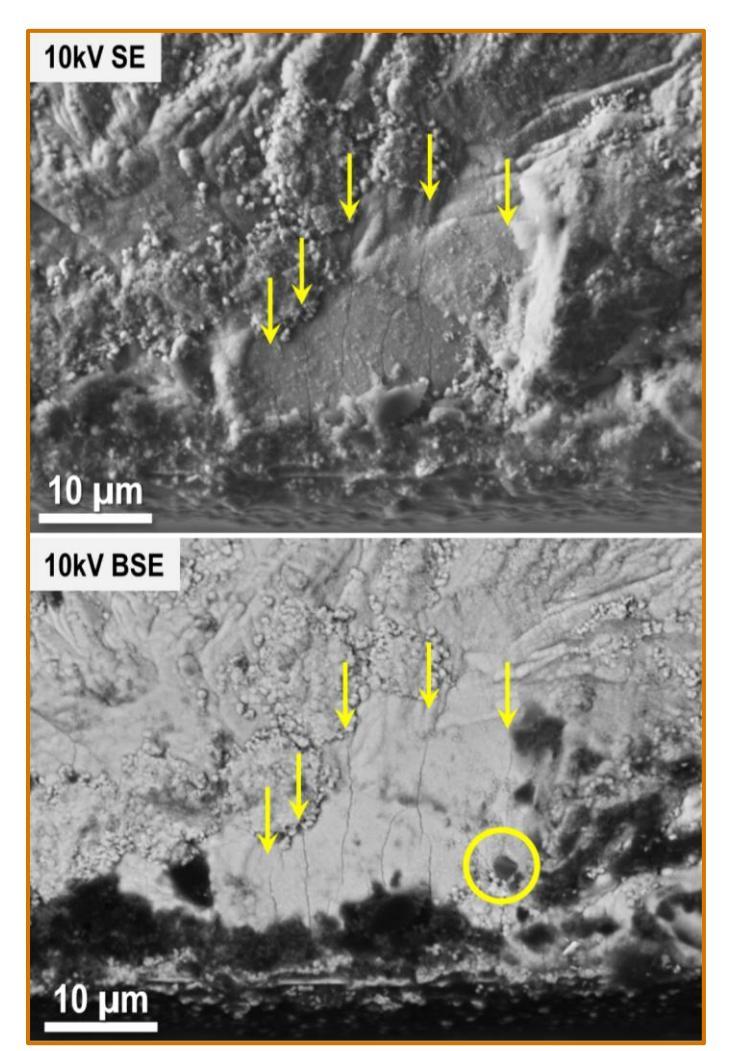
Figure 30. Close-up SE (upper) and BSE (lower) images of the initiation site found on the crack surface of one failed half of FTS027.

EDS of this region also identified a 2 μ m-size particle rich in Al, Si, and Cl located on the fracture surface approximately 10 μ m away from the gauge surface (circled item in Figure 30 with composition mapping shown in Figure 31). As with the air fatigue tested specimen, this particle may have contributed to crack initiation.

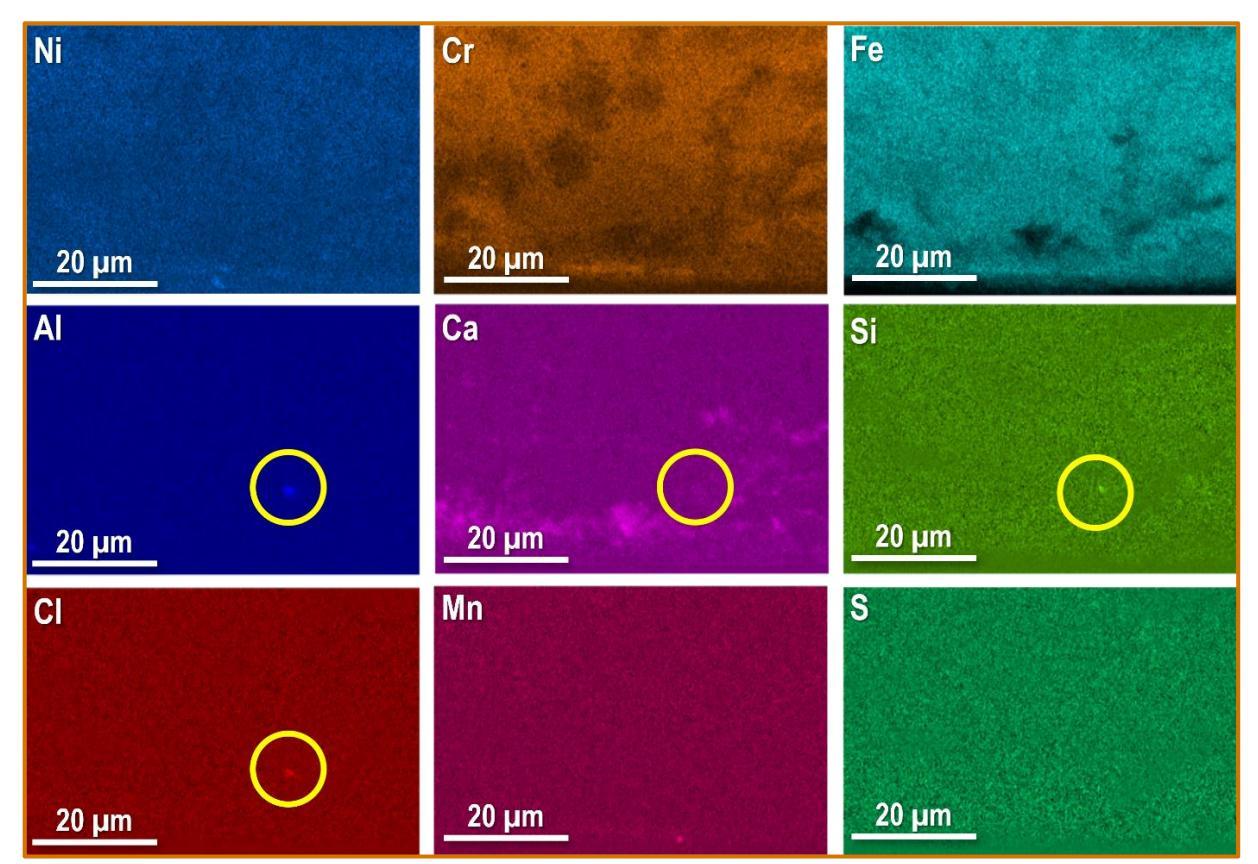
Figure 31. EDS elemental mapping of the area around the crack initiation site as shown in Figure 30.

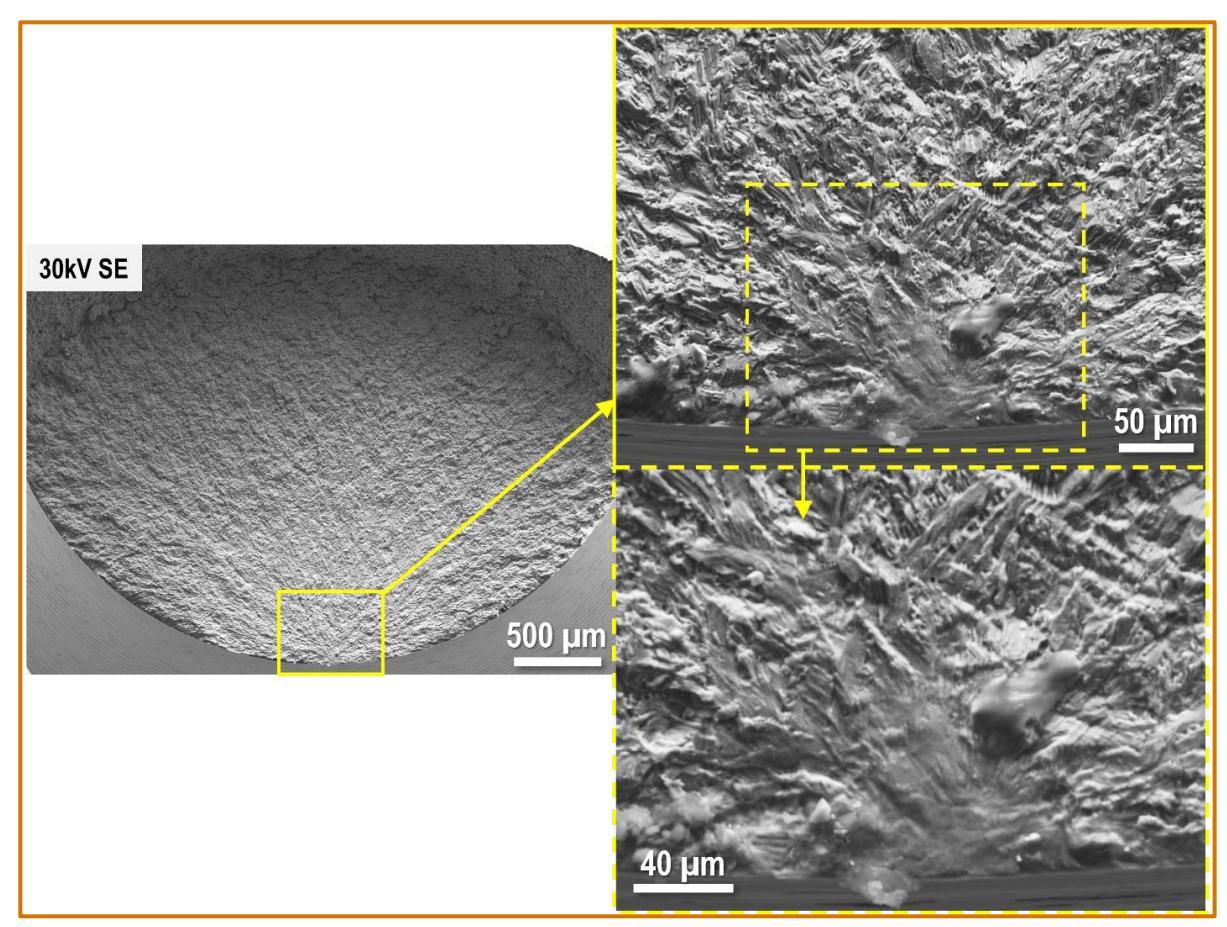
Figure 32. High-keV SE montage image showing the topological morphology around the initiation site on the crack surface of one failed half of FTS001.

It should be noted that the initiation site morphology of FT004 is not unique. FTS001 tested in the same batch also revealed a similar smooth surface at the initiation site (Figure 32). Indications of more profound oxide presence were also found at this initiation site (Figure 33). It is assumed that this oxide build-up occurred at the initial stage of crack nucleation when the crack grew relatively slowly, allowing more time for the material to interact with the water environment to drive the formation of an oxide layer.

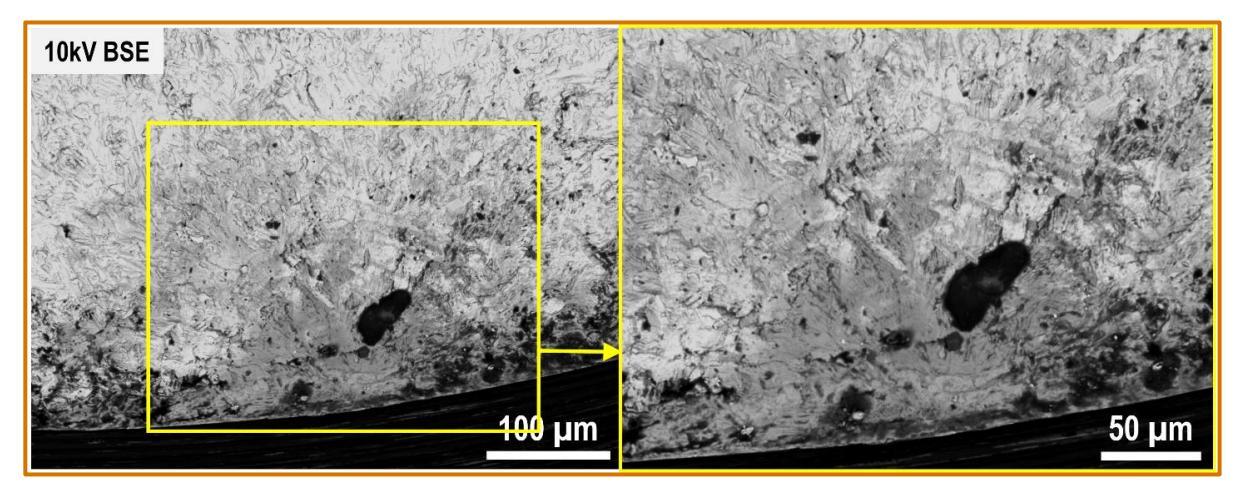
Figure 33. Low-keV BSE montage image showing heavier oxides near the initiation site on the crack surface of one failed half of FTS001.

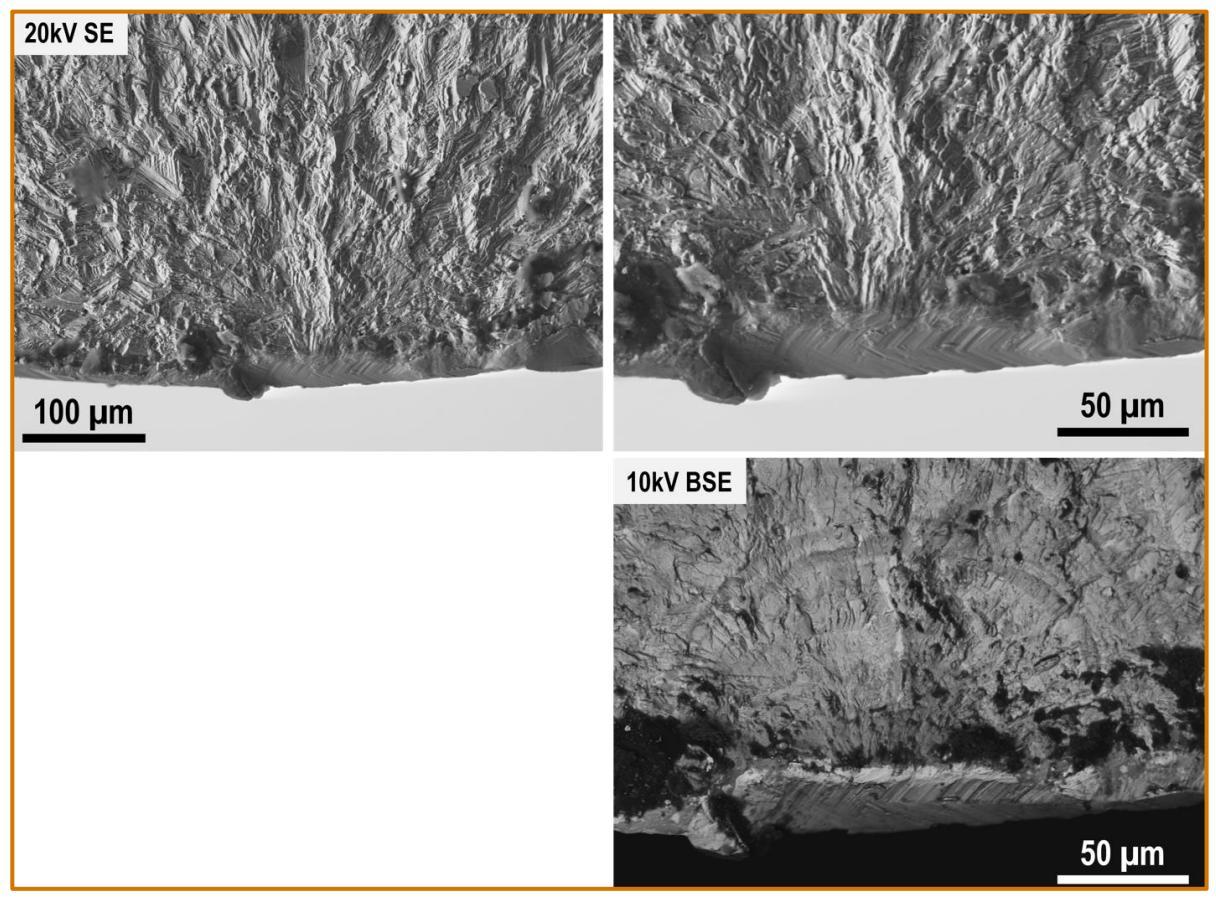
Figure 34. High-keV SE (upper) and low-keV BSE (lower) montage image of the top-down view of the crack surface on one failed half of FTS019.

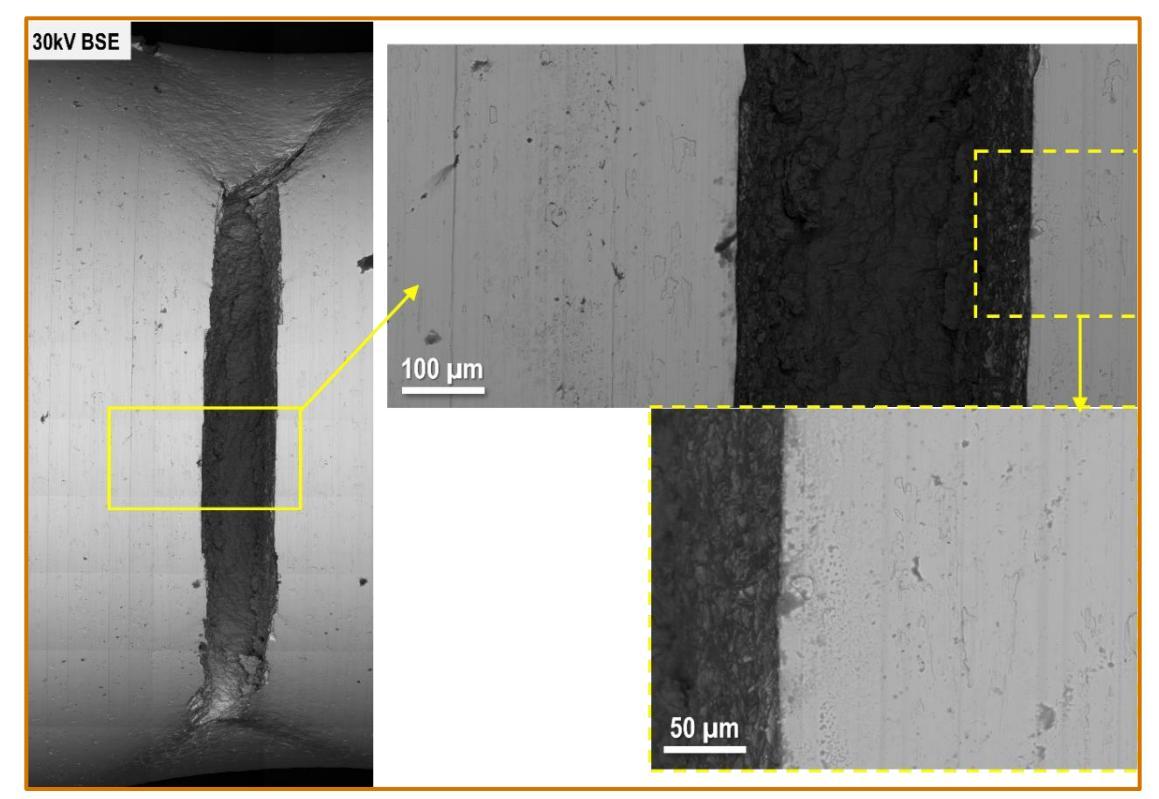
Figure 35. Low-kV BSE image showing the surface morphology near the crack center on the gauge surface of FTS020.

The gauge surface morphology of FTS020, which was stopped before fracture, is presented in Figure 35. No other cracks were found in the gauge surface, suggesting that once crack initiation occurs, the crack propagates across the specimen very rapidly. A very small oxide patch was observed on the gauge surface on one side of the crack mouth (the right side crack flank as shown in Figure 35). This oxide patch is much smaller than the oxide build-up that was correlated to the point of initiation for FTS027. Almost opposite this feature on the left crack flank there is another slightly larger feature with darker contrast. This was found to be a piece of external junk adhered to the flank instead of a corrosion product formed on the surface.

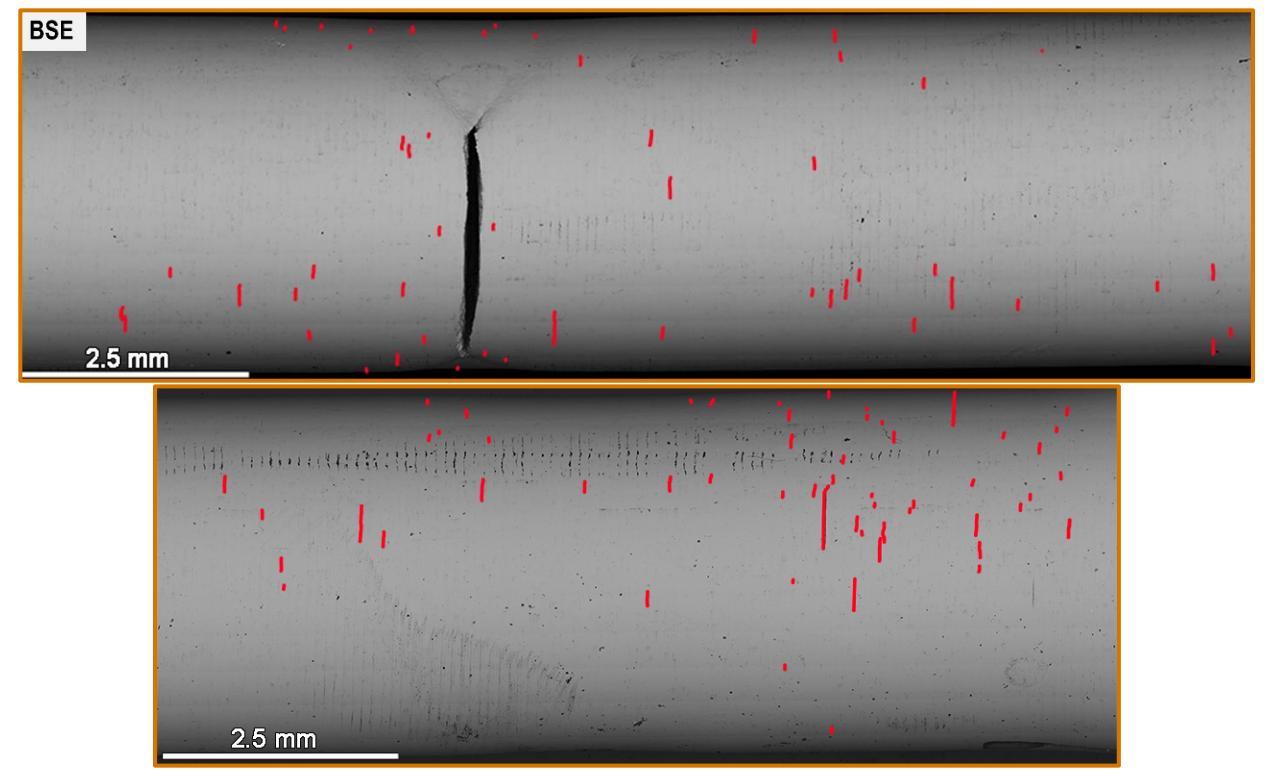
Figure 36. BSE montage image of two rotations of FTS043 showing a high density of cracks observed on the gauge surface (highlighted in red besides the largest crack).

The last set of specimens examined in detail (FTS043, FTS044, FTS045) were tested at high stress amplitude in 90°C CRW with the addition of the corrosion inhibitor Amersite 61W. Fatigue cycling of FTS043 and FTS045 was stopped before the specimens failed, and thus the characterization focused on documenting the gauge surface morphology of these two specimens. As shown in Figures 36–40, these specimens distinguish themselves from previous specimens by containing multiple cracks on the gauge surface. As can be seen in Figures 36 and 38, besides a large crack that dominated the DCPD response for crack detection, multiple small cracks with a surface length of hundreds of micrometers also formed on the gauge surface, especially in FTS043. High-magnification images are provided in Figures 37 and 39.

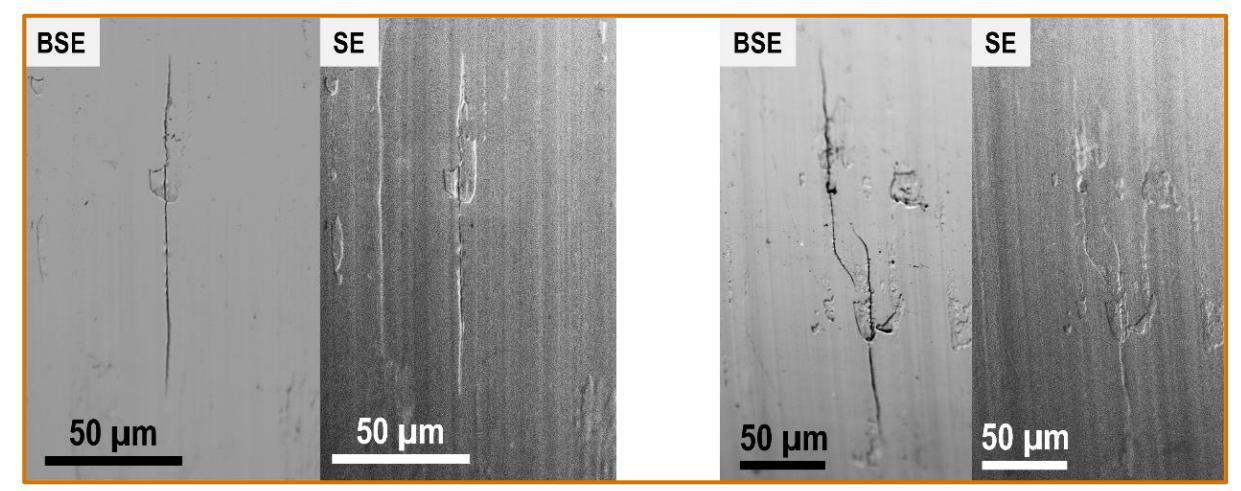
Figure 37. Zoom-in BSE and SE images of representative small cracks found in FTS043.

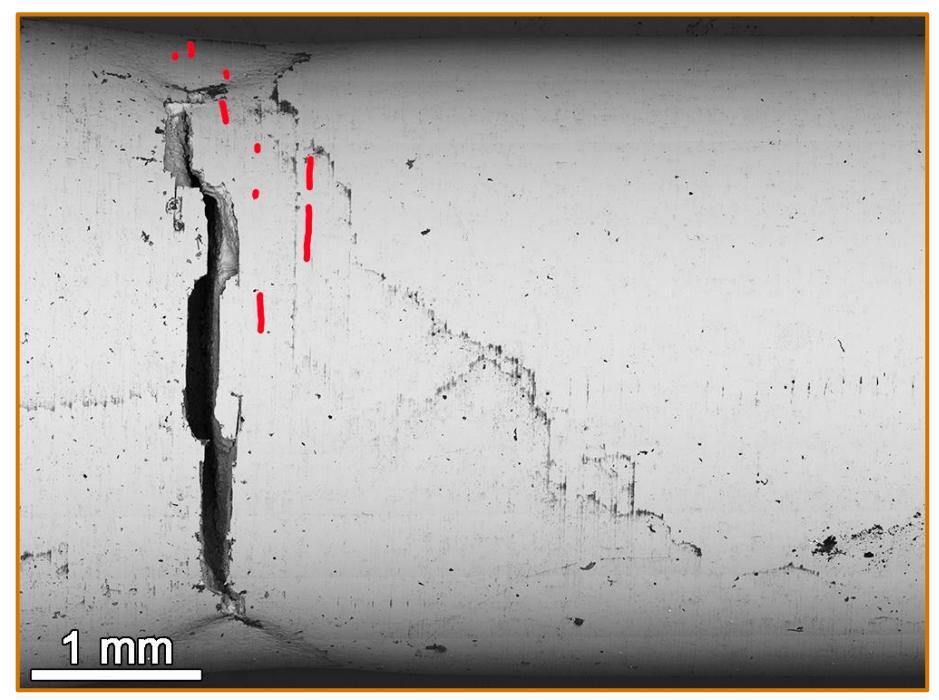
Figure 38. BSE montage image of one rotation of FTS045 showing multiple cracks found on the gauge surface (highlighted in red besides the largest crack).

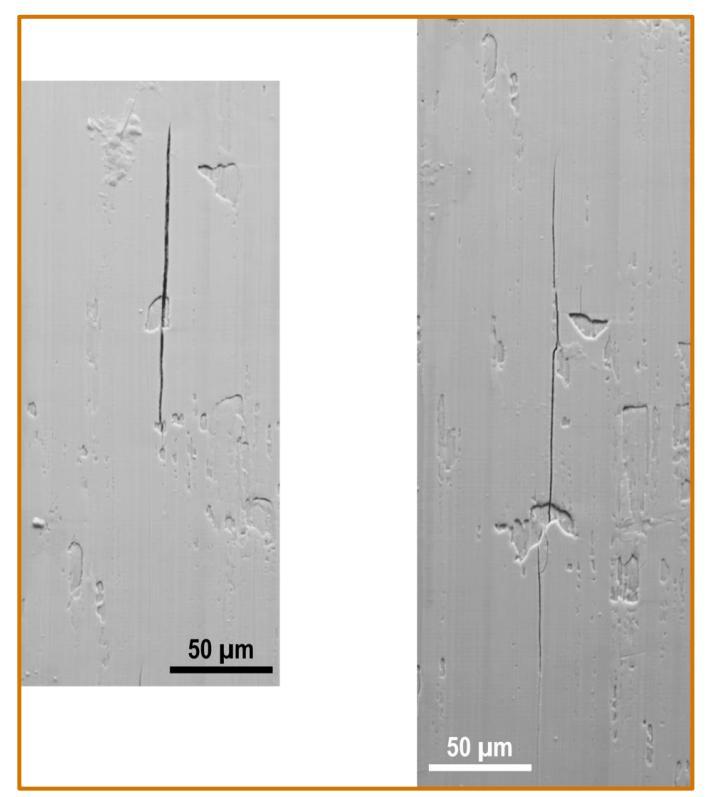
Figure 39. Higher magnification BSE images of representative cracks found in FTS045.

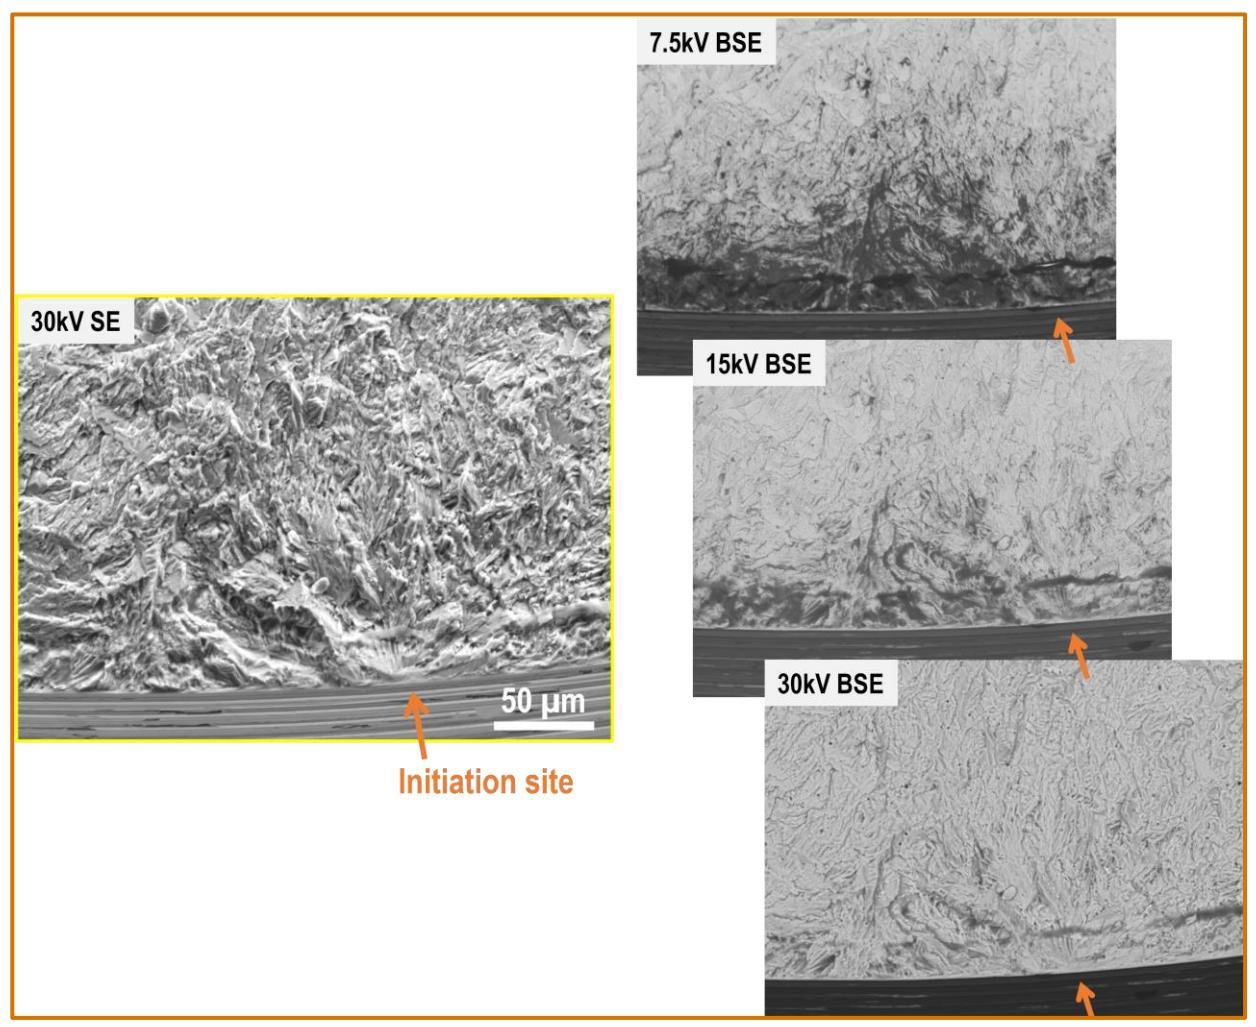
Figure 40. High-keV SE image (left) and BSE images taken at three different keV levels (right) on the crack initiation site (highlighted by arrows) on the surface of one failed half of FTS044.

SEM observations were also performed on the crack surface of FTS044, which failed before load cycling could be stopped. As shown in Figure 40, the SEM-SE image of the crack surface of FTS044 exhibited a different morphology than the specimens tested without the corrosion inhibitor. No beach marks were observed in the SEM-BSE images conducted at several different accelerating voltages. The appearance of the crack surface of the specimen tested with the corrosion inhibitor is more typical of a cleavage morphology while the specimens tested without corrosion inhibitor exhibited features consistent with ductile fatigue.

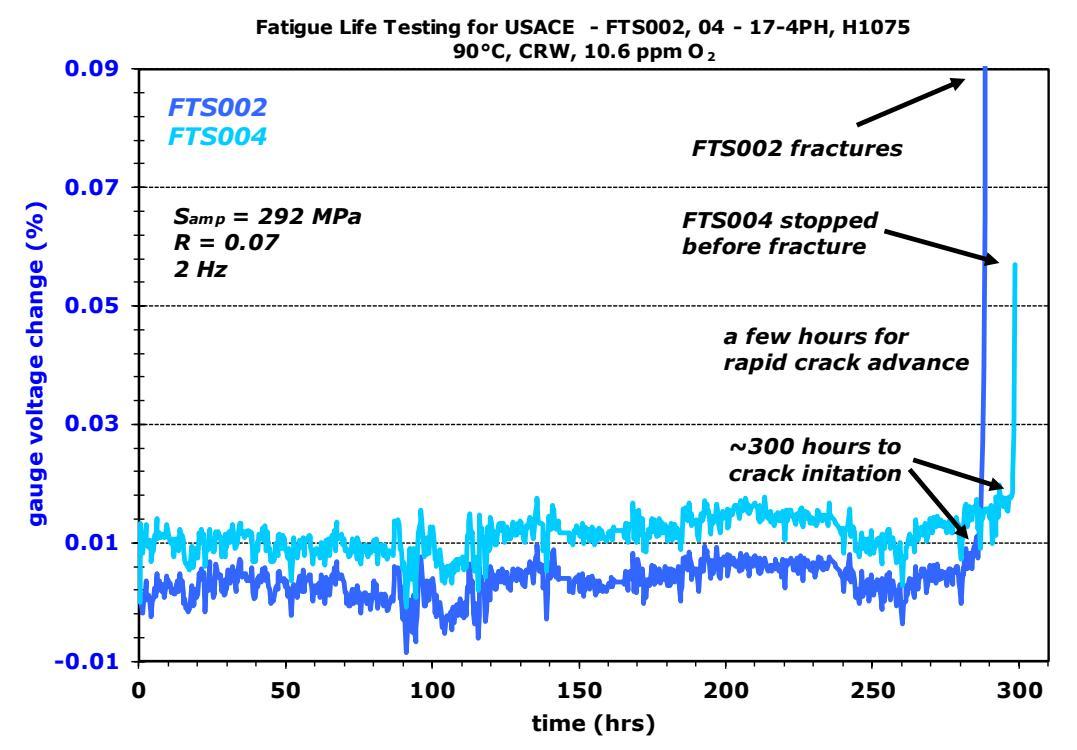
Figure 41. Example of crack initiation and propagation for two fatigue tensile specimens.

An example of typical fatigue specimen response using the DCPD measurement method is provided in Figure 41. In this plot, the gauge voltage is monitored as a function of time, and when crack initiation and growth occur, the gauge voltage increased substantially above the baseline voltage range. For this test conducted in 90°C ACRW at a low S_a , FTS002 and FTS004 initiated just before reaching 300 hours of exposure. For both specimens, the time from the moment of obvious crack initiation to specimen failure (FTS002) or stopping before fracture (FTS004) was no more than 2 hours, which is <1% of the total lifetime of the specimens. Time to initiation typically dominates because after a crack forms, a significant stress riser forms along the crack front that accelerates the fatigue process.
