SANDIA REPORT

SAND2024-07522

LYNM PE1 Pre-Experiment A Site Characterization Report

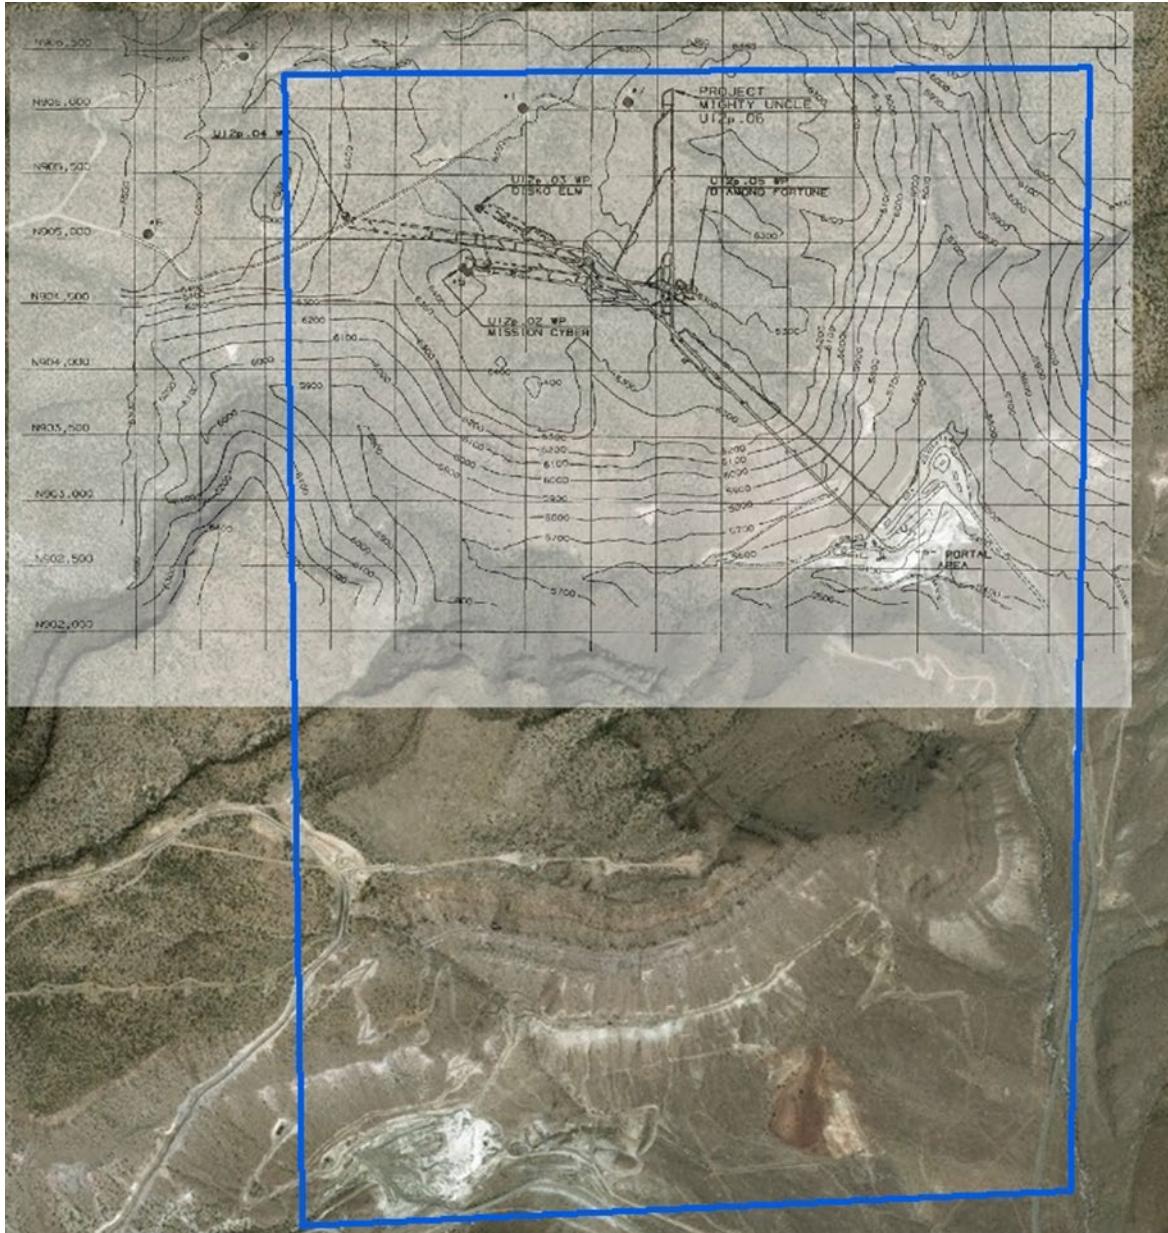
Figure 14. Map showing the extent of the high-resolution DEM (blue rectangle). The overhead image is taken from Google Maps. Also shown is a contour map overlay that shows the extent of the interior P-Tunnel complex prior to construction of the PE1 testbed.

A high-resolution digital elevation map (DEM) of Aqueduct Mesa was generated for the UNESE project (Vigil 2016) [21] and has been obtained for use in PE1 (Figure 14). This DEM has a horizontal pixel size of ~ 7.5 cm with ± 3 cm vertical accuracy.

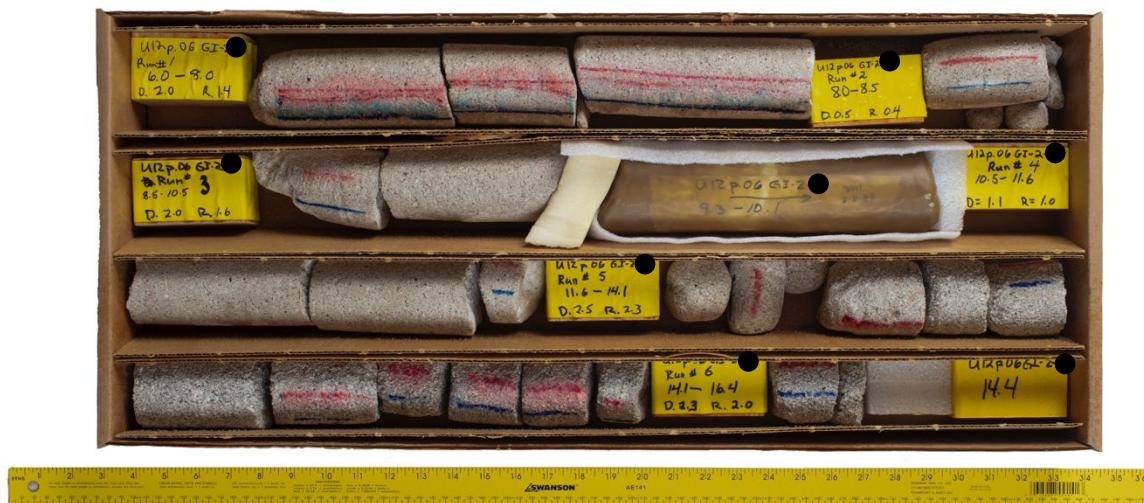
Figure 15. Example of the high-resolution photographs taken for the PE1 core in the USGS Core Library. This example is from the GI-2 borehole under dry conditions. Some samples are coated in wax to preserve water content.

For many of the boreholes, particularly those designated for site characterization use, a subset of the core was preserved in layers of foil and wax to preserve the in situ water content. The collected core was inventoried and relocated to the United States Geological Survey (USGS) Core Library at NNSS for storage and management. High resolution photographs of the samples were taken at the Core Library in both dry and wet conditions (Figure 15).

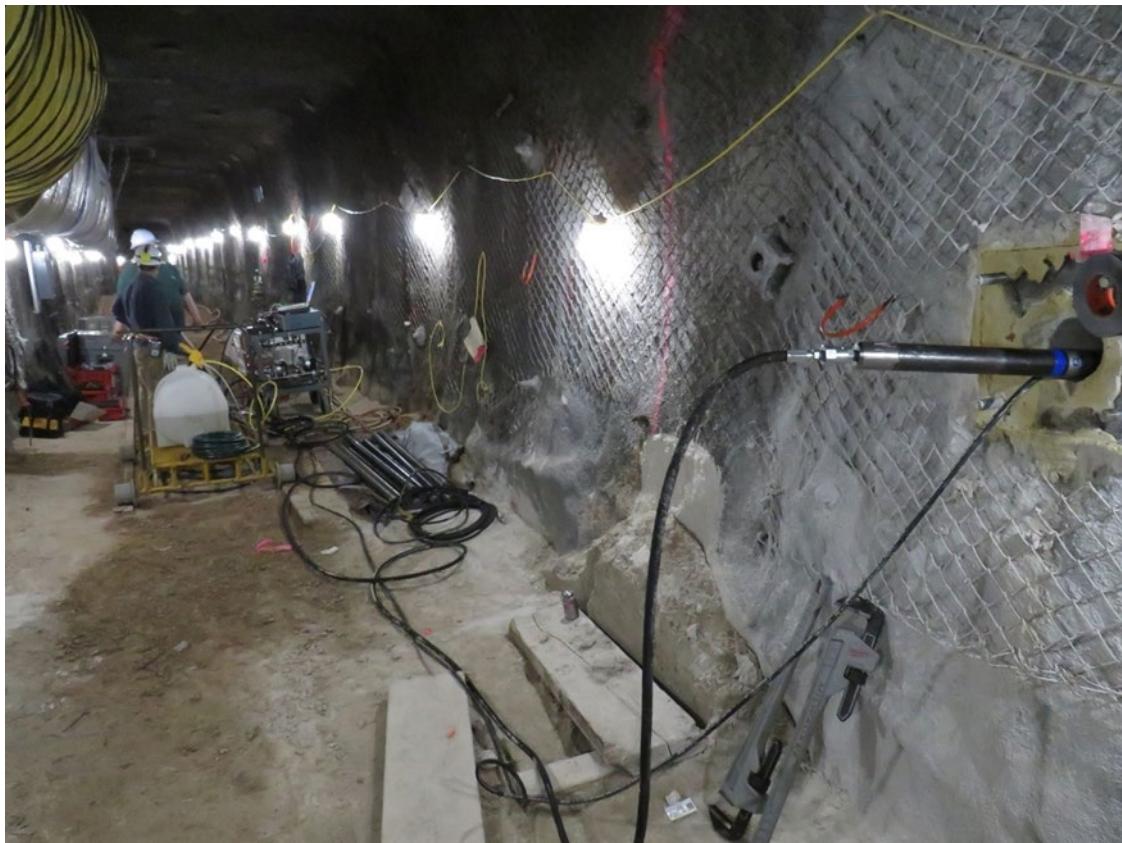
Figure 21. Photograph of the Hydrofracture system being run in GI-3.

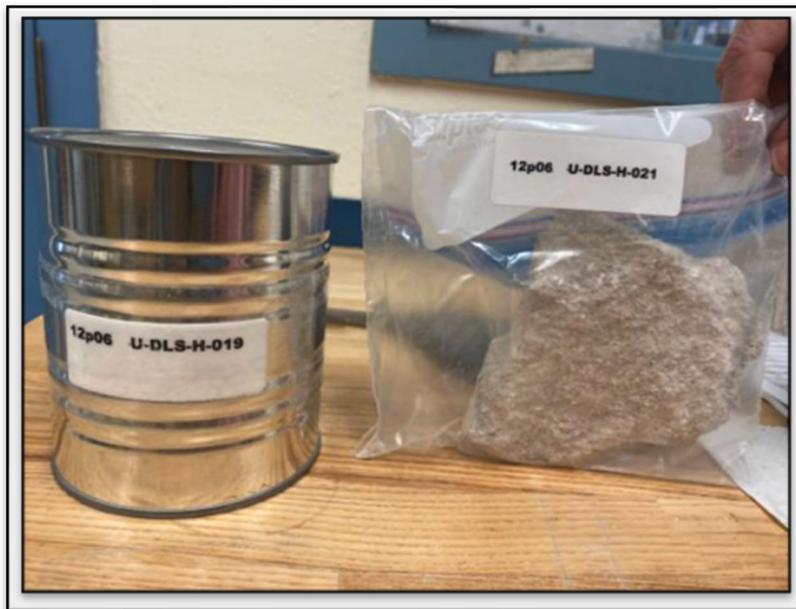
Figure 22. Photograph of two geologic grab samples from the 1490 drift. Leftmost sample is preserved, and rightmost sample is bagged.

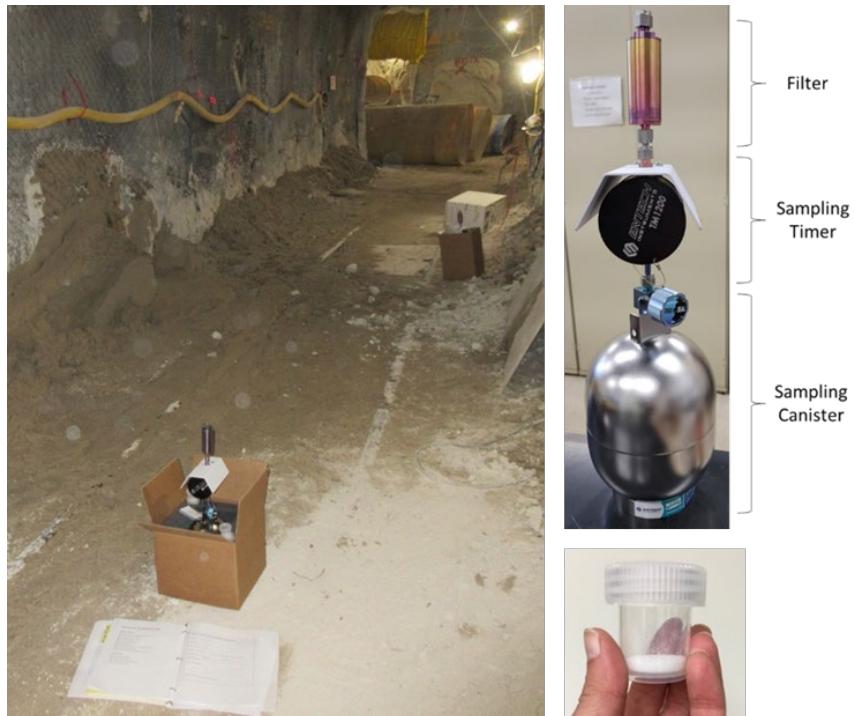
Figure 31. Photograph showing (left) the emplacement of a small volume gas sampler and liquid absorbents in the tunnel drift, (upper right) the small volume gas sampler system configuration, and (lower right) an example liquid absorbent sample.
