**Pacific Northwest
National Laboratory**

Results of Performance Evaluation Testing of Electrical Leak-Detection Methods at the Hanford Site Mock Tank – FY 2002-2003

February 2003

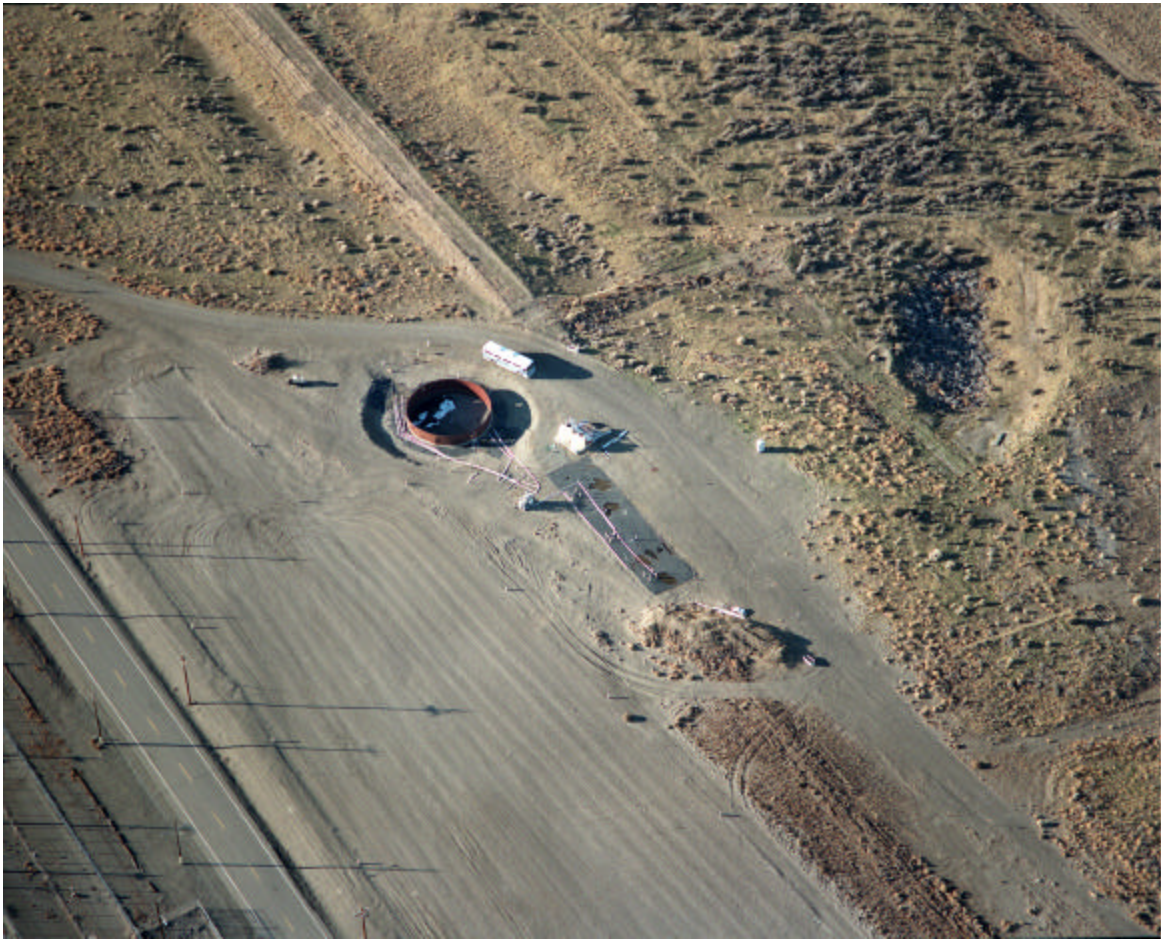
Figure 2.1. Oblique Aerial View of the Mock Tank Site from the Southeast. This photograph was taken in November 2001 before installing equipment for the FY 2002-2003 PE testing. The rectangular covering to the lower right of the tank is part of the Subsurface AirFlow Extraction (SAFE) testing apparatus deployed concurrently with geophysical methods in 2001. Also visible are the bus used as a mobile lab in 2001 and the permanent water-storage tanks (upper right and right of tank, respectively).

The 105-A Mock Tank (Mock Tank) is located in the 200-East Area of the Hanford Site (Figure 2.1 and Figure 2.2). The Mock Tank was constructed in 1994–1995 and previously used to test the applicability and effectiveness of an array of electrical-resistivity sensors in providing tomographic imaging of simulated waste leaks beneath the tank. This remains the primary design goal of the facility; several infrastructural improvements have been made to the site to electrically simulate SST tank-farm conditions, to allow numerous leak-simulation scenarios, and to allow testing of a wider variety of geophysical methods.

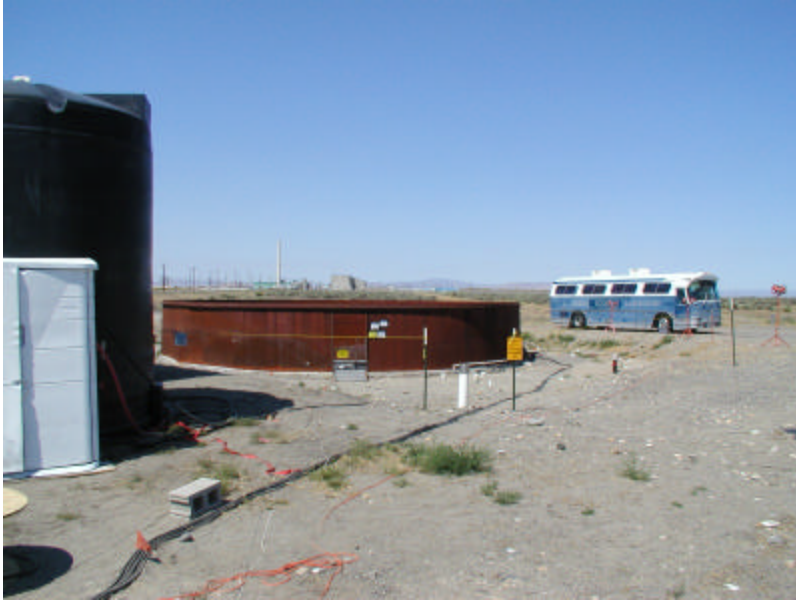
Figure 2.5. View Looking West at the Mock Tank Just Prior to Test Start. The 26,120 L (6,900-gal) solution tank holding the leak simulant solution (sodium thiosulfate) and the pump/controller housing (white) is at far left. The Mobile Laboratory (bus) used in the FY 2001 tests is in the background.

The 105-A Mock Tank (Figure 2.5 and 2.6) was built in 1994-1995 for the express purpose of testing ERT as a method of leak detection in the presence of a large steel tank. The history of construction and testing at the Mock Tank is summarized in Appendix A (p. A.7 to A.14) and by Barnett et al. (2002). Improvements to the site in preparation for the FY 2002-2003 PE Testing are described in this section.

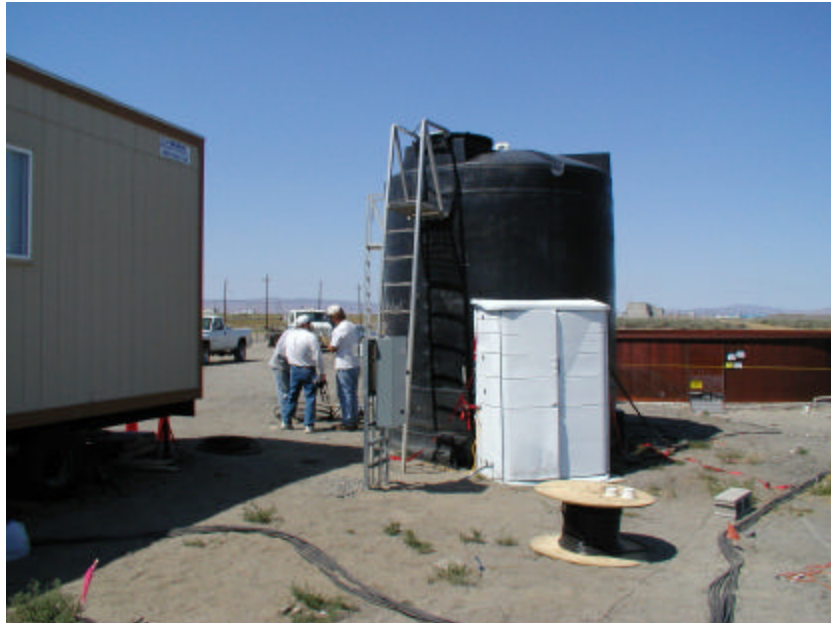
Figure 2.6. View Southwest of Mock Tank Site Showing the Solution Tank, Pump/Controller Housing, and Field Office at Left. The heavy cables seen at bottom contain bundles of individual leads to electrodes that are emplaced around the Mock Tank.

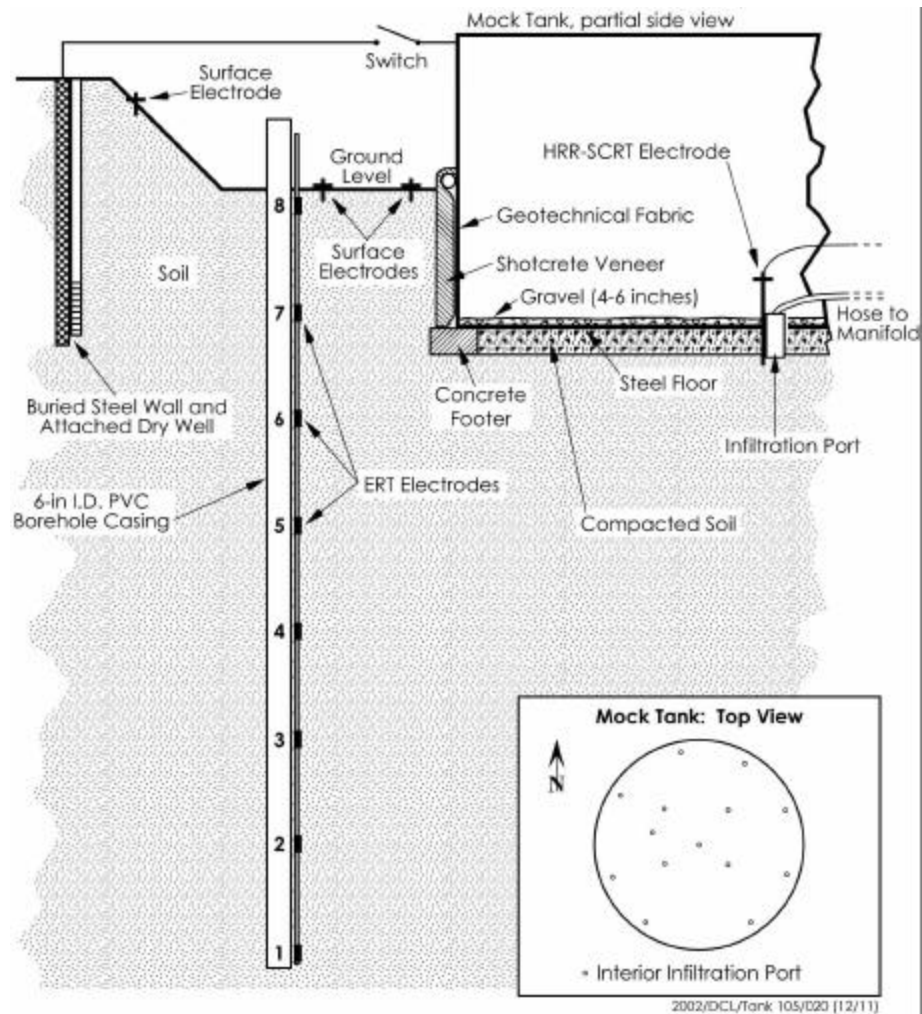
Figure 2.7. Schematic Cross Section of a Portion of the Mock Tank Structure. Also shown are the steel wall and dry well, one of 16 ERT arrays, and electrical connections. The inset shows the locations of access (monitoring) and infiltration ports inside the tank.

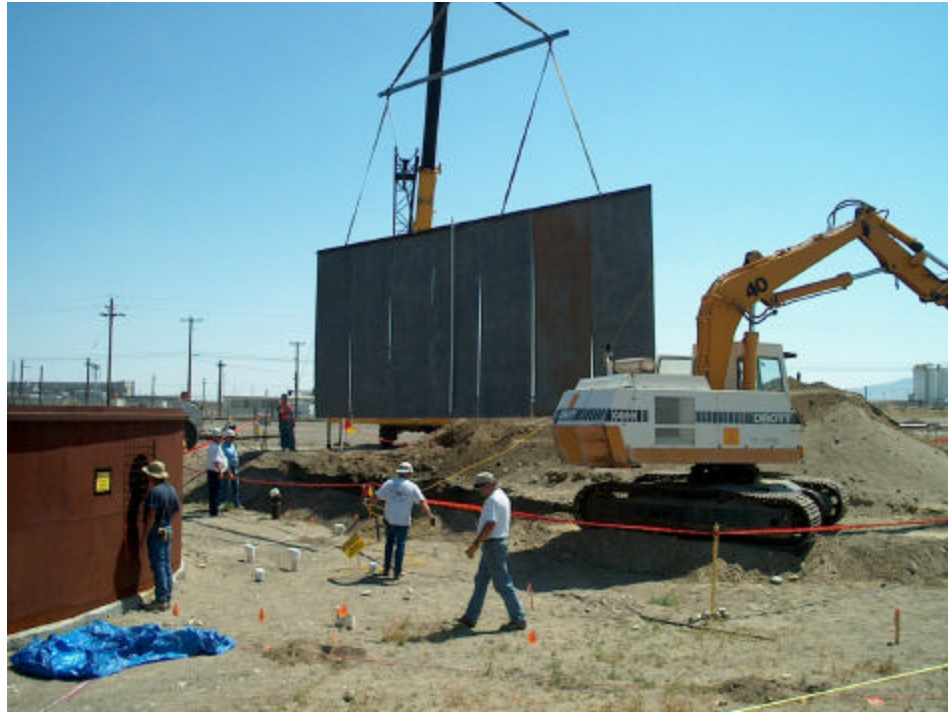
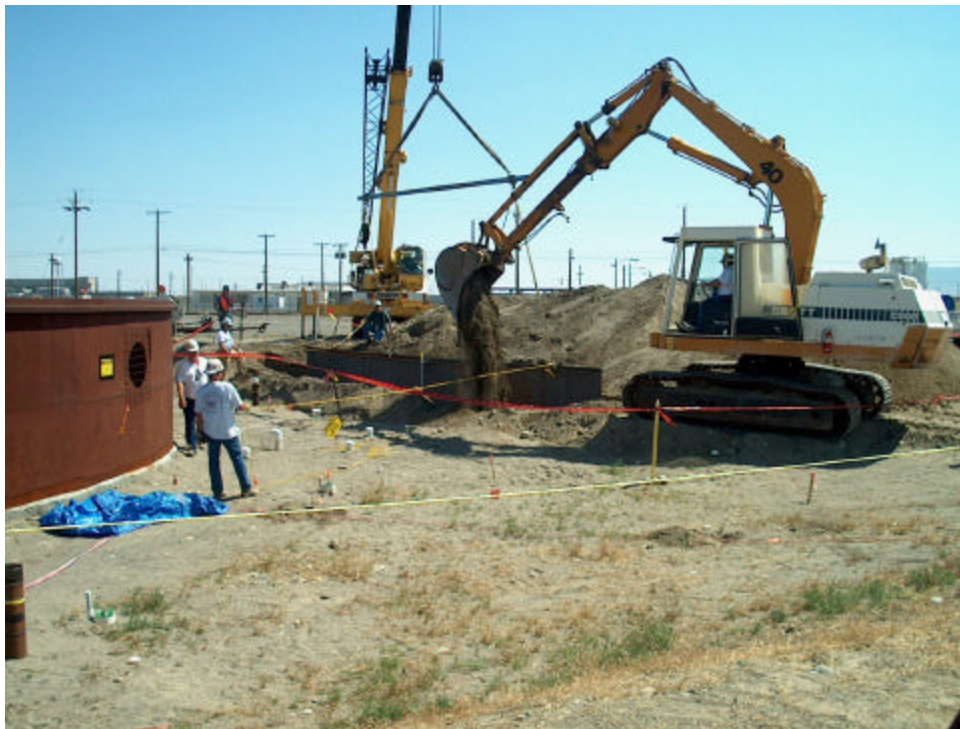
Figure 2.8. Installation of the Steel Sheet Wall at the Mock Tank. The PVC riser attached to the center of the wall for injecting water or waste surrogate near the wall was not used during the test.

Seven sections of 11-gauge steel were transported to the Mock Tank Site and assembled into a 4.5-m (15-ft) deep by 10.7-m (35-ft) long wall. One end of each section of steel sheeting was attached to a 0.64-cm (0.25-in.)-thick, 10.67-m (35-ft) length of channel steel to provide electrical continuity and to aid in emplacement. The installation also included a 5-cm (2-in.)-diameter, 3.35-m (11-ft) section of PVC piping for the purpose of simulating a side leak from an adjacent tank structure, although this feature was not used during the FY 2002-2003 PE test. Figure 2.8 shows portions of the installation sequence of the steel wall.

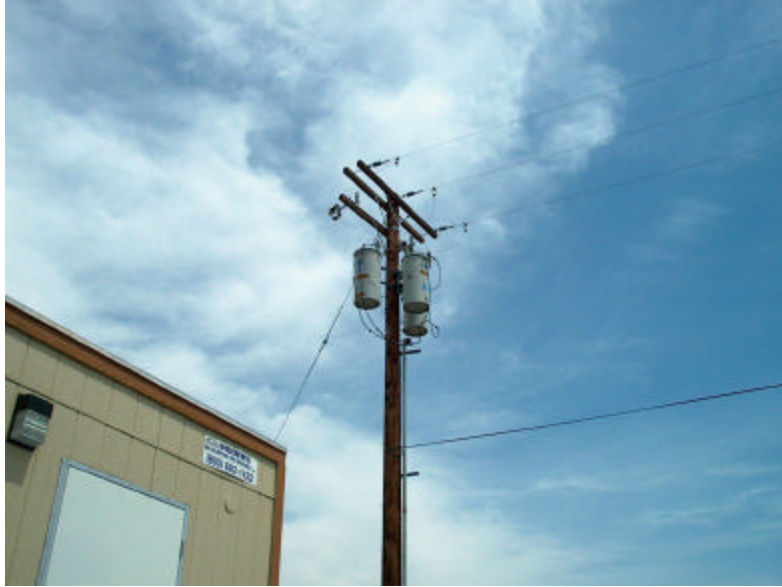
Figure 2.9. The Pole Installed at the 105-A Site, with the Three 13.8-kV Primaries Feeding Three 480-V Stepdown Transformers; the Integrated Services Digital Network (ISDN) Telephone Line Can Be Seen Beneath the Electrical Lines. The mobile field office is at lower left.

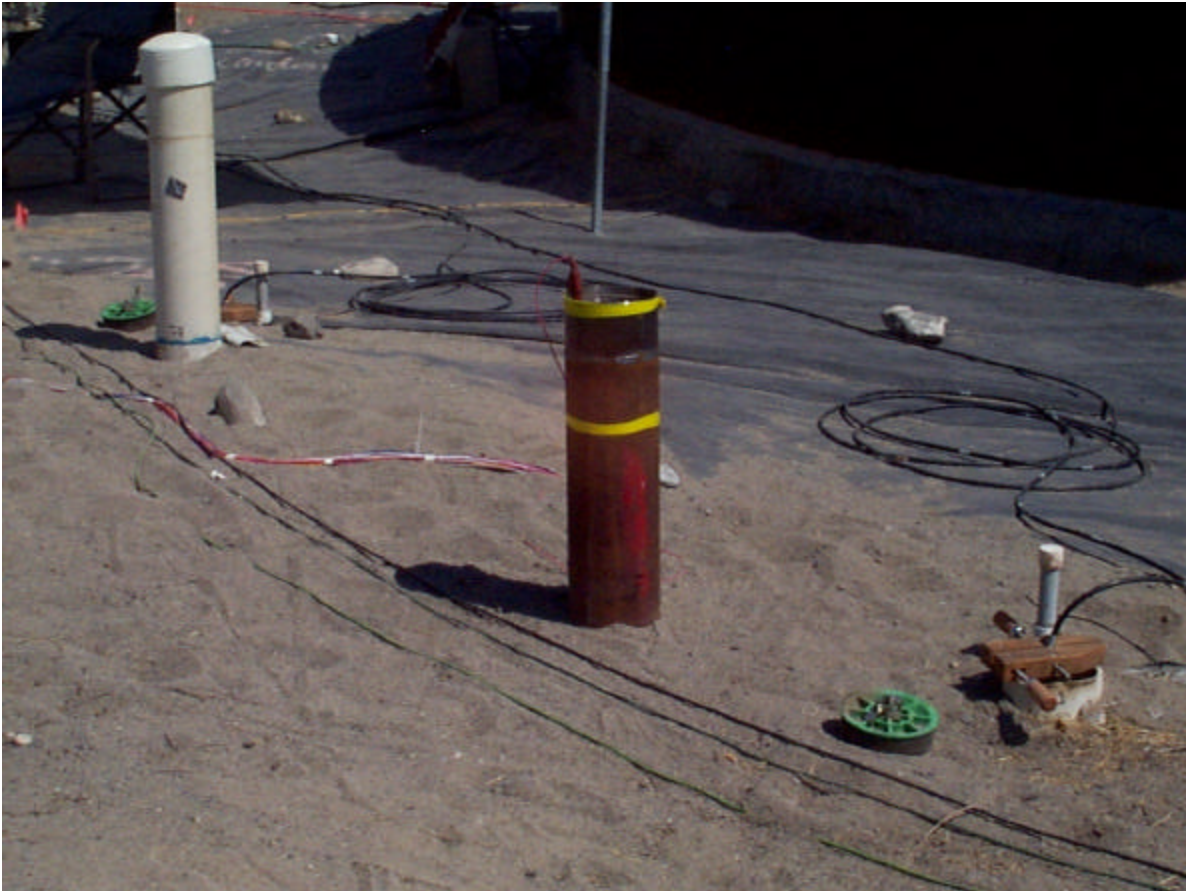
Figure 2.11. One of Four Steel Casings Used as Long Electrodes During the FY 2002-2003 Testing at the Mock Tank (center). To the lower right is 1 of the 16 ERT arrays around the tank. As indicated here, the caps of the 15-cm (6-in.) PVC casings with the arrays can be removed to allow access for accessory logging by neutron probe or other instruments. Eight of these arrays were used during the FY 2002-2003 testing.

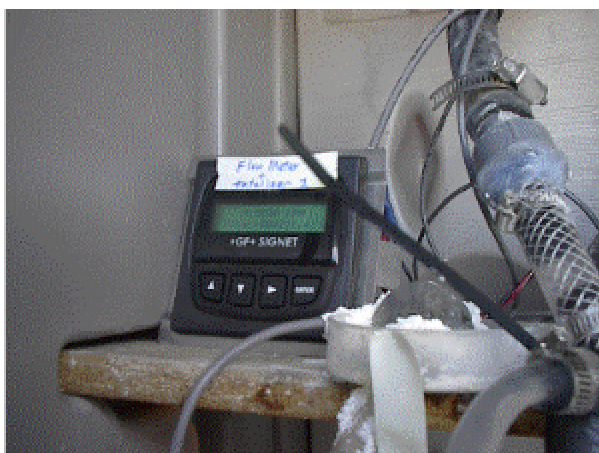
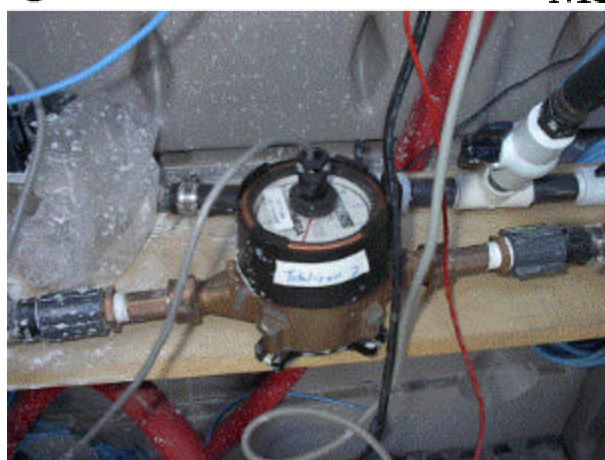
Figure 2.13. Solution Delivery System Components as Installed in the Housing Next to the Storage Tank

Signet Flow Gauge

Mechanical Totalizer

This system employed two metering pumps (Fluid Metering, QD-2) with a variable output (3.8 to 68 L/hr [1 to 18 gph]). This system also used two measurements to verify correct solution delivery; a solution-compatible flow sensor (GF Signet 2507) connected to a flow transmitter (GF Signet 8550-1) and the gravimetric analysis as performed with the previous system.

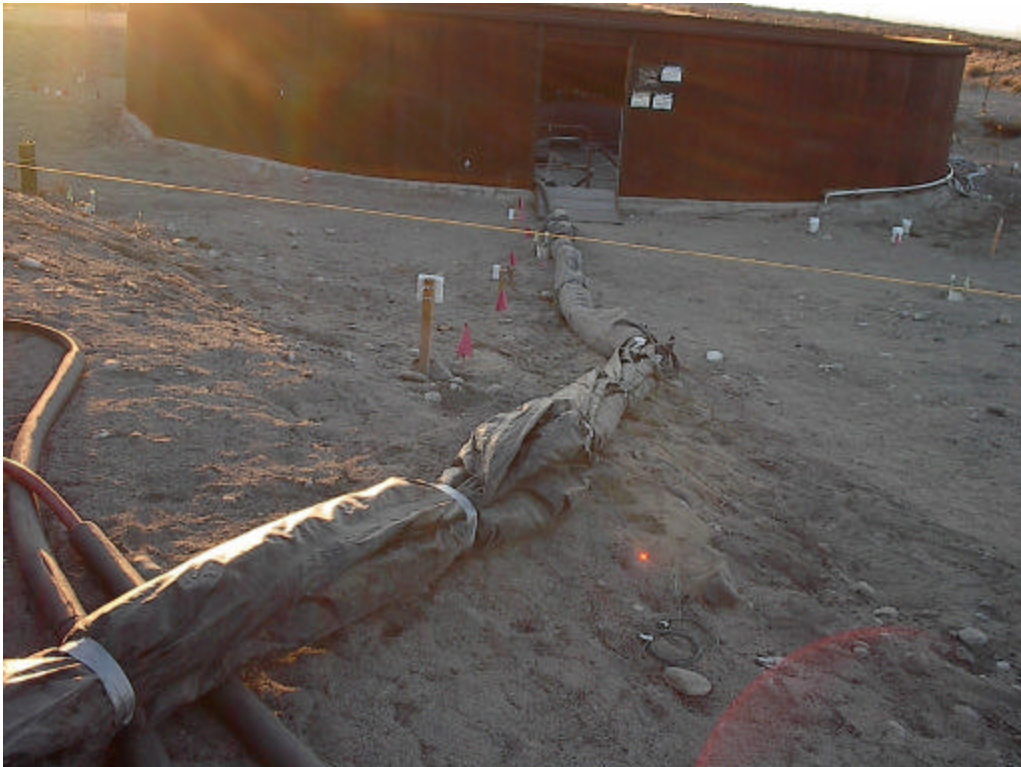
Figure 2.16. The Solution-Delivery Line Leading from the Pump/Metering Housing to the Manifold Inside the Mock Tank. This photograph shows the hose wrapped for cold weather to avoid crystallization/precipitation of the sodium thiosulfate solution.

A heating apparatus was designed for the solution delivery system in anticipation of colder weather as the test progressed into the fall. The solution delivery line was wrapped with insulation (see Figure 2.16). An inline water heater was plumbed into the recirculation loop at the centrifugal pump outlet, and the solution storage tank was insulated with a blanket of 0.64-cm (0.25-in.) foam insulation (Figure 2.17). These modifications maintained the tank solution temperature at 30° to 35°C (86° to 95°F). The solution-delivery system was wrapped with heat tape and insulated with 1.9-cm (0.75-in.) pipe-foam insulation from the control components to each individual riser.

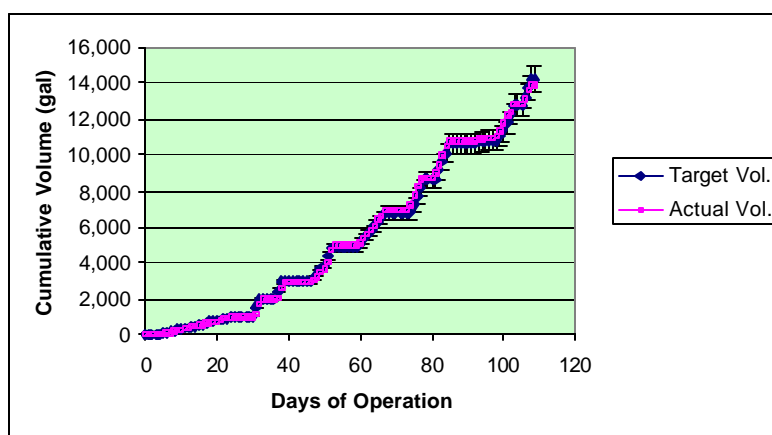
Figure 3.1. Cumulative Volume Vs. Time: Target Volume vs. Actual

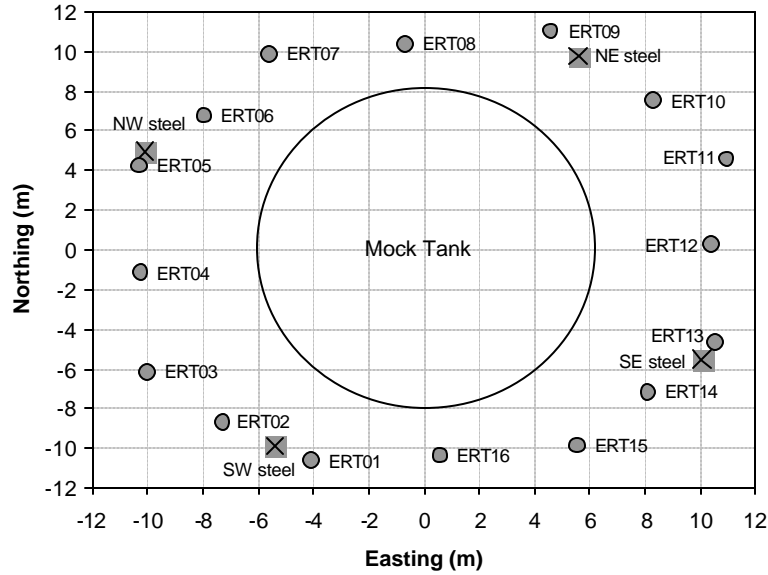
Figure 3.4. Plan View of the Mock Tank Monitoring-Well Layout Showing External Monitoring Points

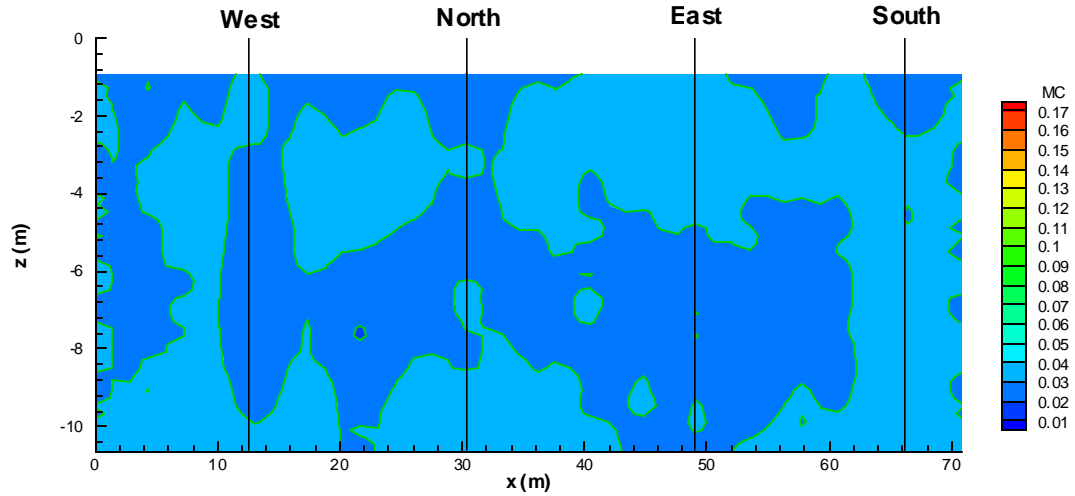
Figure 3.5. Mock Tank Baseline Water Content (July 5th)

Figure 3.5 shows the neutron-probe-measured two-dimensional baseline moisture content around the periphery of the mock tank. The moisture content throughout the measurement domain is fairly uniform, with moisture content values ranging from a high value of $0.0434 \text{ (m}^3 \text{ m}^{-3}\text{)}$ in the south quadrant to a low value of $0.0169 \text{ (m}^3 \text{ m}^{-3}\text{)}$ near the surface of the southwest quadrant. The measured difference in duplicate measurements for neutron-probe moisture content taken on July 5th is shown in Figure 3.6. On average, the difference in duplicate measurements was $\pm 0.002 \text{ (m}^3 \text{ m}^{-3}\text{)}$, with the maximum difference in duplicate measurements being $0.009 \text{ (m}^3 \text{ m}^{-3}\text{)}$. The relatively small difference between duplicate measurements demonstrates the stability of the neutron-probe method.

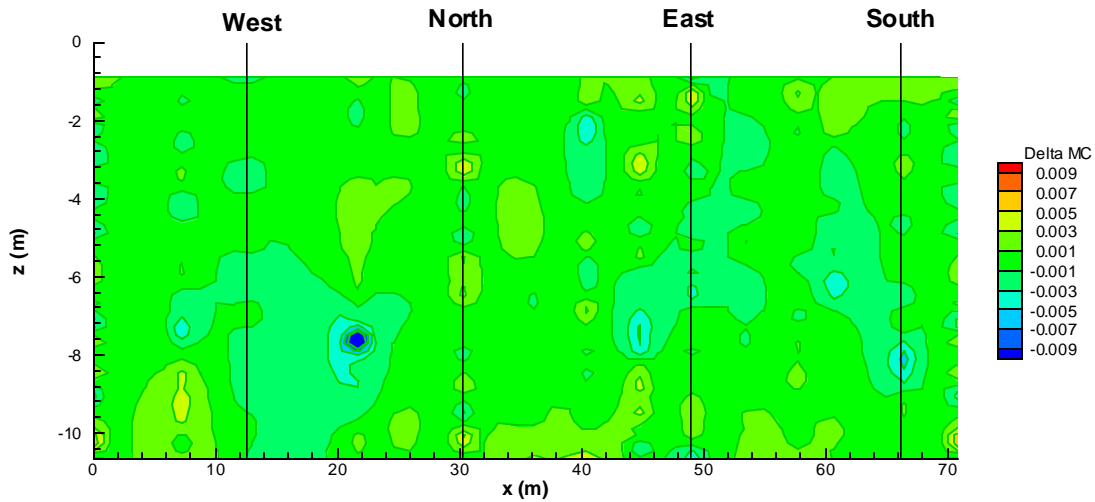
Figure 3.6. Difference in Duplicate Moisture Content Measurements (July 5th)

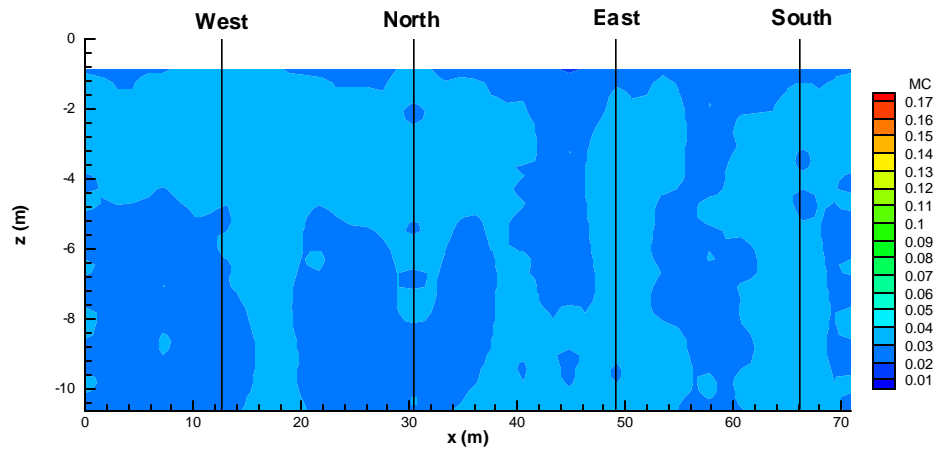
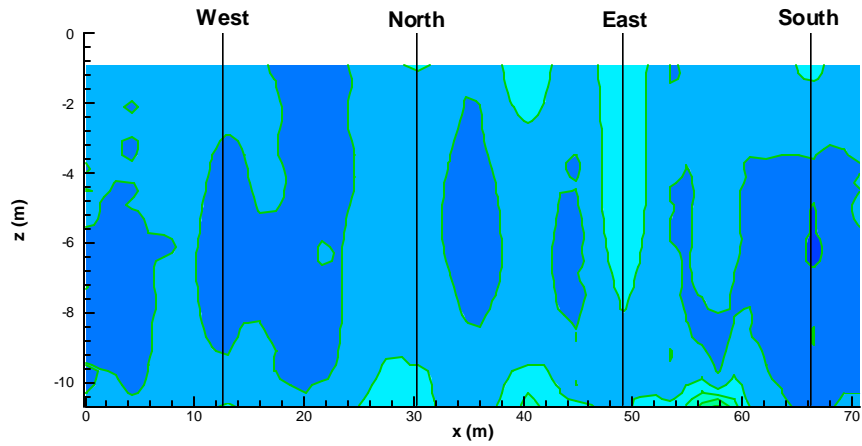
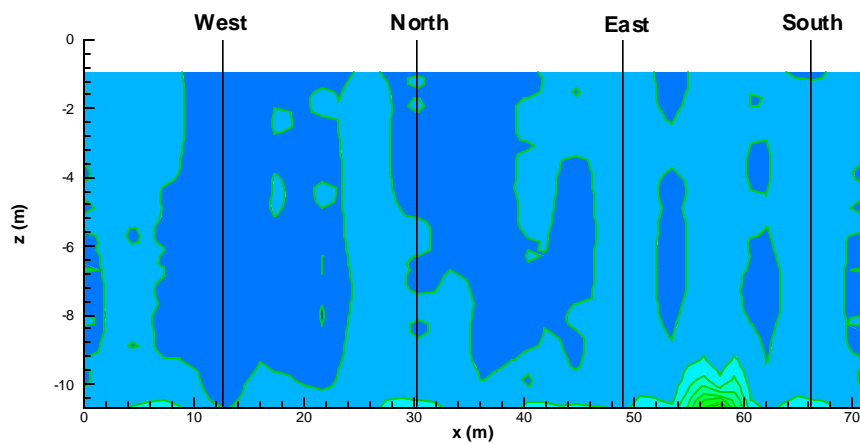
Figure 3.7. August 30th Measured Moisture Content

Figure 3.8. September 13th Measured Moisture Content

Figure 3.9. October 2nd Measured Moisture Content

Figure 3.7 through Figure 3.9 again show the neutron-probe-measured two-dimensional moisture content at the Mock Tank Site for the dates of August 30th, September 13th, and October 2nd, respectively. The August 30th moisture content is stable and essentially unchanged from the baseline measurement. Alternatively, the September 13th measurements capture an increase in moisture content at the maximum measurement depth in the southeast quadrant of the site. Although not entirely evident in Figure 3.8 due to kriging effects, the moisture content has increased from a baseline measurement of $0.0344 \text{ (m}^3 \text{ m}^{-3}\text{)}$ to $0.0978 \text{ (m}^3 \text{ m}^{-3}\text{)}$. This increased moisture content is likely due to lateral movement of the simulated tank leak. The increased moisture content in the southeast quadrant continued to persist on October 2nd, now encompassing a larger area and attaining maximum moisture content of $0.1539 \text{ (m}^3 \text{ m}^{-3}\text{)}$.

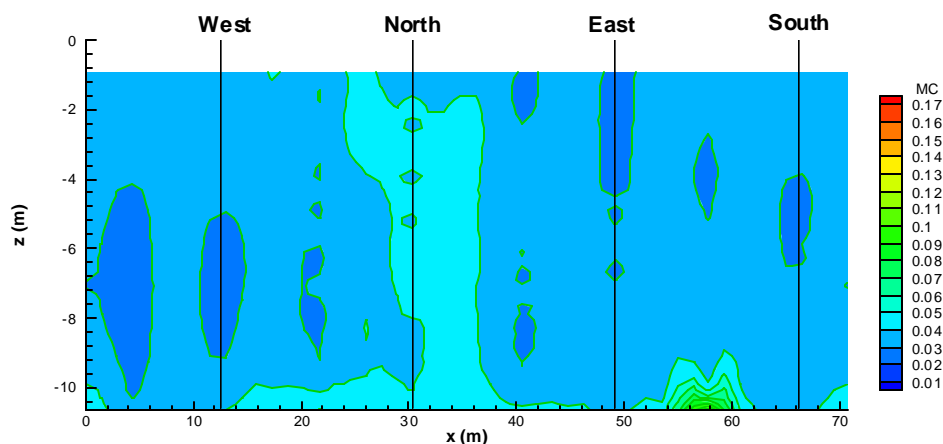
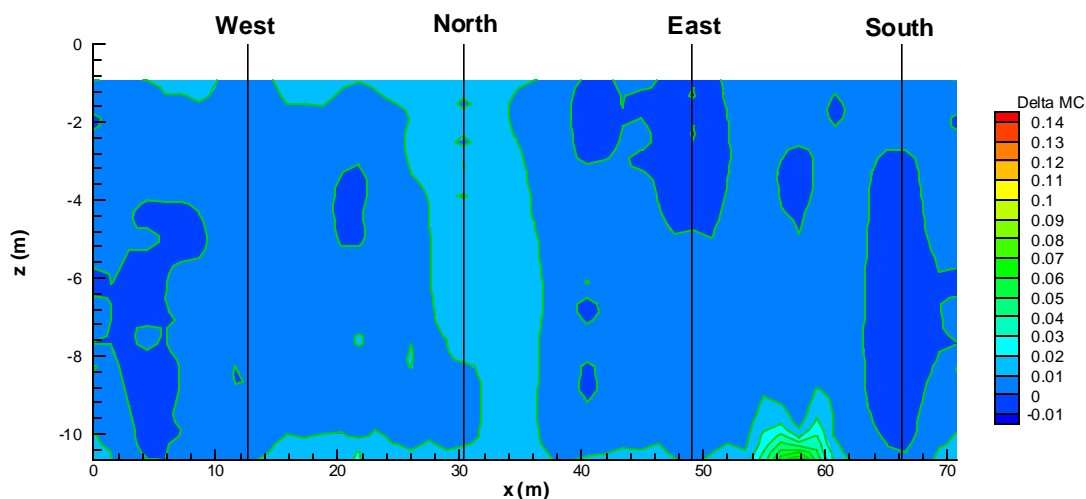
Figure 3.10. October 24th Measured Moisture Content

Figure 3.11. Measured Change in Moisture Content Between July 5th and October 24th

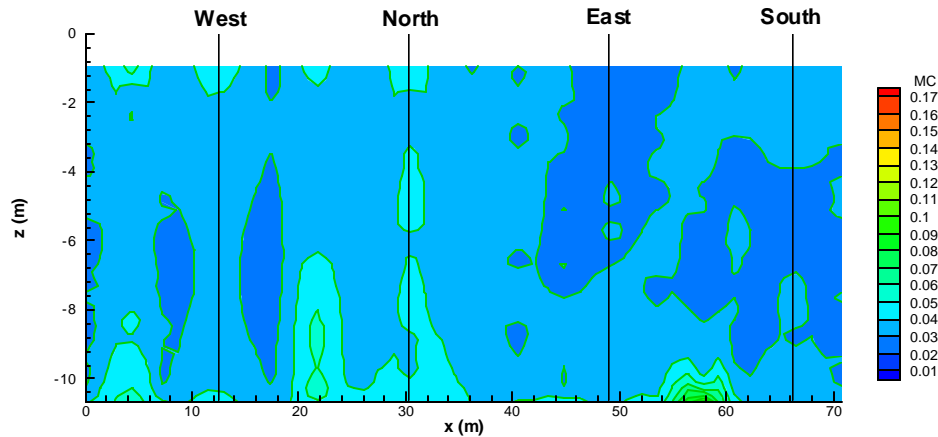
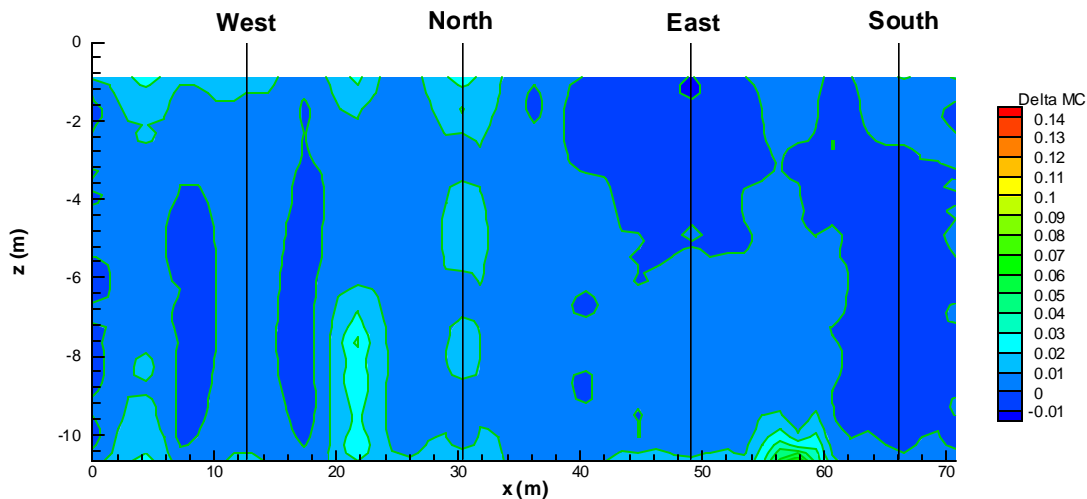
Figure 3.12. November 13th Measured Moisture Content

Figure 3.13. Measured Change in Moisture Content Between July 5th and November 13th

Figure 3.12 and Figure 3.13 reveal that by November 13th, much of the infiltrated water present in the north quadrant on October 24th had either redistributed throughout the profile or moved beyond the vertical extent of our measurement. Increased moisture content in the southeast quadrant still remains and has not experienced an appreciable change in size or moisture content since the October 2nd moisture-content measurements.

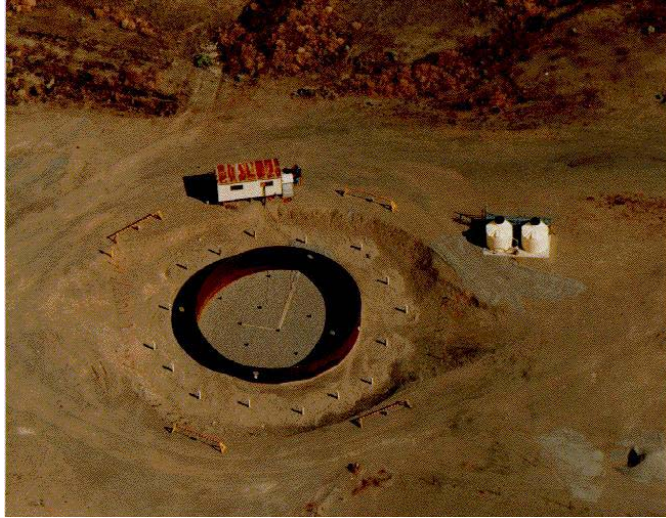
Figure 2. Top: The Mock Tank Site Before Start of FY 2001 Activities.

Shown are the sixteen 1995 ERT arrays, the previous field laboratory, and two 2,500-gal (9,464-L) tanks used in the 1995–96 experiments. Bottom: Oblique aerial view of the Mock Tank from the northwest following FY 2001 testing, showing the mobile geophysics laboratory (bus lower left of tank) and SAFE Development Area (SDA) (upper left of mock tank). A 4,000-gal (15,140-L) tank, which contained the sodium thiosulfate solution for the FY 2001 testing, had already been removed at the time of the photograph.

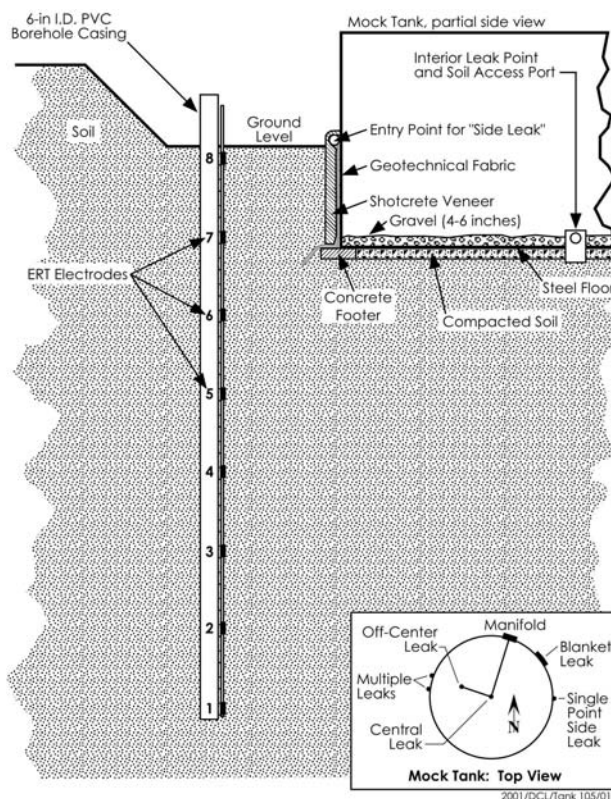
Figure 3. Details of the Mock Tank Construction in Relation to One of the 1995 ERT Installations. The Mock Tank is approximately 50 ft (15.2 m) in diameter; the ERT array extends to 35 ft (~10.6 m) below ground level, with an electrode every 5 ft (1.52 m).

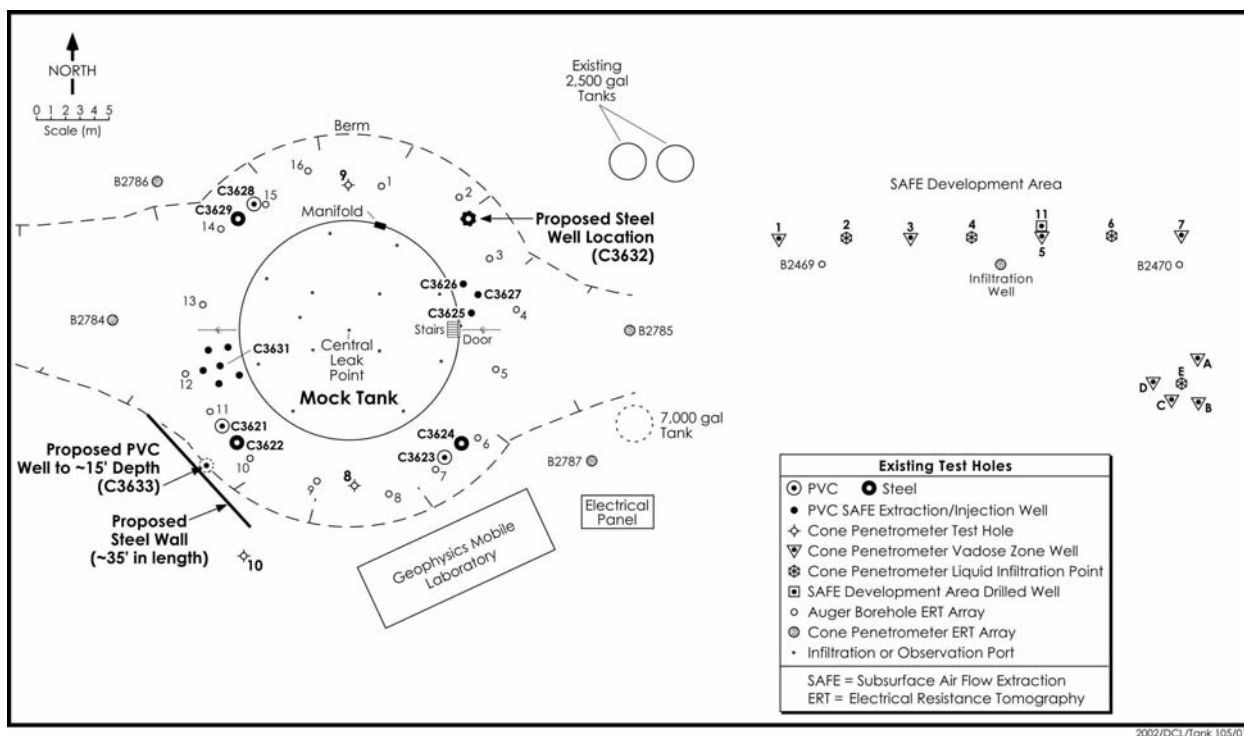
Figure 4. Site Layout for the Mock Tank Showing Additional Infrastructure Planned for the FY 2002–2003 Performance Evaluation Testing

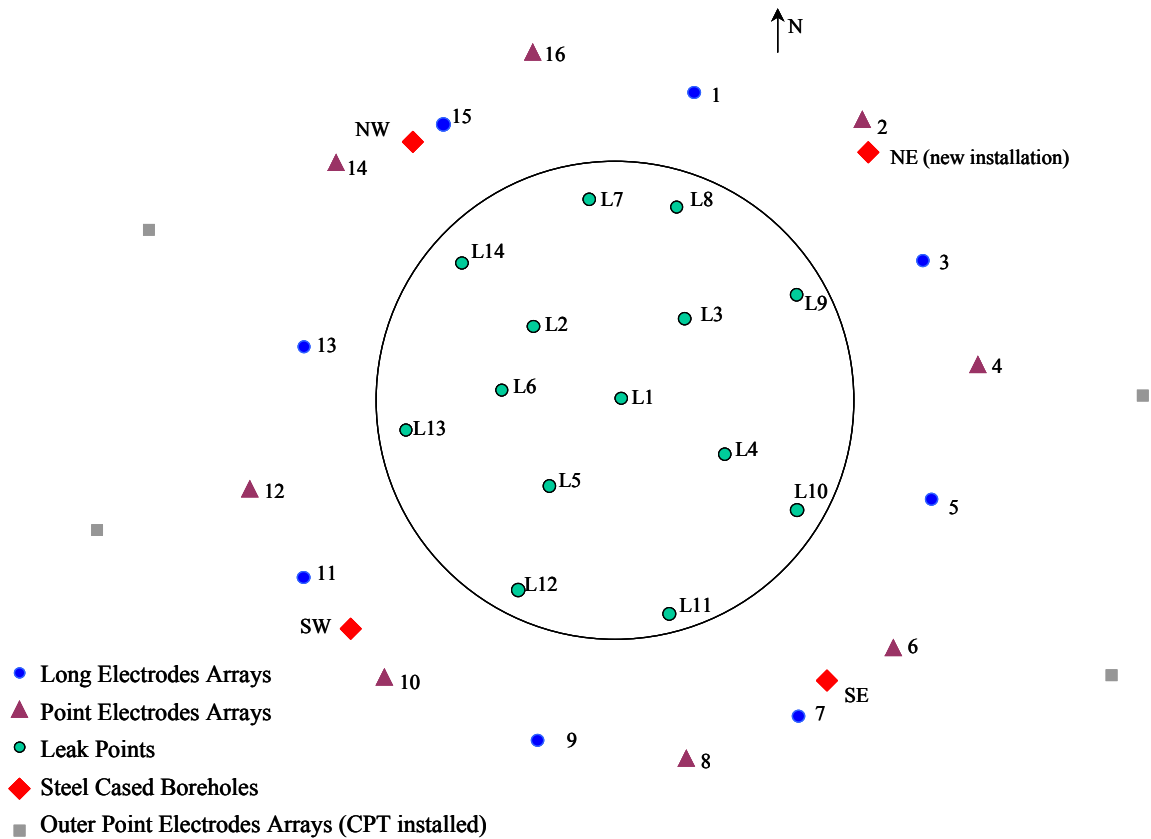
Figure 5. Locations of Boreholes, ERT Arrays, and Interior Access Ports (“leak points”) at the Mock Tank Site (after Bratton et al. 2002b)

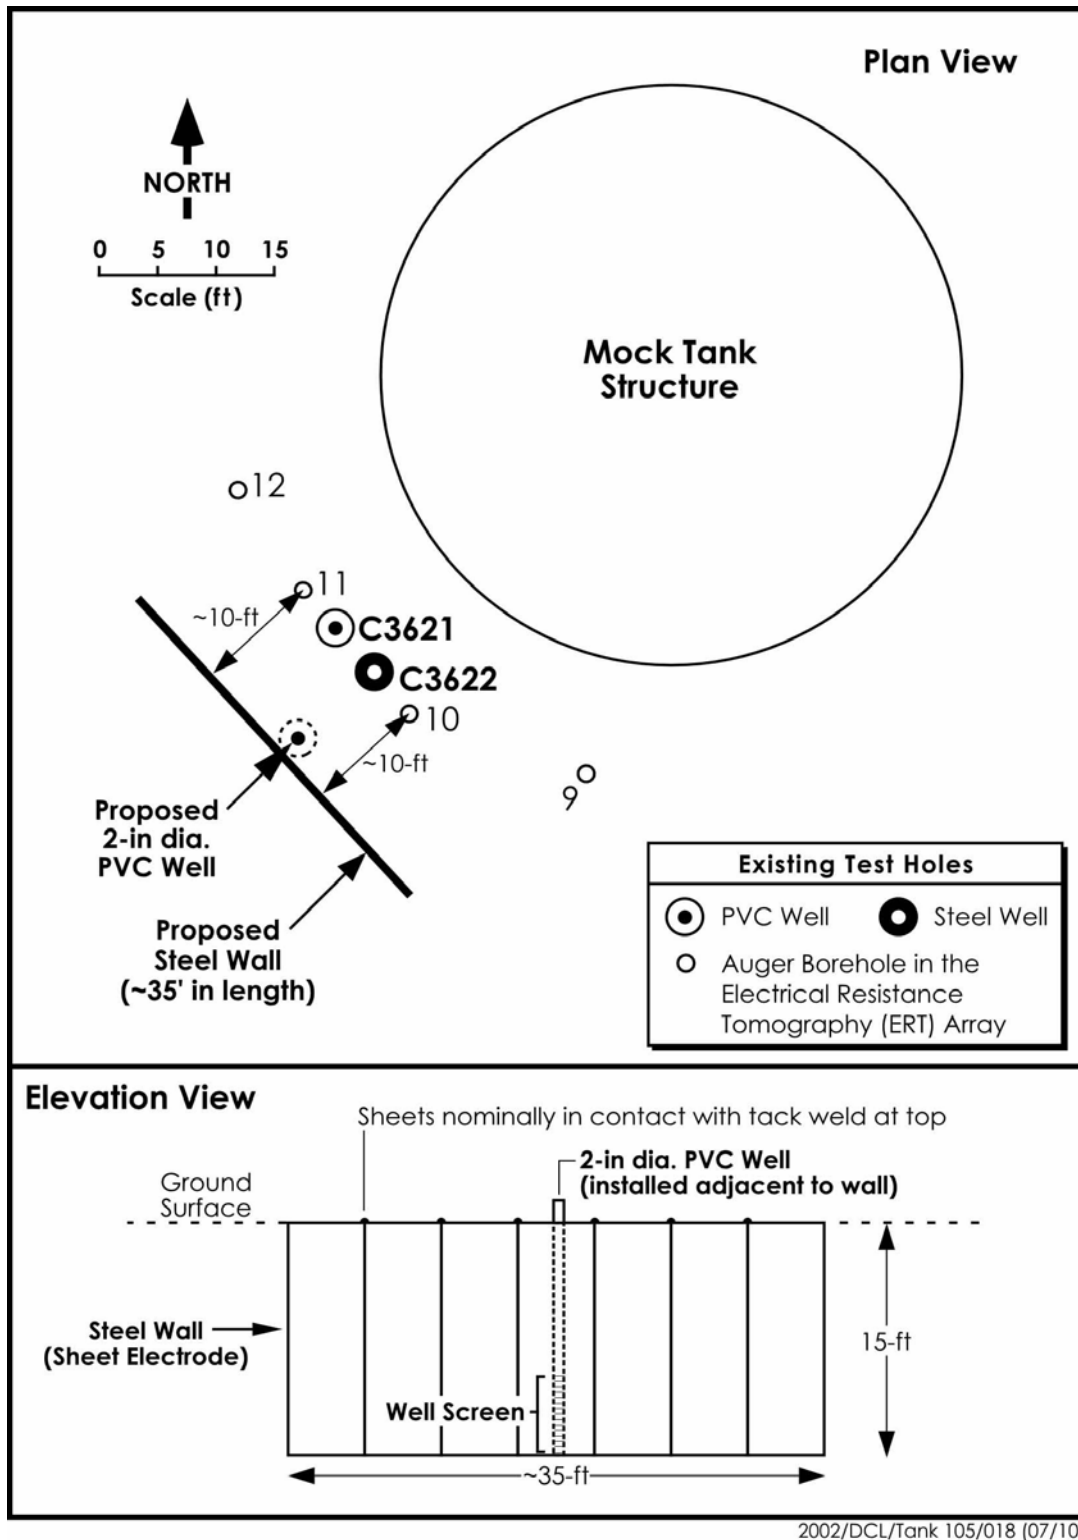
Figure D.2. Design Layout of Steel Sheet Wall to be Installed near the Mock Tank

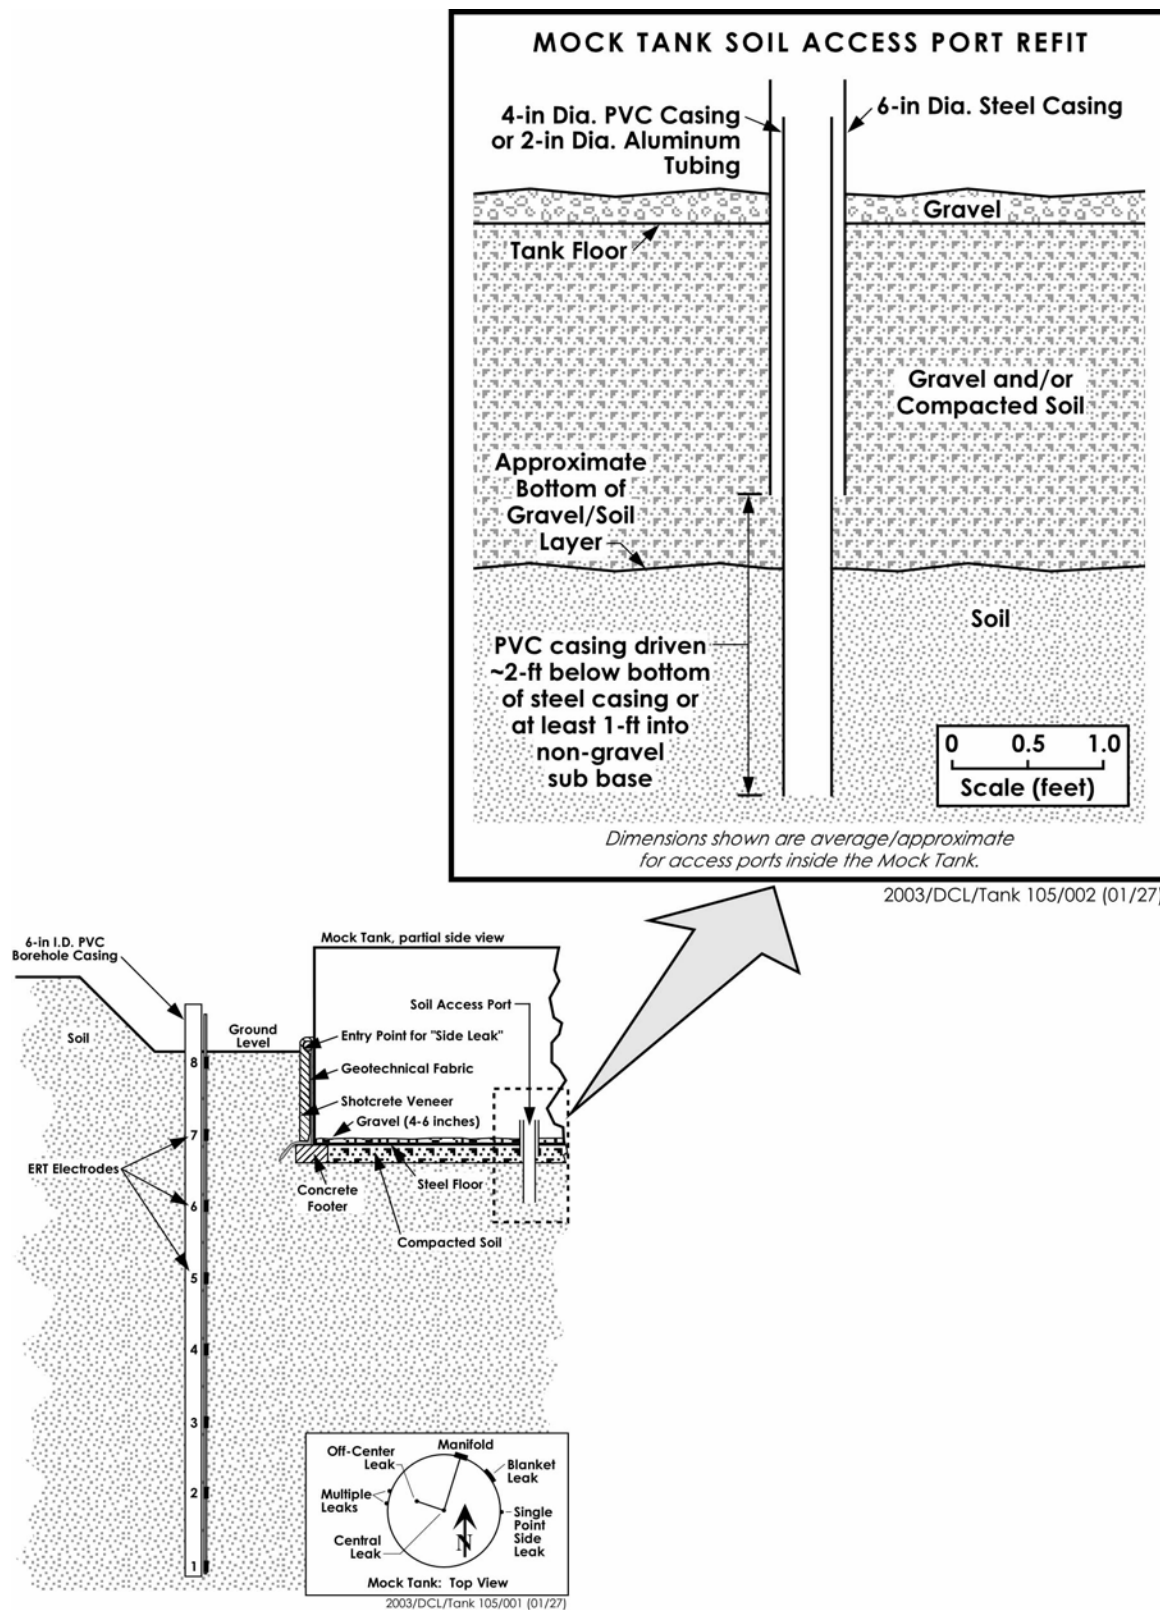
Figure D.3. Refitting of Access Ports for Neutron Probe Measurements

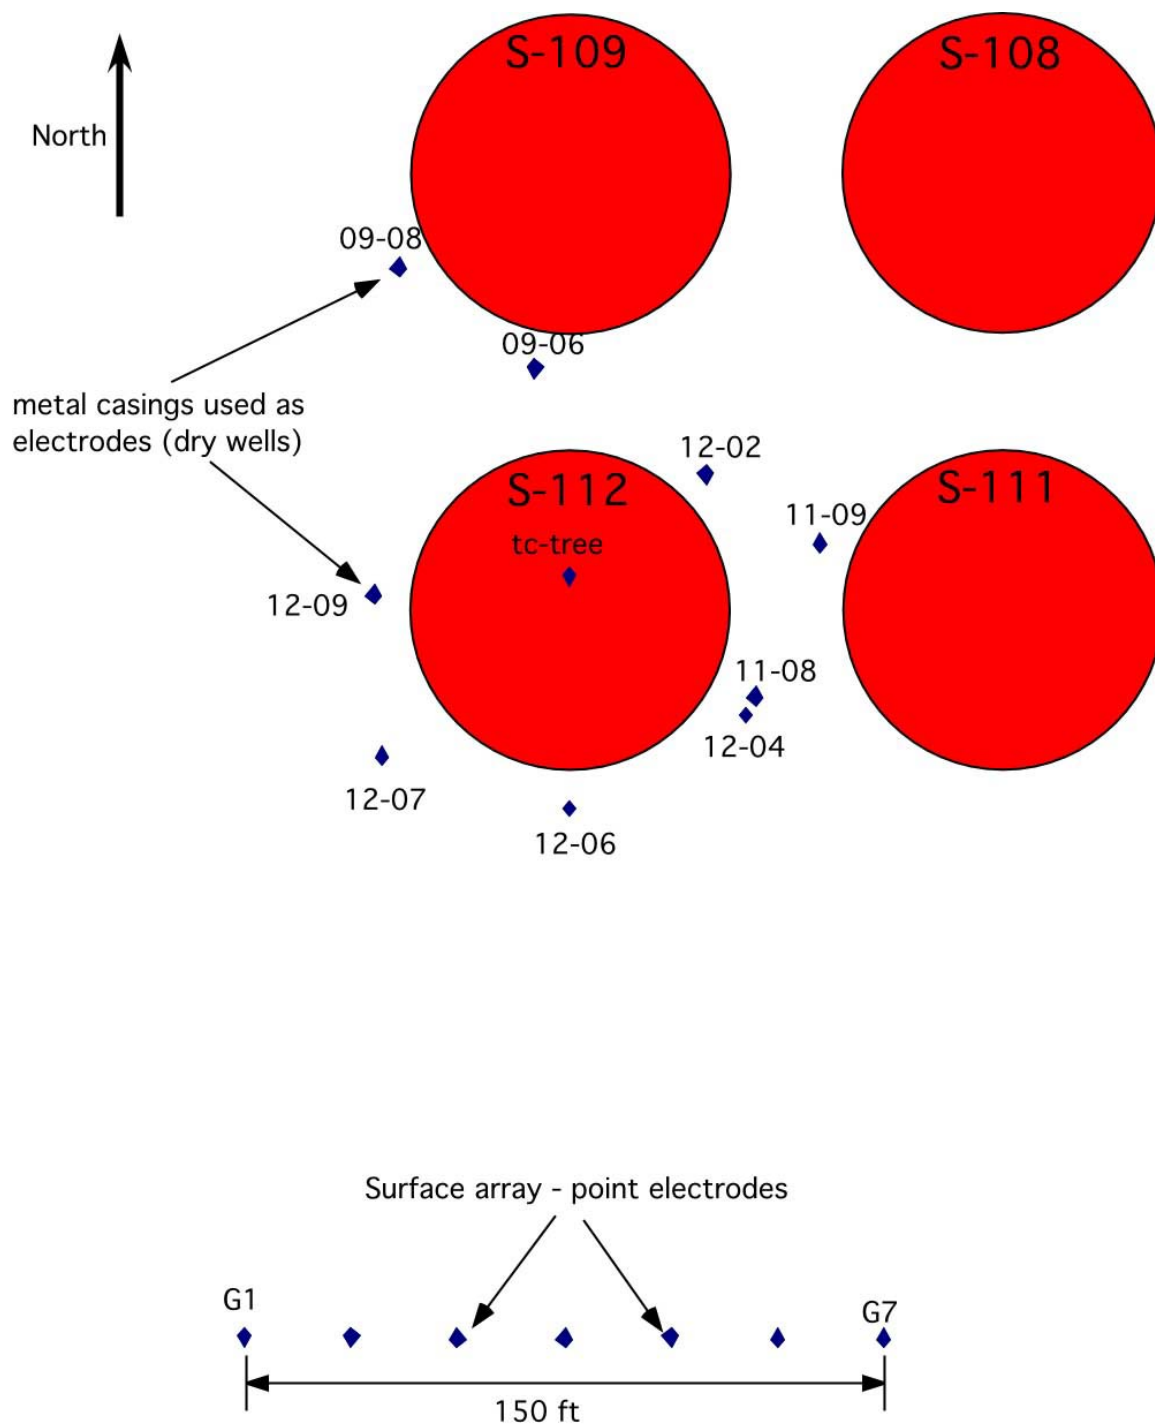
Figure 1. The location of the dry wells and thermocouple (tc) tree used as electrodes is shown. Only the dry wells and trees used to collect the data discussed in this report are shown. Also shown are surface (point) electrodes used to measure the bulk resistivity of the sediments near S-112.
