**Pacific Northwest
National Laboratory**

Results of Performance Evaluation Testing of Electrical Leak-Detection Methods at the Hanford Site Mock Tank – FY 2002-2003

February 2003

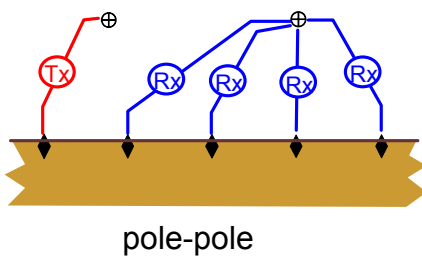
Tests 4 and 5 used a modified pole-pole array that consisted of energizing one shallow electrode and one dry well, and recording the resulting potential at various receiver electrodes and a receiver dry well. The pole-pole array uses two remote reference electrodes that are theoretically placed at an infinite distance from the active electrodes (shallow electrodes). In reality, once the remote reference electrodes exceed a sufficient distance from the active electrodes, mathematically

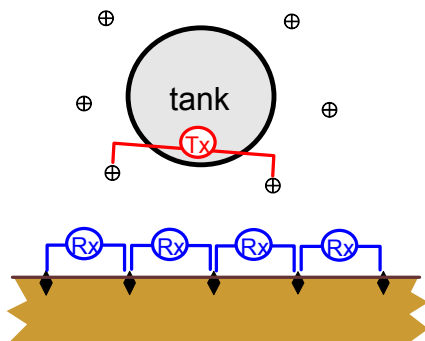
All measurements were recorded using the dipole-dipole array configuration. Data collection consisted of energizing a pair of dry wells (Tx = transmitter dipole) and recording the resulting potentials at various pairs of receiver shallow electrodes (Rx = receiver dipole).

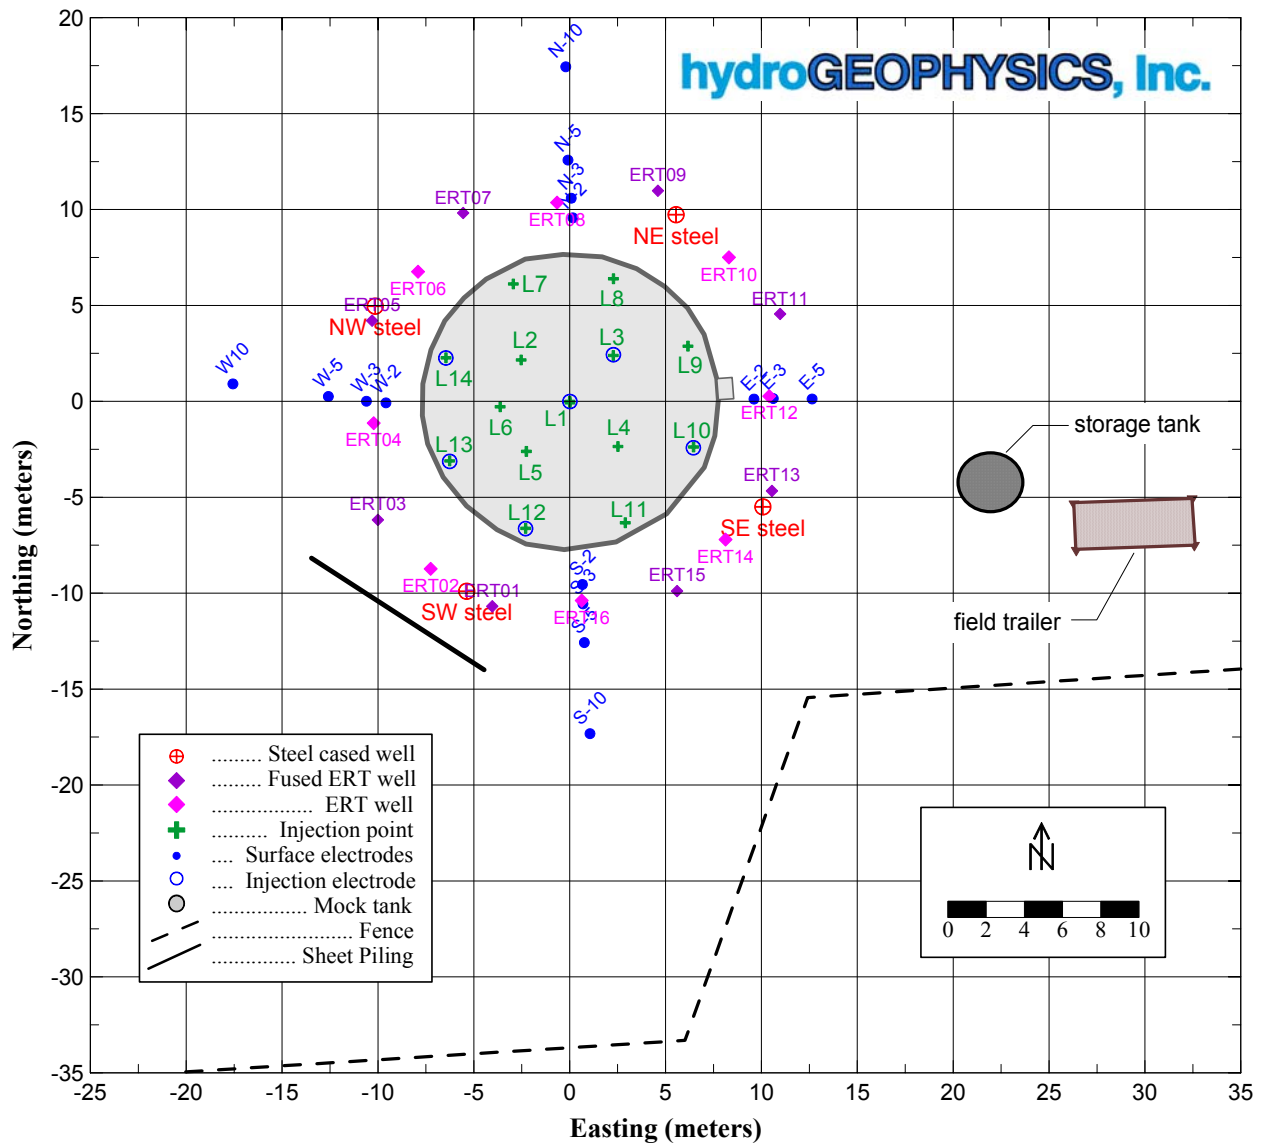
Figure C.1. Plan map showing the location of the mock tank, the four steel casings, the surface electrode array, injection ports, and other relevant features for the 2002 LDMM PE Test

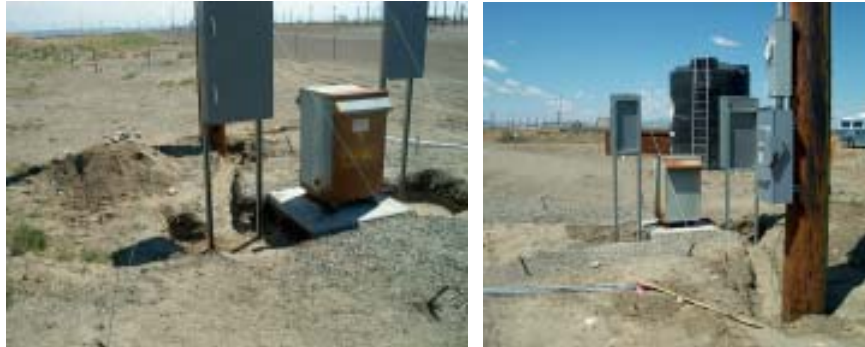
Figure C.4. Installation of Site Power

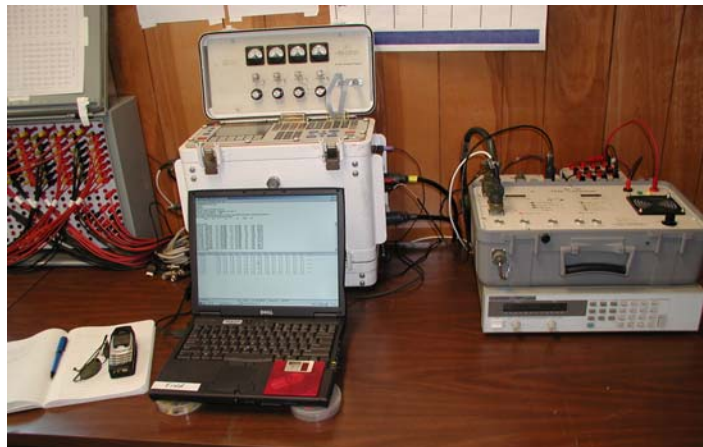
Figure C.6. Shows Resistivity System Setup with HP Power Supply (bottom right), Transmitter (top right), Remote Computer (bottom center), Receiver (top center) and Patch Panel (far left)

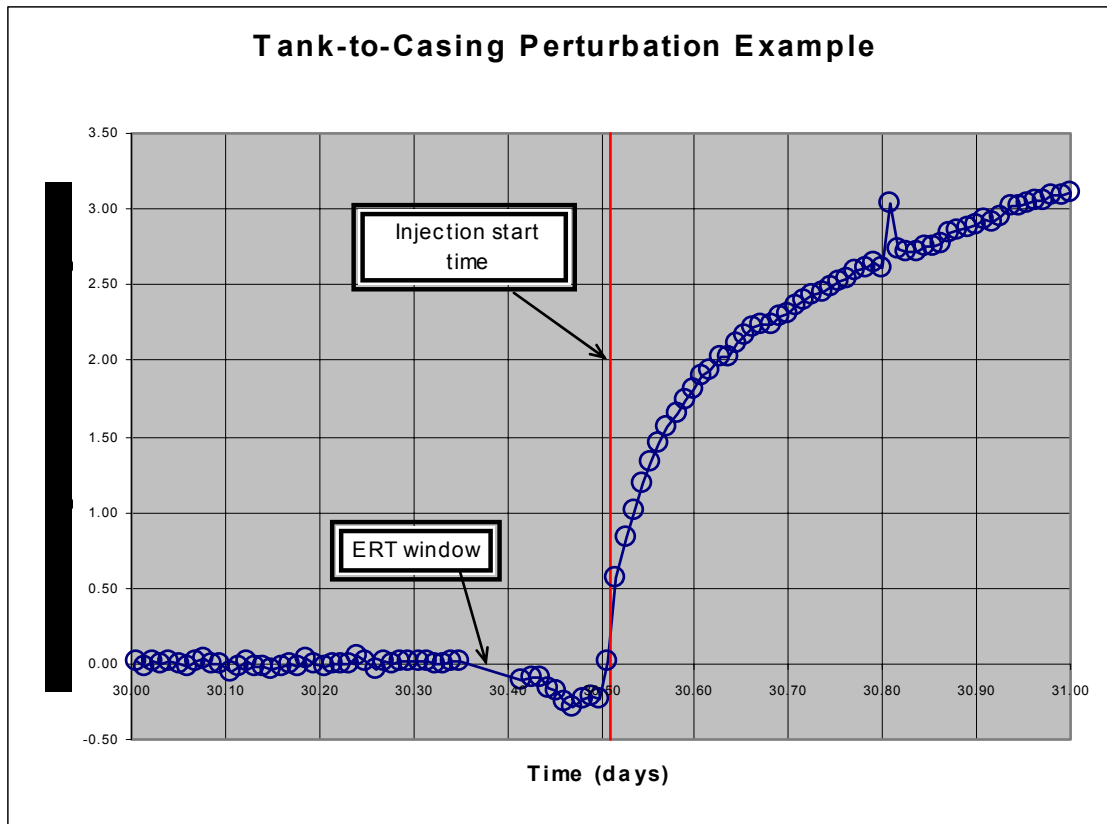
Figure C.9. An example of the Relative Change in Signal Level that Indicates a Perturbation Event upon the Start of a Leak

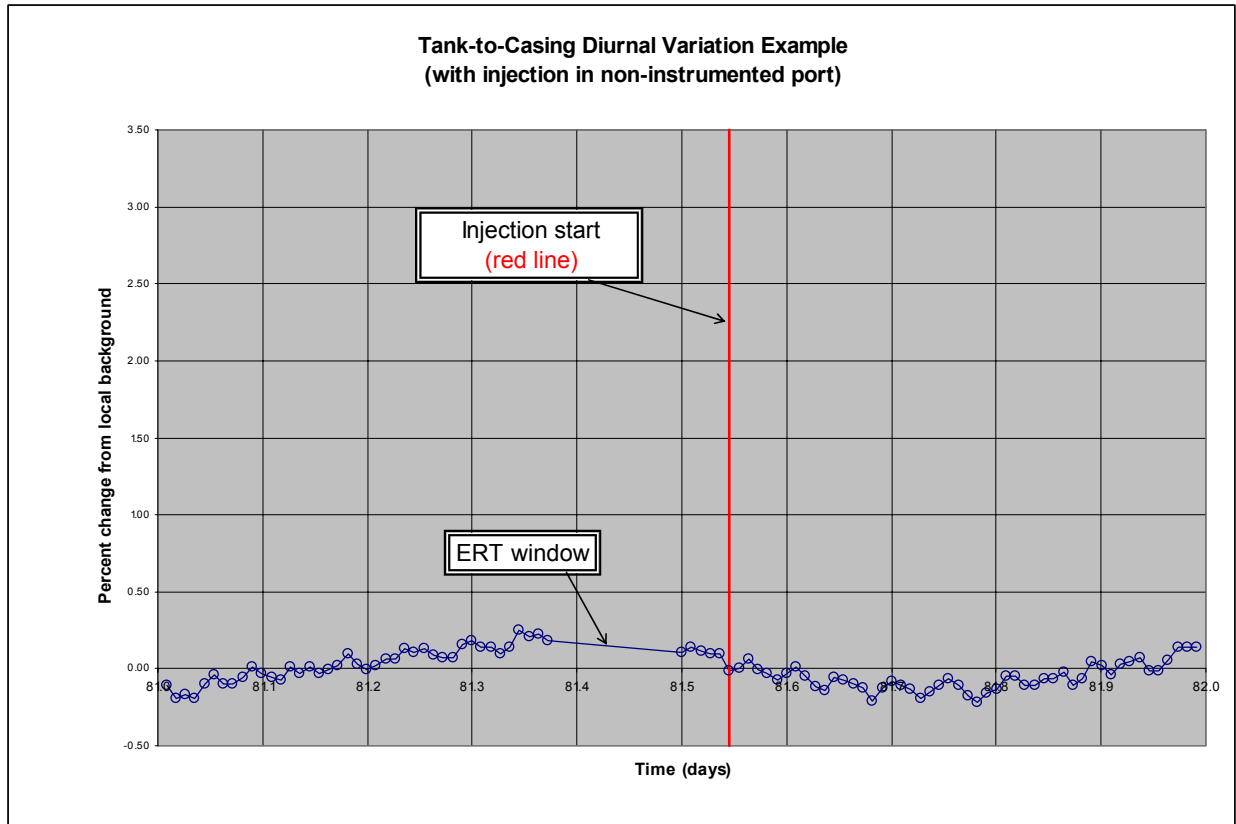
Figure C.10. An Example of the Relative Change in Signal Level that Does Not Indicate a Leak Because the Leak Port Was Not Instrumented. Diurnal variation is more apparent in this example.

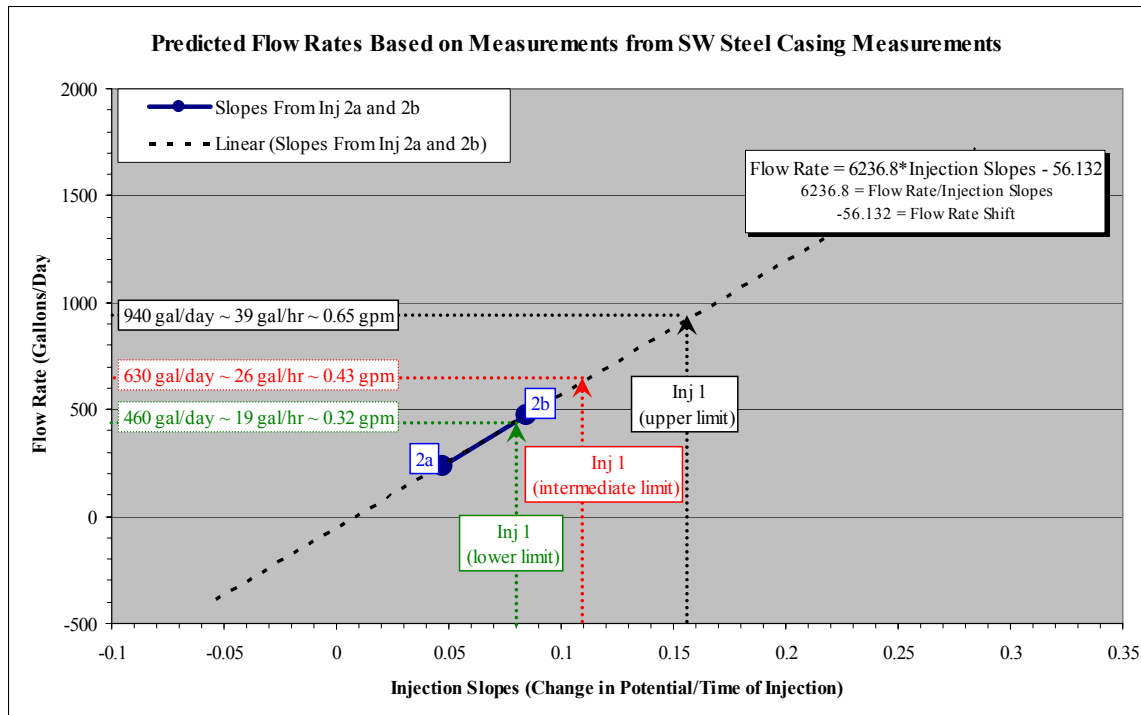
Figure C.12. Flow Rates vs. Injection Slopes

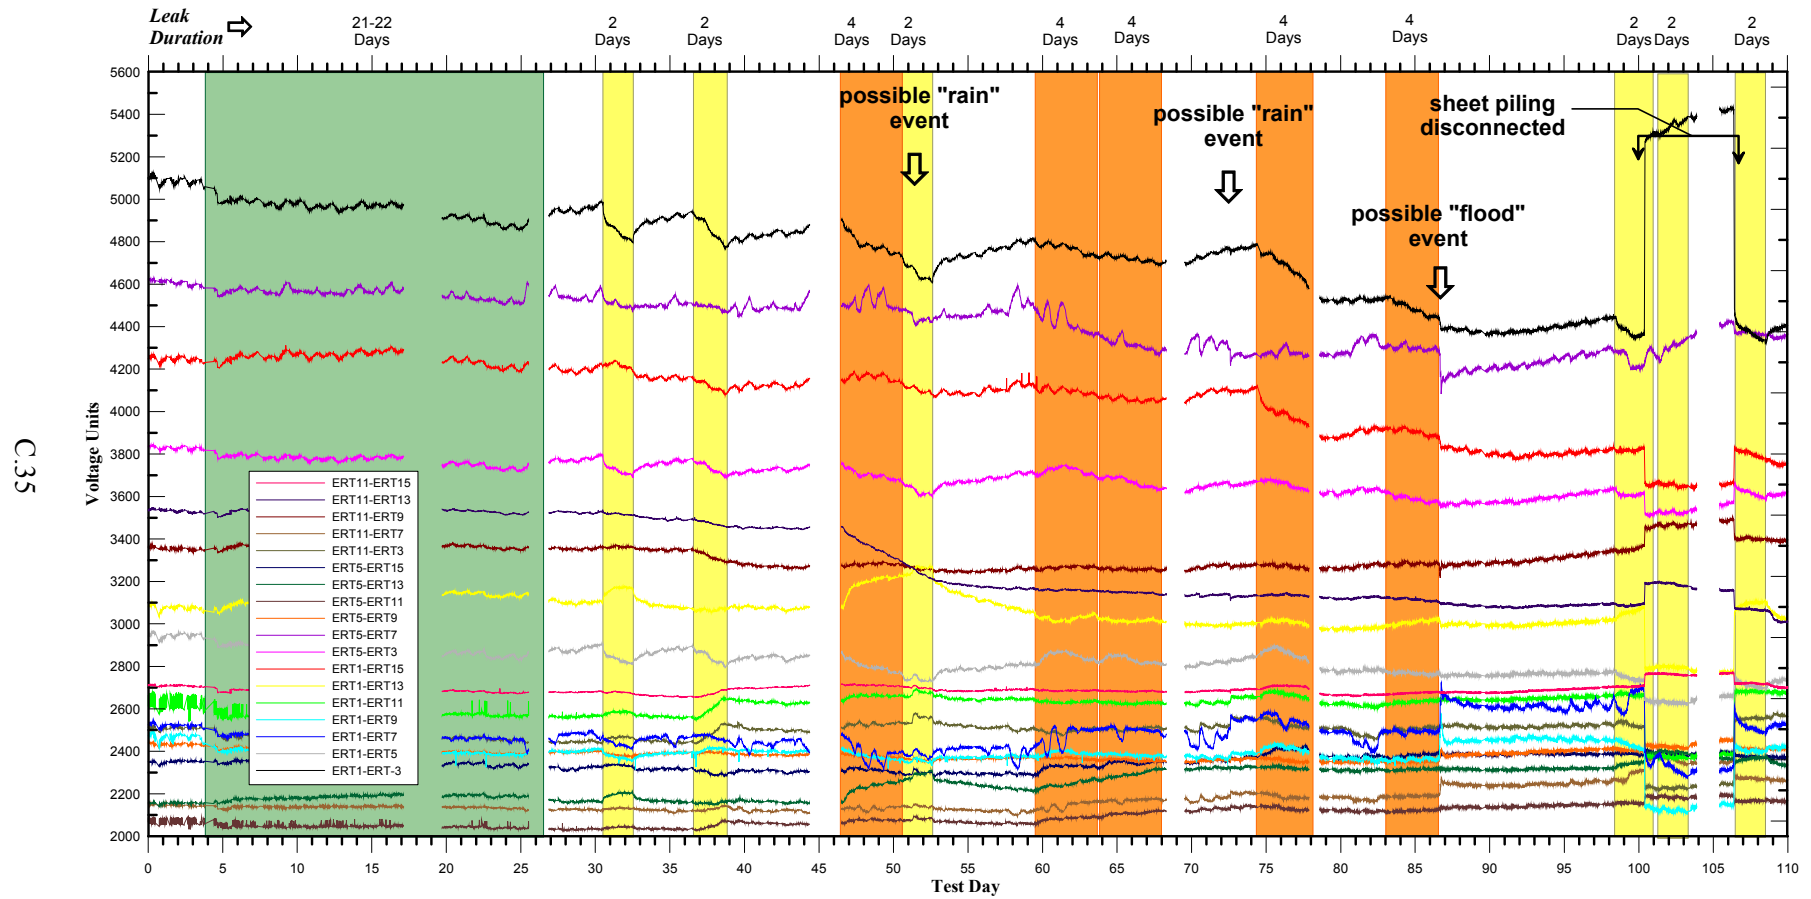
Figure C.13. Interpreted Leak Detection Time Series of "Fused" ERT Well to "Fused" ERT Well Potential Measurements

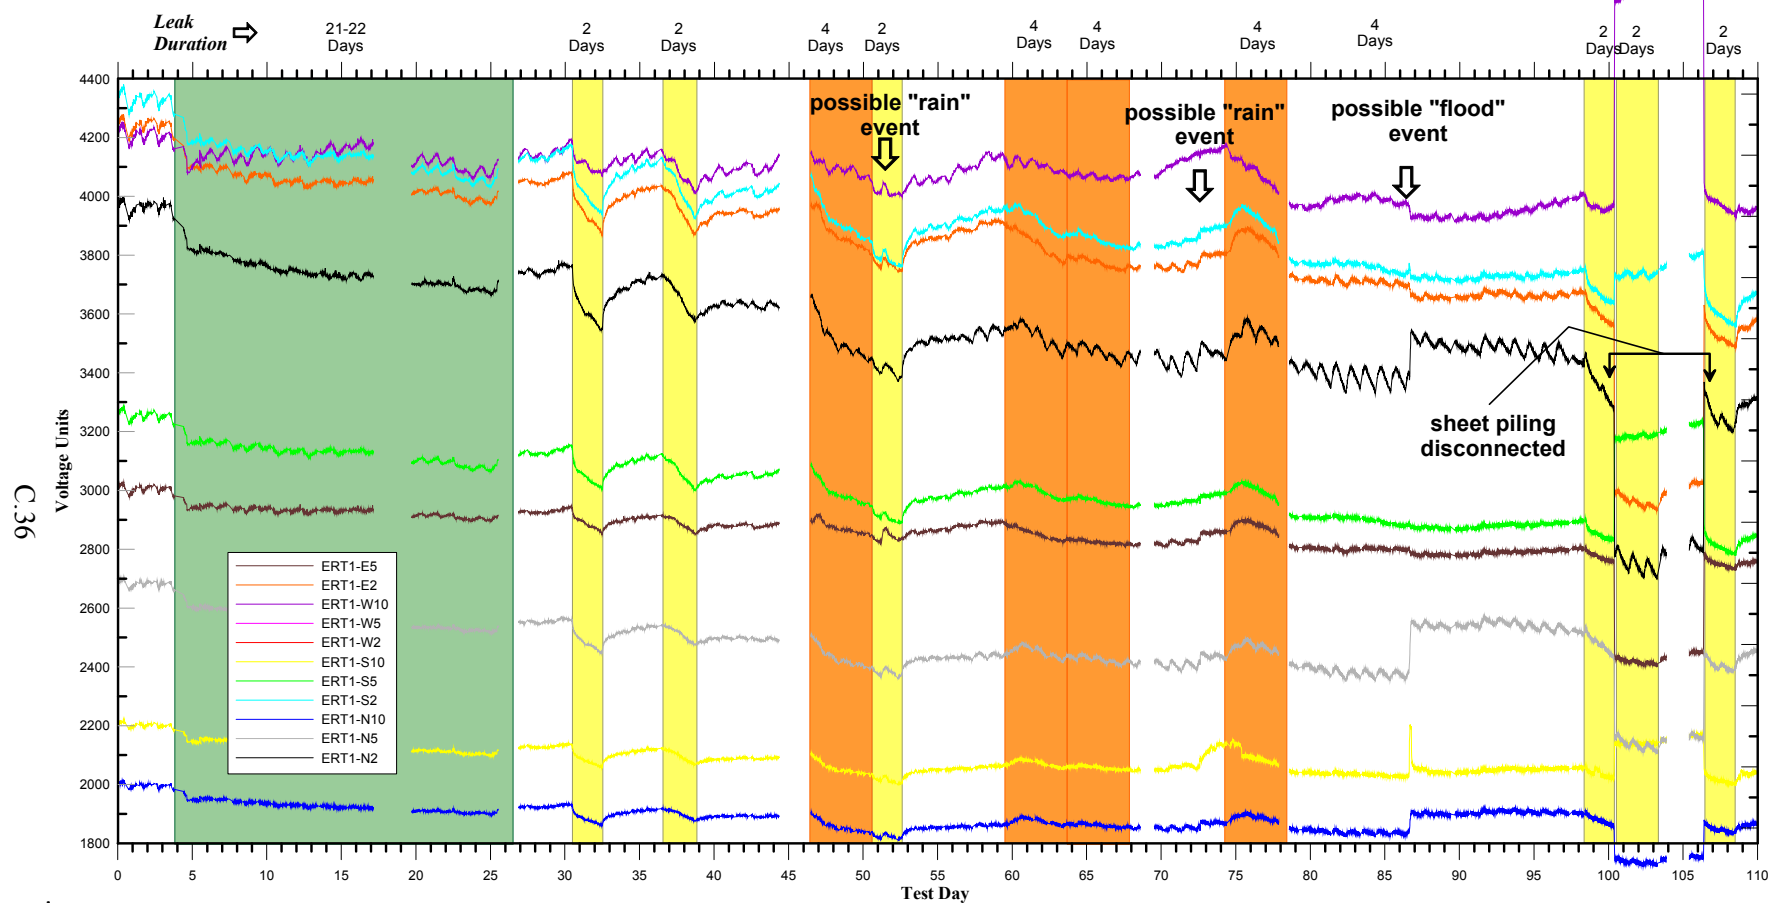
Figure C.14. Interpreted Leak Detection Time Series of "fused" ERT Well to Surface Potential Measurements

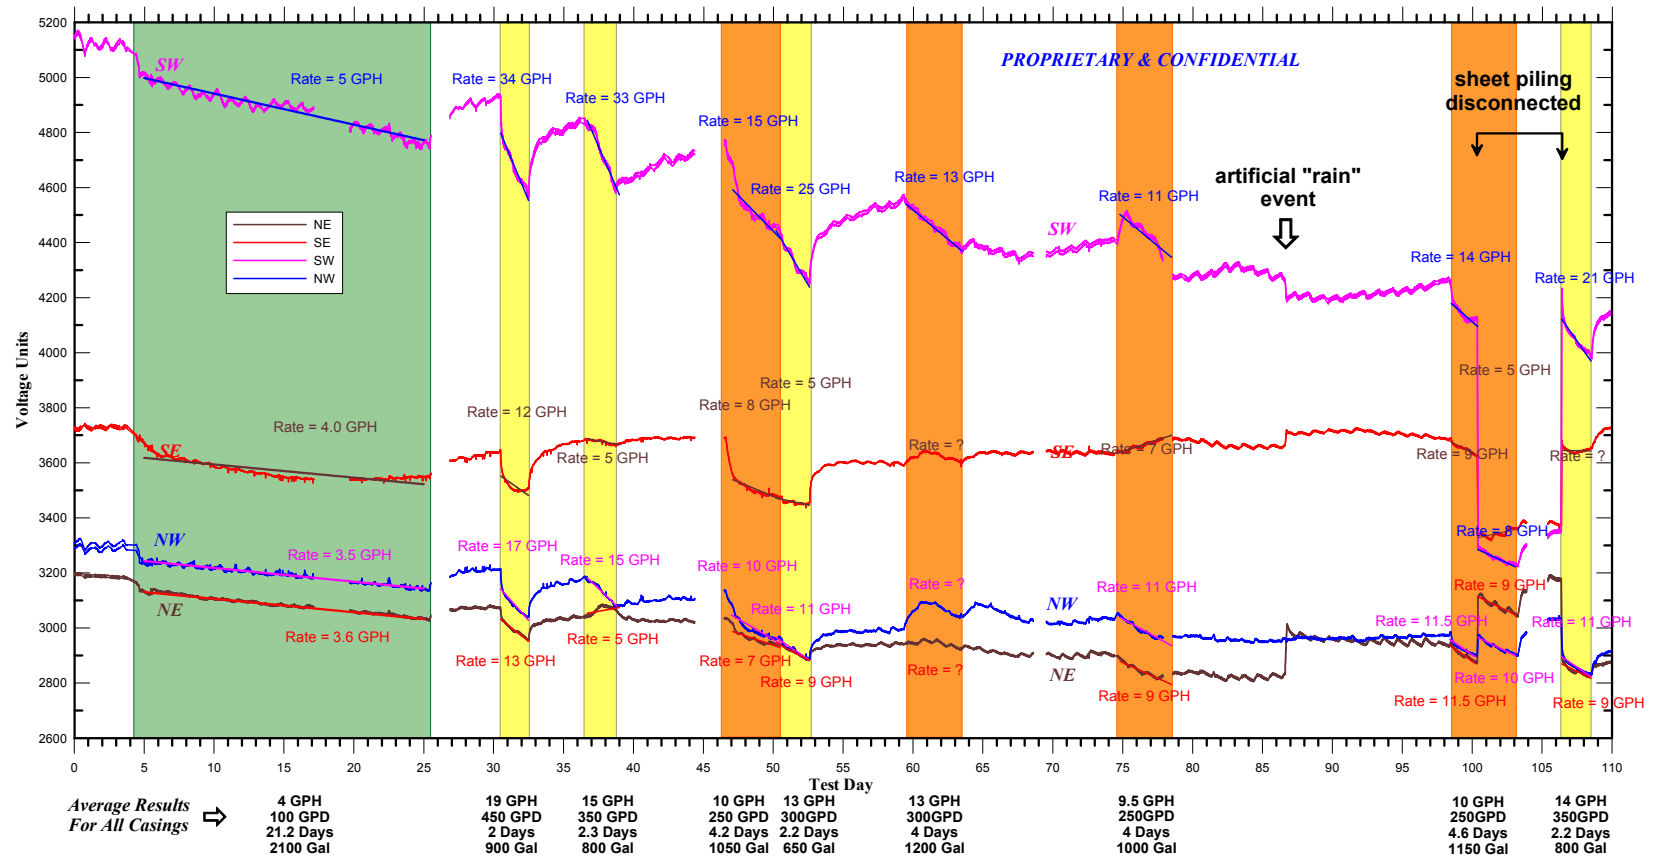
Figure C.15. Interpreted Leak Detection Time Series o Injection System Electrodes to Steel Casing Potential Measurements

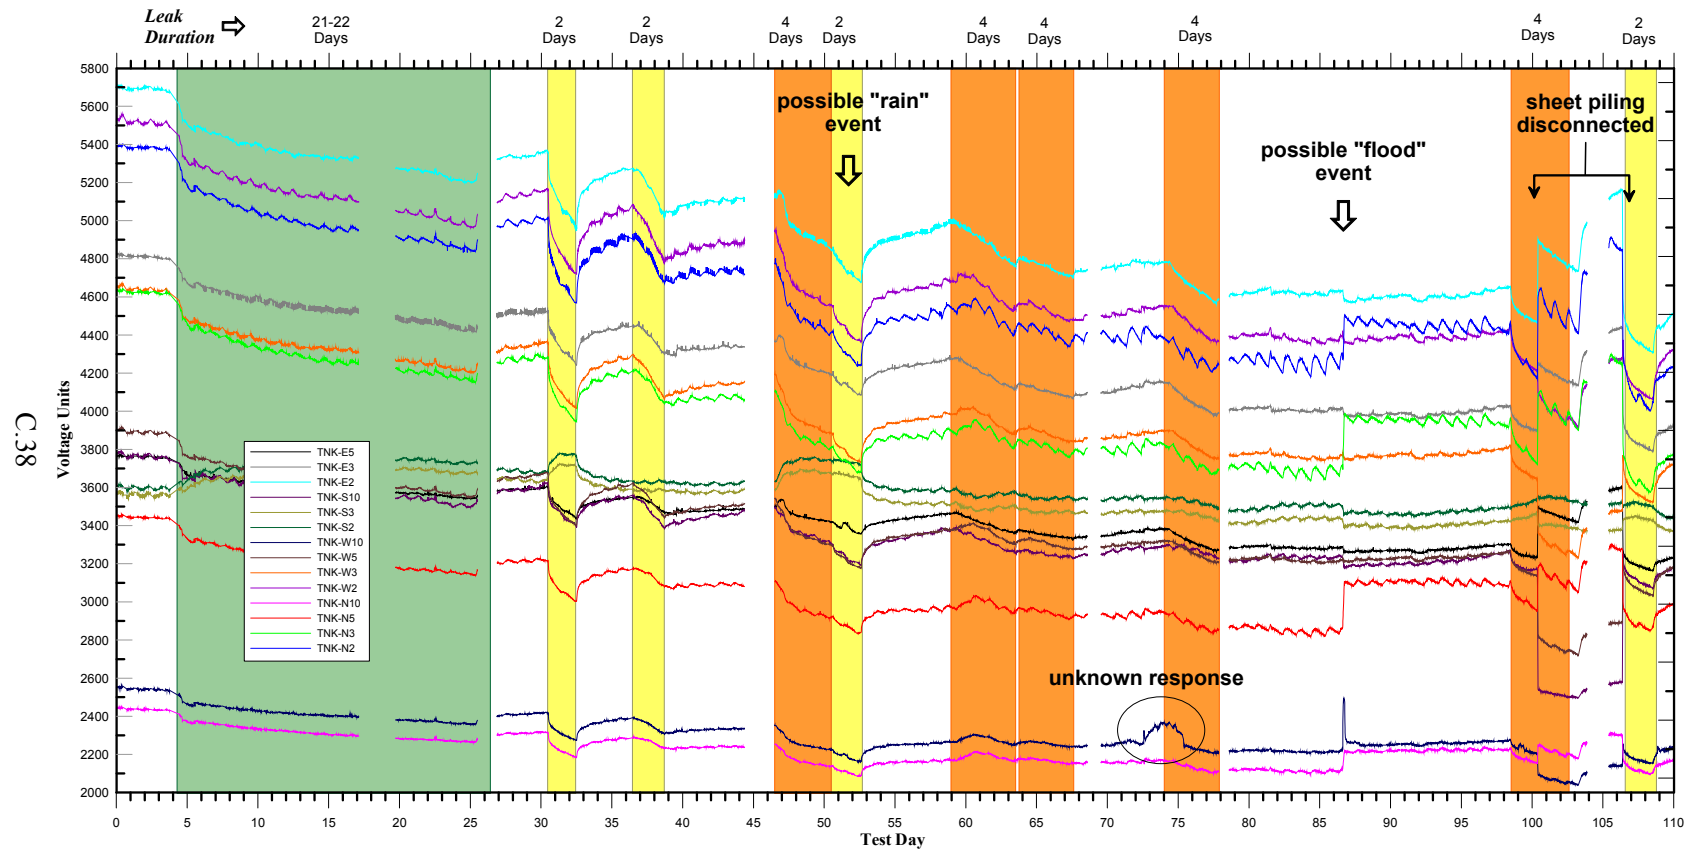
Figure C.16. Interpreted Leak Detection Time Series of Injection System Electrodes to Surface Electrode Potential Measurements

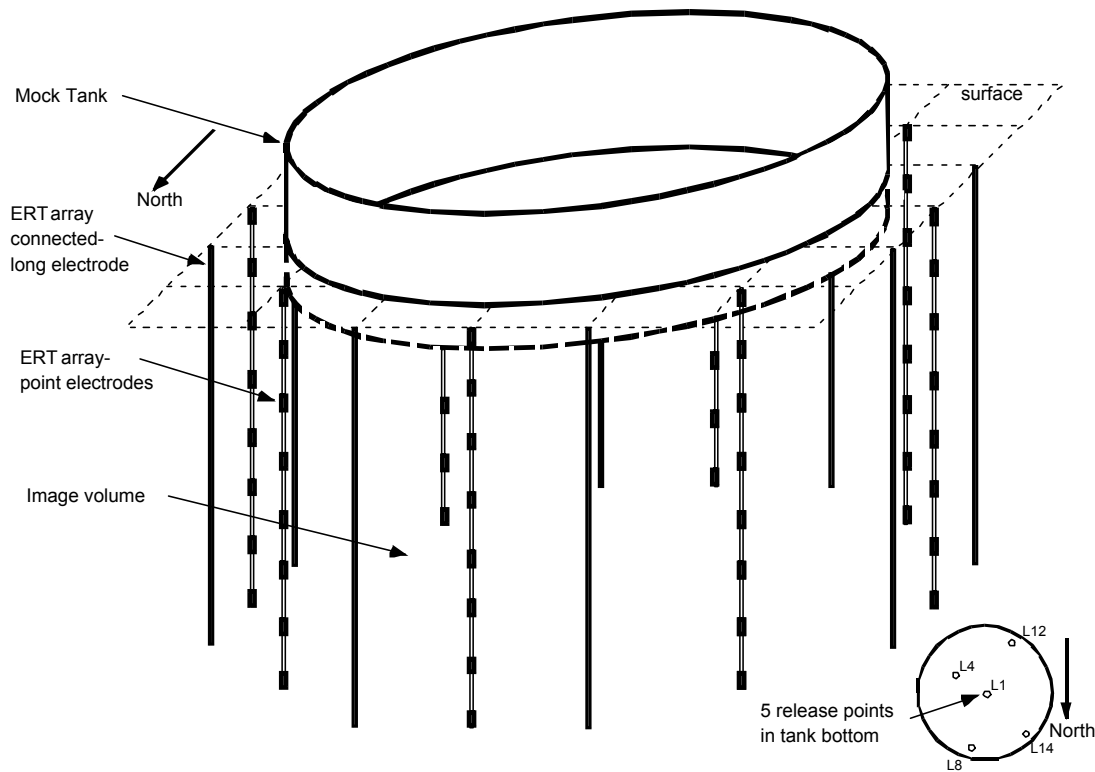
Figure 1. Schematic of the experimental set up for the mock tank. A 15 m diameter steel tank, the lower 1 m of which is buried, contains several built-in leak points shown in the lower right insert. Sixteen boreholes on an approximately 19 m diameter circle, each with 8 electrodes uniformly spaced between the surface and 35 feet depth, surround the tank. For every other electrode array the electrodes are connected together to approximate a continuous electrode 35 feet long.

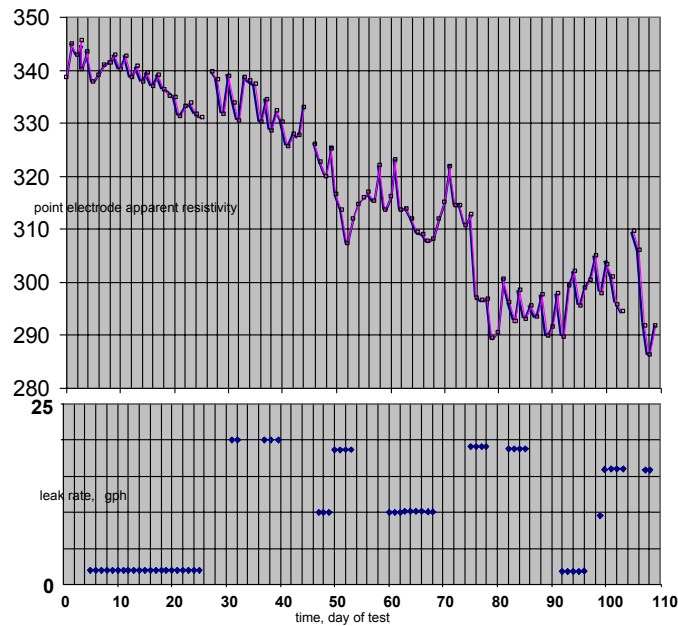
Figure 4. The apparent resistivity beneath the tank as measured from data on the eight point electrode arrays for each of the 110 days of the test (top) plotted with the actual release rates in gallons per hour (bottom)

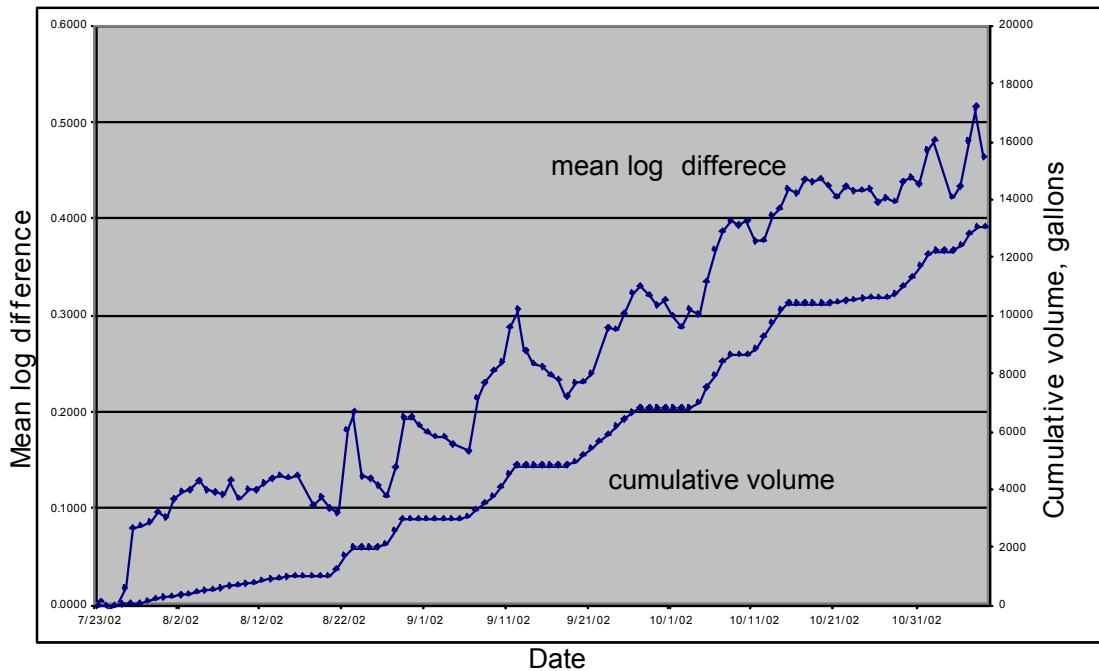
Figure 13. Comparison of apparent resistivity differences as measured using the point electrodes for each of the 110 days of the test (top) plotted with the actual release rates in gallons per hour (bottom). The apparent resistivity on day a is $R^a = \sum_{i=1}^n (\log t_j^a - \log t_j^{a-1})/n$ where t_j^a is the j^{th} transfer resistance on day a.

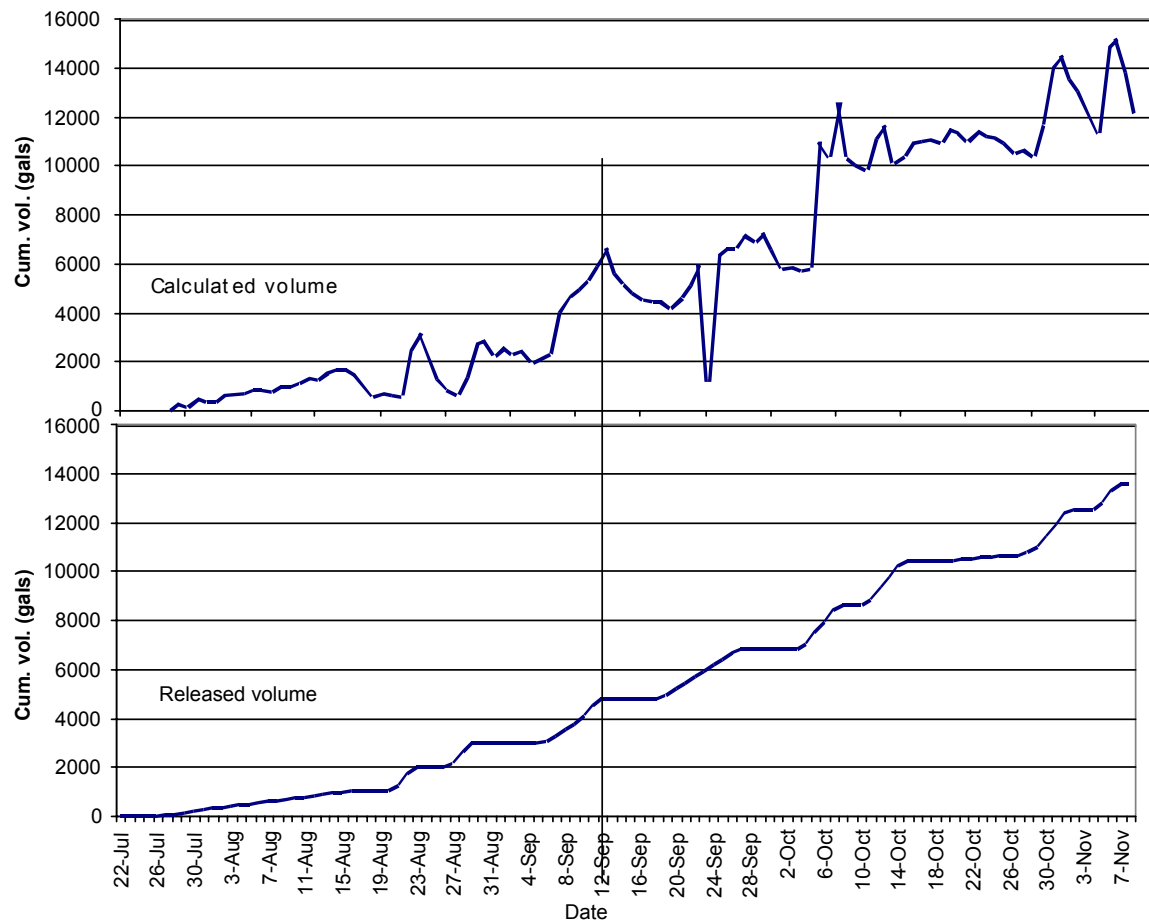
Figure 14. The release volume calculated from equation (6) and using July 22 as a baseline is compared with the actual cumulative release volume.
