Demonstration Assessment of Light-Emitting Diode (LED) Parking Lot Lighting, Phase I

***Host Site: T.J.Maxx,
Manchester, New Hampshire***

**Final Report prepared in support of the
U.S. DOE Solid-State Lighting
Technology Demonstration GATEWAY Program**

June 2010

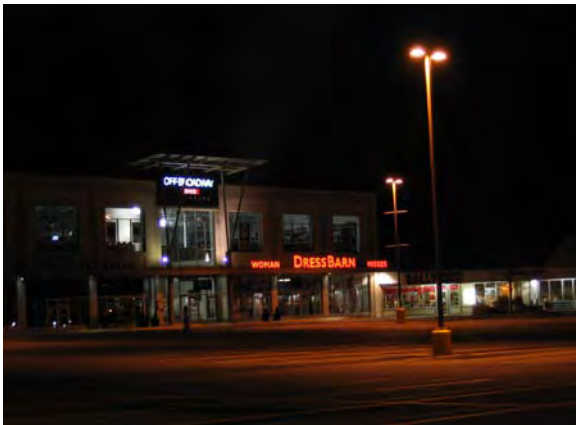
Figure 2.2. Original HPS Luminaires

The luminaires originally installed at the T.J.Maxx plaza were Spaulding “Cambridge” series 400W high-pressure sodium (HPS) with a Type V distribution (model number CE-400-HPS) (see Figure 2.2). Most recently, Philips Ceramalux 400W HPS lamps had been installed, with a 50,000 initial lumen rating, a CCT of 2100K, and a CRI of 21. The ballast type is assumed to be constant wattage autotransformer (also known as CWA), based on the manufacturer’s published information.

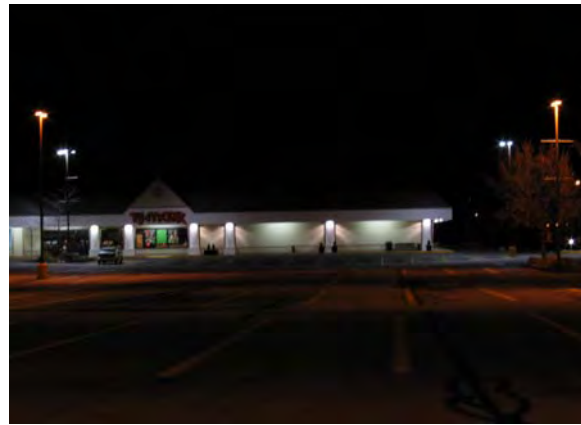
Figure 2.3. Original Metal Halide Luminaires (Visible Behind HPS Luminaires)

Additionally, some of the original HPS luminaires near the T.J.Maxx had been replaced with metal halide (MH), with two poles, each supporting three 400W metal halide luminaires (see Figure 2.3). Other exterior sources include metal halide downlights and fluorescent wrap-around luminaires used under the canopy, and metal halide bollards at the entrances to the parking lot. Some luminaires mounted to the canopy were replaced with LED luminaires, but these were not part of the study. The freestanding walk-up ATM has its own HPS wall pack lighting system.

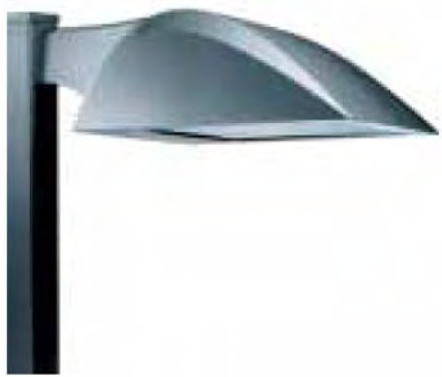
Figure 2.4. PMH Luminaire

Originally, the plaza owner was considering a PMH luminaire. Ruud Lighting (manufacturer of conventional luminaires; subsidiary division BetaLED manufactured the LED luminaires actually installed) provided a lighting design using “Medium Aviator” luminaires (BAA-AVM-V-T3-320PMH, see Figure 2.4). The Aviator has a Type III distribution (Figure 2.5); a backlight, uplight, and glare (BUG) rating of B3-U3-G5 and a luminaire efficiency of 73%. A 320W pulse-start metal halide lamp was selected with a 33,000 lumen output, nominal CCT of 4000K, and a CRI of 65. The design assumes

a luminaire with magnetic ballast and an input power of 368W. Based on this information, the initial luminaire efficacy calculates to 65 lumens per watt (LM/W).

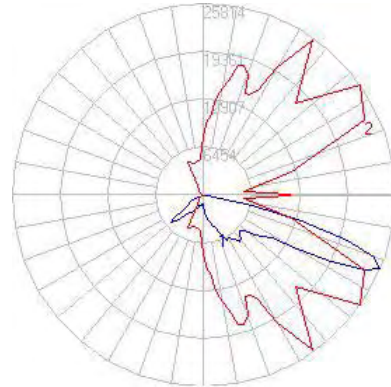
Figure 2.5. PMH Candela Polar Plots

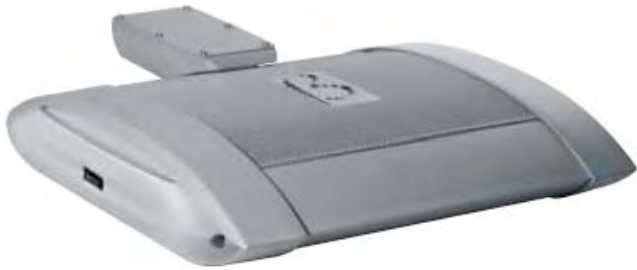
Figure 2.6. BetaLED Luminaire

BetaLED provided the LED design that was ultimately installed at the plaza. The luminaire selected was the BetaLED The Edge® Area Light (BLD-T3-102-LED-B-UH-BZ-TL) with adjustable arm and bronze finish to match the existing poles. See Figure 2.6 for an image of the luminaire. Based on manufacturer data, the luminaire has Type III distribution (Figure 2.7) and a BUG rating of B3-U1-G3. The LEDs had a nominal CCT of 6000K and a CRI of 70.

The Edge luminaires are modular, assembled from arrays (BetaLED nomenclature of “bars”) of 20 LEDs each to provide the desired lumen output. The installed luminaire had an assembly of 6 bars totaling 120 LEDs. The plaza owner chose occupancy sensors to reduce the lighting from high output (driven at 525 mA) to low output (175 mA) on a given pole when no movement is detected near that pole. Table 2.1 provides the BetaLED data for different drive currents.

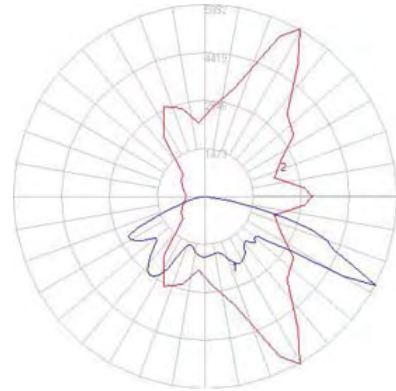
Figure 2.7. BetaLED Candela Polar Plots

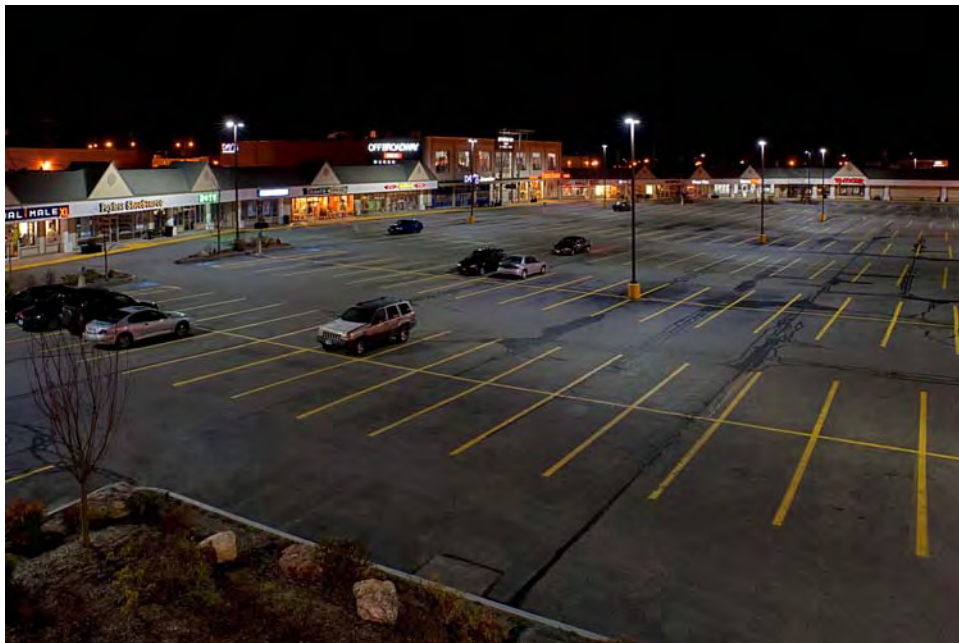
Figure 2.8. Parking Lot After Installation of LED Luminaires (Source: BetaLED)

The 25 LED luminaires were installed in 12 hours (roughly 30 minutes per luminaire) with no notable issues. Figure 2.8 shows the LED luminaires installed at the plaza.

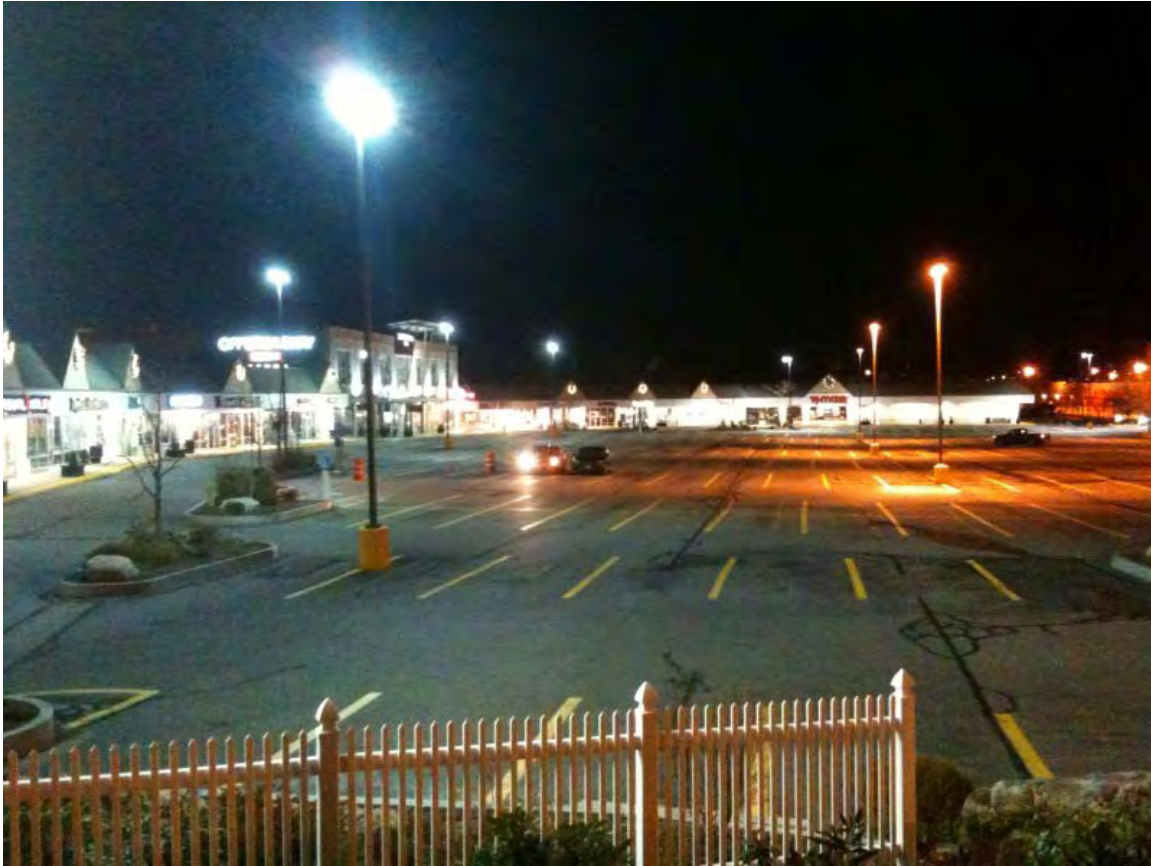
Figure 2.9. Visual Comparison of LED and HPS Areas of the Lot
