Prepared for Ducks Unlimited, Inc.

Hydrodynamic Modeling Analysis for Leque Island and zis a ba Restoration Feasibility Study

JM Whiting TP Khangaonkar

January 2015

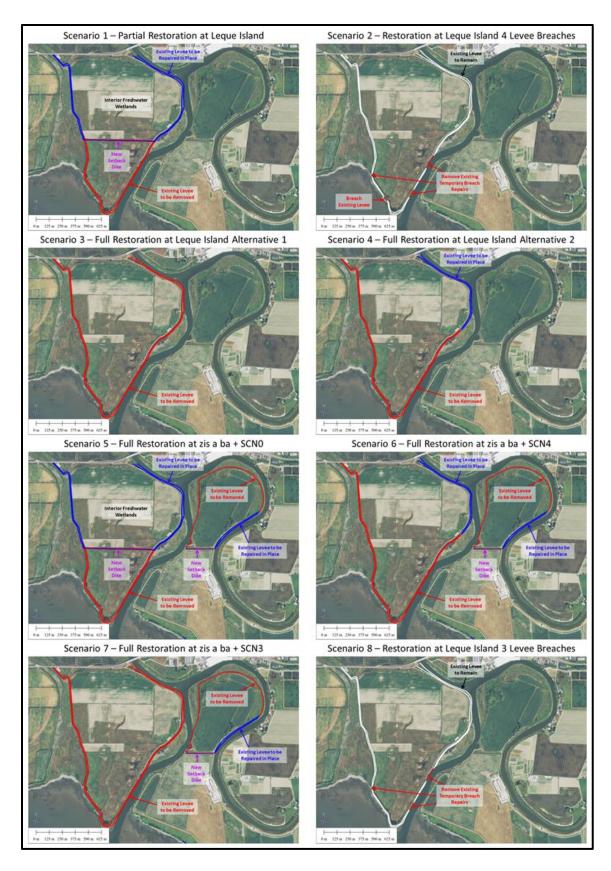
Figure 1-3: Schematic representation of the proposed restoration scenarios

The corresponding model runs are numbered SCN0 to SCN8 representing the restoration scenarios. SCN0 represents baseline existing condition. The scenarios are shown in **Figure 1-3** and are described below in **Table 1-1**.

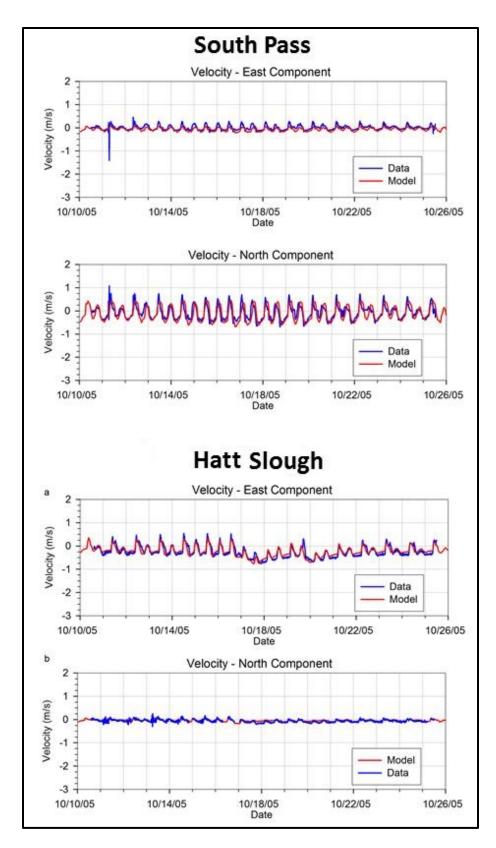
Figure 2-8: Comparison of predicted and measured velocity components at the Hatt Slough and South Pass stations respectively. Data from mid-depth of the water column

Predicted velocities in general matched the observed data at both the South Pass and Hatt Slough stations (**Figure 2-8**). Model predictions match the field data well at a level of accuracy similar to Phase I calibration effort. Unlike water-surface elevations, the signature of the neap-spring tidal cycle and diurnal inequality was not strong in velocity distributions because of the damping effects of river inflow and the presence of a shallow tide flat area. Velocities are dominant in the north component of the South Pass station and in the east component of the Hatt Slough station because of the orientations of the river channels. Dominant seaward (westward) flow was observed at the Hatt Slough station during the high-river-flow period (October 17, 2005 to October 21, 2005).

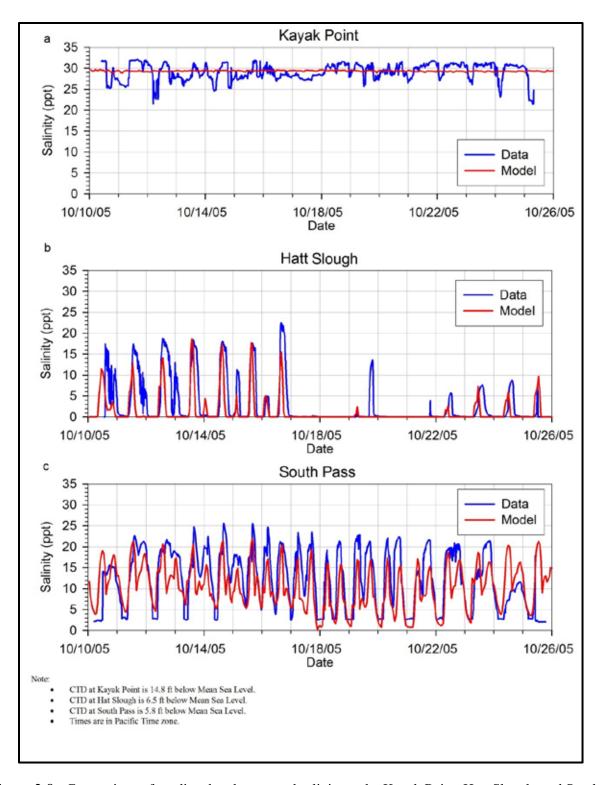
Figure 2-9: Comparison of predicted and measured salinity at the Kayak Point, Hatt Slough, and South Pass stations, respectively

Figure 2-9 compares salinity time histories at the Kayak Point, Hatt Slough, and South Pass stations. Overall, predicted salinities matched the observed data reasonably well, similar to those in the Port Susan Bay model calibration. The predicted salinity at Kayak Point showed little variation, mainly because salinity at Kayak Point was controlled by the open-boundary condition, which was specified as constant at 30 ppt. However, the mean generally followed the trend of observed data, representing the salinity of Puget Sound water. Salinities at the South Pass station showed strong tidal fluctuations, varying from 0 ppt during low tide to 15 - 20 ppt during high tide in a full tidal cycle. At the Hatt Slough station, sharp salinity intrusion was observed during high tide. Salinities reduced significantly during the high-river-flow period (October 17, 2005 to October 21, 2005), indicating that most of the Stillaguamish River flow discharges into Port Susan Bay through Hatt Slough.

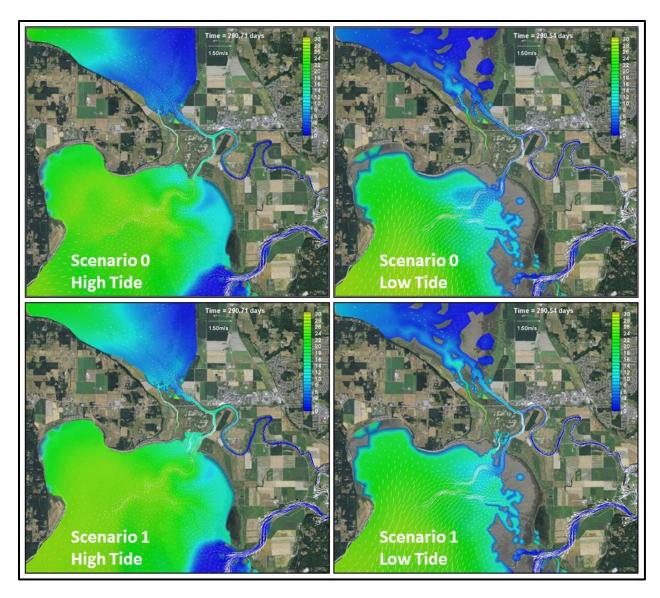
Figure 4-6: Comparison of salinity at high tide and low tide during Scenario 0 and Scenario 1 on October 17, 2005.

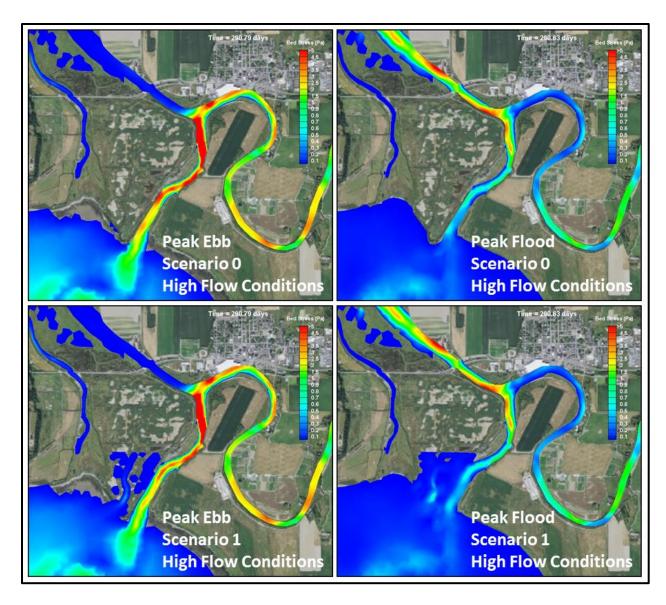
Figure 4-7: Comparison of bed shear stress at peak ebb and peak flood during Scenario 0 and Scenario 1 at high flow conditions

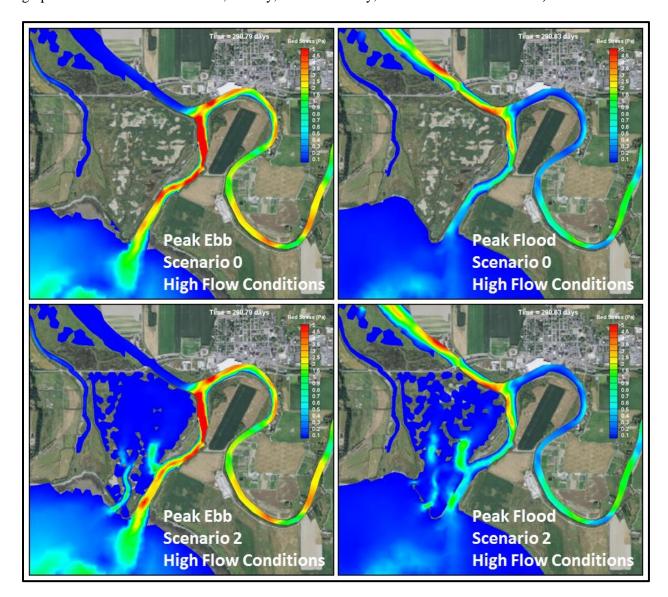
Figure 4-11: Comparison of bed shear stress at peak ebb and peak flood during Scenario 0 and Scenario 2 at high flow conditions

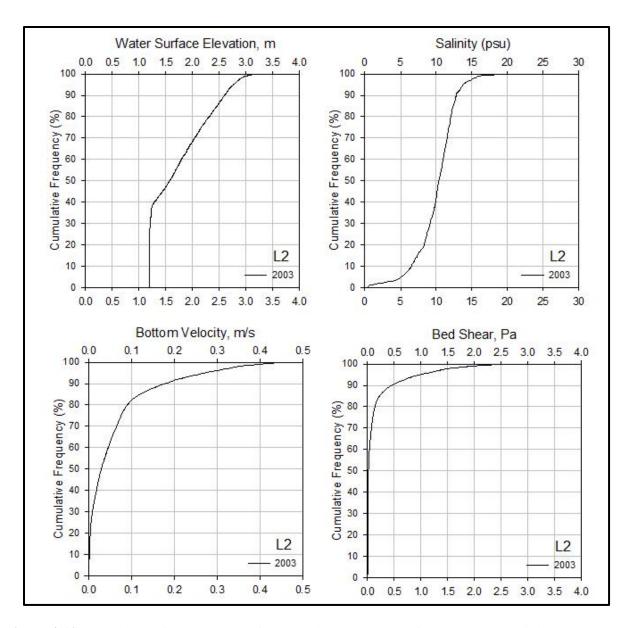
Figure 4-12: Cumulative frequency plots for Scenario 2 – Water-Surface Elevation, Salinity, Bottom Velocity, and Bed Shear at Station L2 on Leque Island

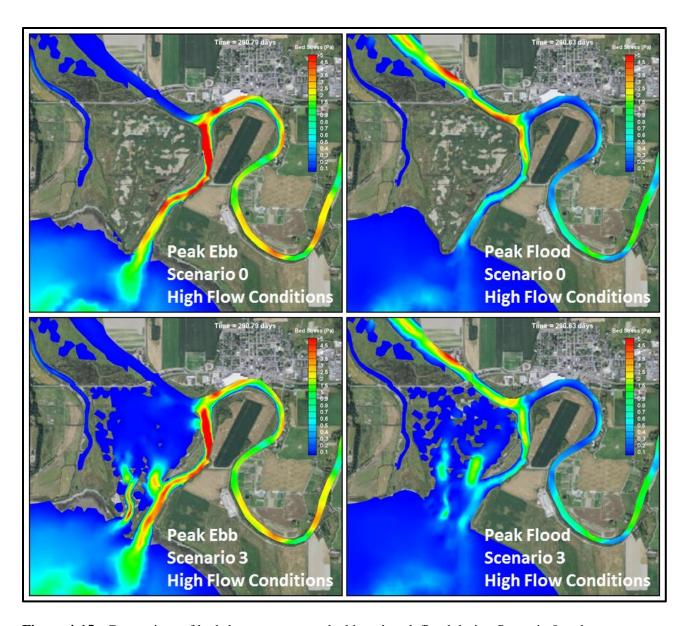
Figure 4-15: Comparison of bed shear stress at peak ebb and peak flood during Scenario 0 and Scenario 3 at high flow conditions

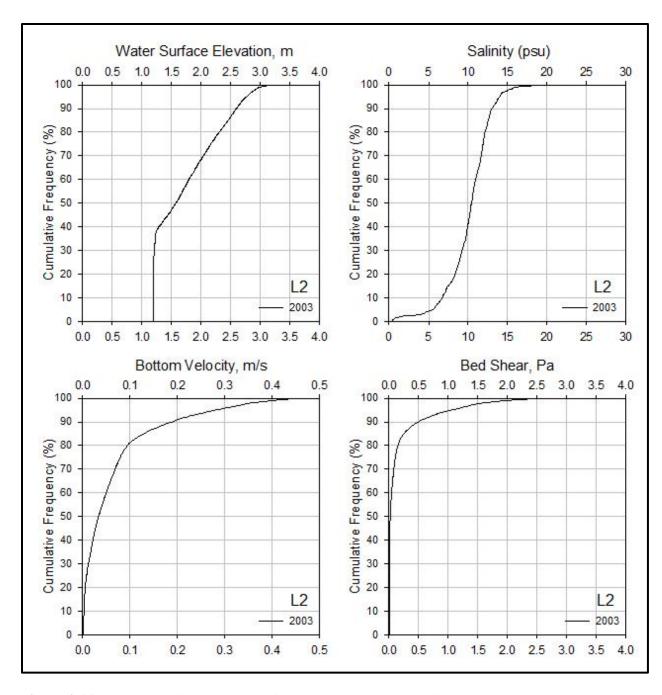
Figure 4-16: Cumulative frequency plots for Scenario 3 – Water-Surface Elevation, Salinity, Bottom Velocity, and Bed Shear at Station L2 on Leque Island

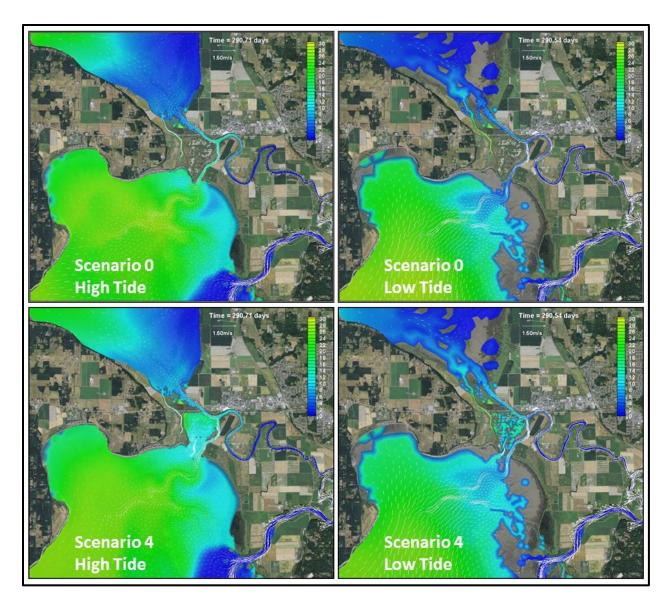
Figure 4-18: Comparison of salinity at high tide and low tide during Scenario 0 and Scenario 4 on October 17, 2005.

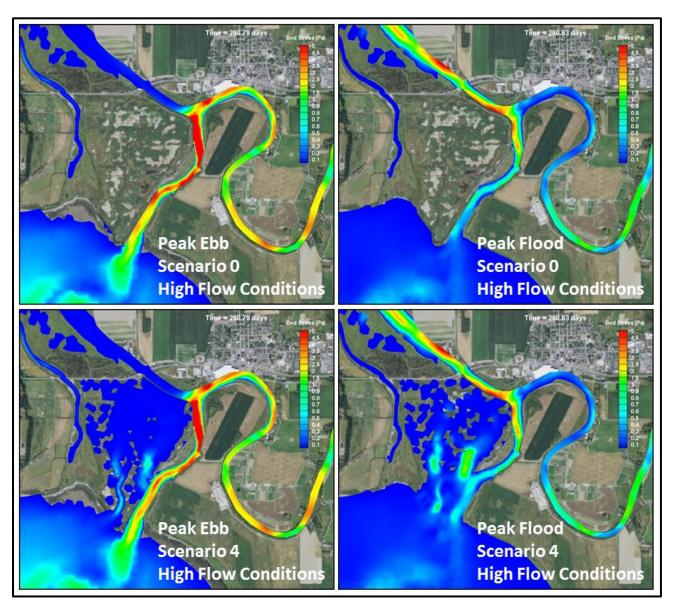
Figure 4-19: Comparison of bed shear stress at peak ebb and peak flood during Scenario 0 and Scenario 4 at high flow conditions.

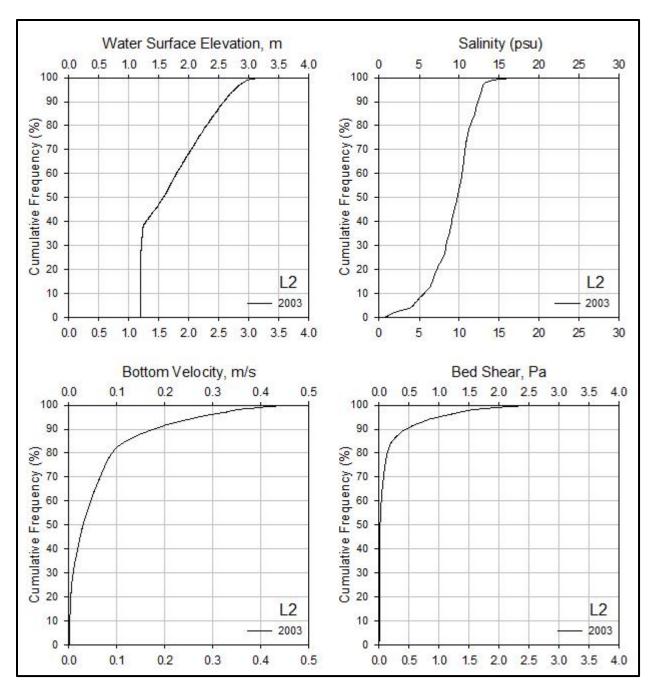
Figure 4-24: Cumulative frequency plots for Scenario 5 – Water-Surface Elevation, Salinity, Bottom Velocity, and Bed Shear at Station L2 on Leque Island

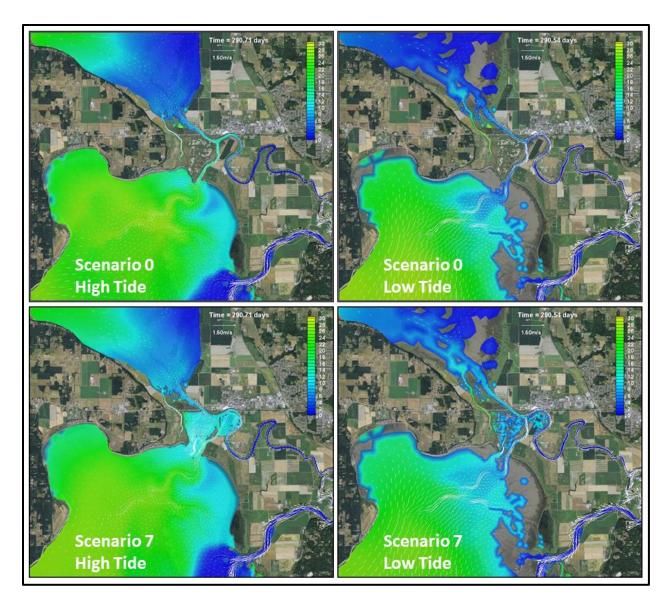
Figure 4-32: Comparison of salinity at high tide and low tide during Scenario 0 and Scenario 7 on October 17, 2005.

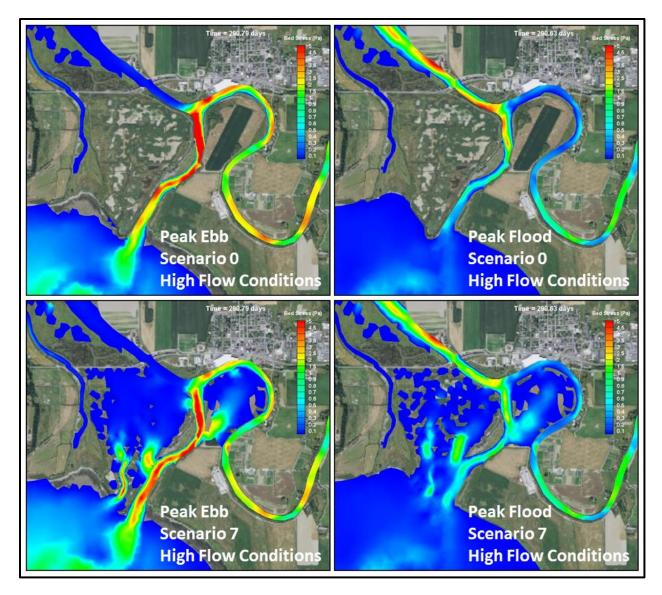
Figure 4-33: Comparison of bed shear stress at peak ebb and peak flood during Scenario 0 and Scenario 7 at high flow conditions

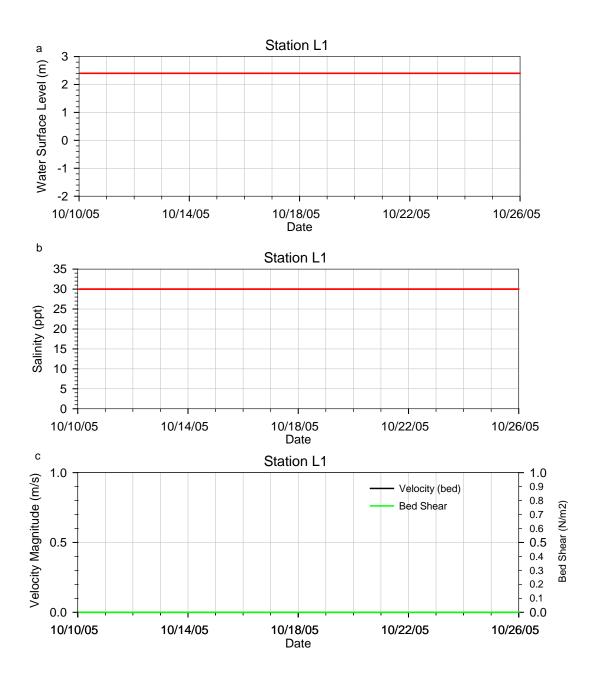
Figure A-2: Scenario 0 (Baseline Condition) – Water-surface elevation, salinity, velocity magnitude, and bed shear stress at Leque Island restoration station L1, October 2005 period

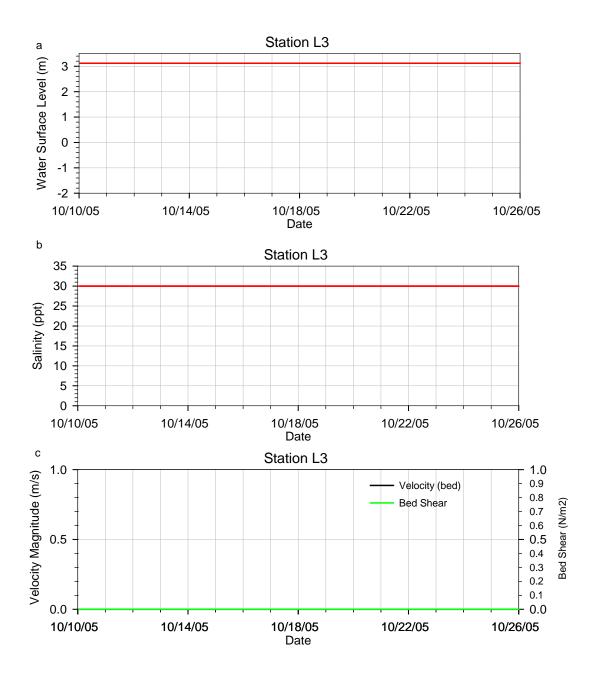
Figure A-4: Scenario 0 (Baseline Condition) – Water-surface elevation, salinity, velocity magnitude, and bed shear stress at Leque Island restoration station L3, October 2005 period

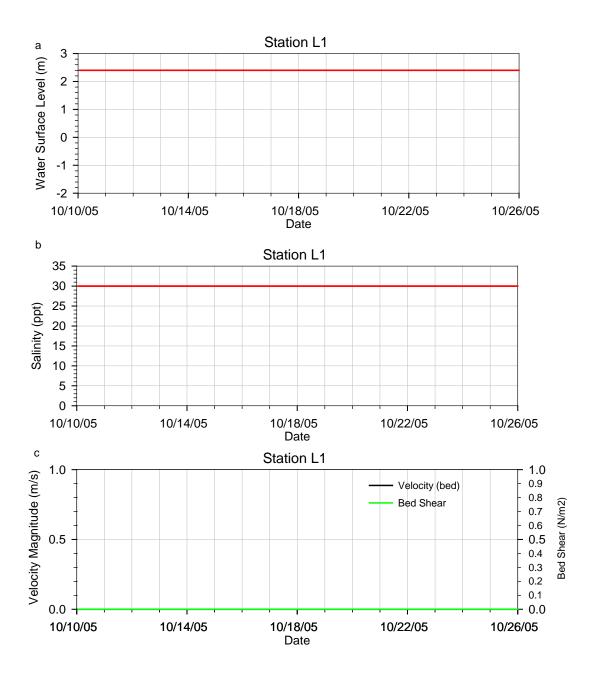
Figure A-5: Scenario 1 (Partial Restoration Leque) – Water-surface elevation, salinity, velocity magnitude, and bed shear stress at Leque Island restoration station L1, October 2005 period

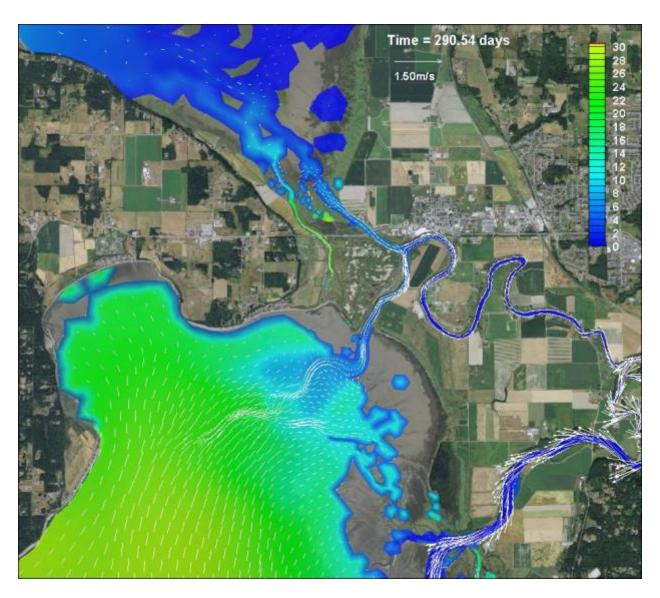
Figure B-2: Scenario 0 (Baseline Condition) – Salinity contours and velocity vectors, October 17, 2005, low tide

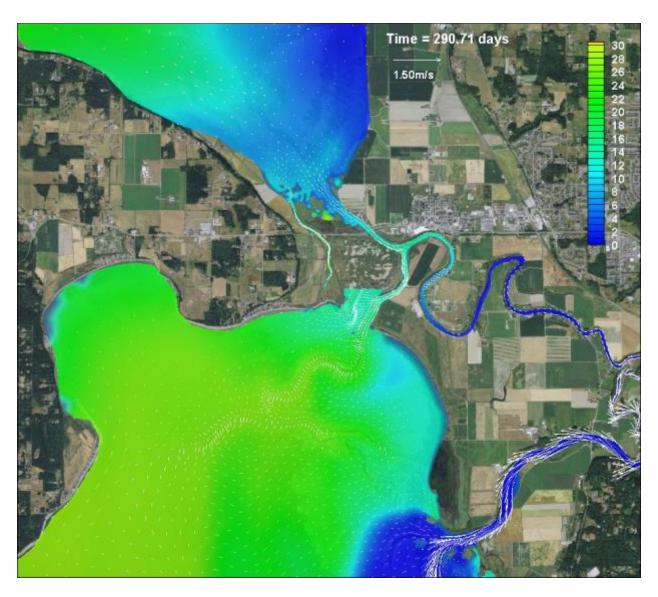
Figure B-5: Scenario 1 (Partial Restoration Leque) – Salinity contours and velocity vectors, October 17, 2005, high tide

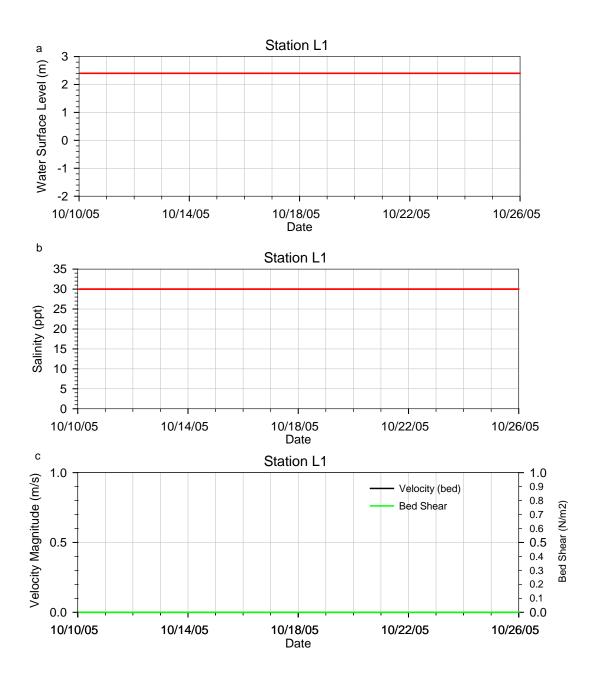
Figure C-2: Scenario 0 (Baseline Condition) – Water-surface elevation, salinity, velocity magnitude, and bed shear stress at Leque Island restoration station L1, full bank conditions at 26,508 cfs river flow (tides and wind corresponding to October 2005)

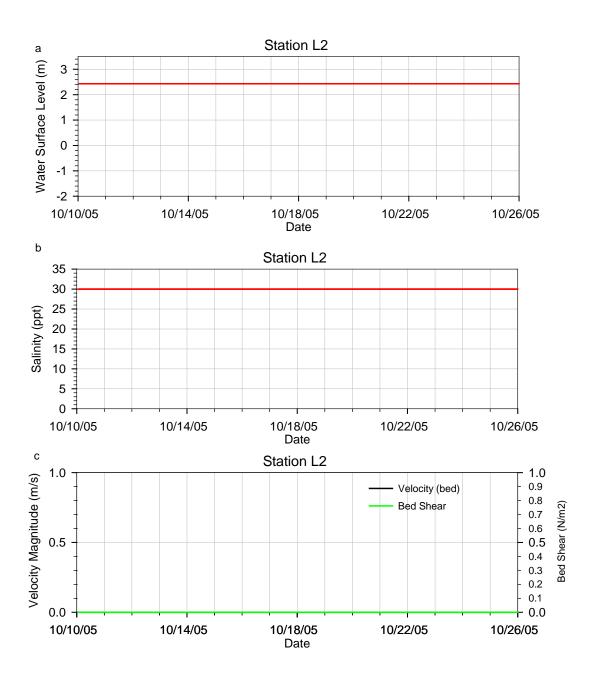
Figure C-3: Scenario 0 (Baseline Condition) – Water-surface elevation, salinity, velocity magnitude, and bed shear stress at Leque Island restoration station L2, full bank conditions at 26,508 cfs river flow (tides and wind corresponding to October 2005)

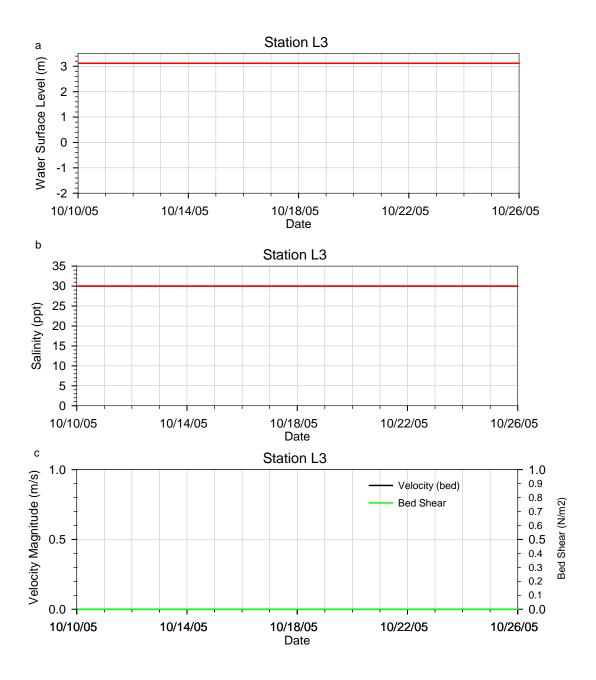
Figure C-4: Scenario 0 (Baseline Condition) – Water-surface elevation, salinity, velocity magnitude, and bed shear stress at Leque Island restoration station L3, full bank conditions at 26,508 cfs river flow (tides and wind corresponding to October 2005)

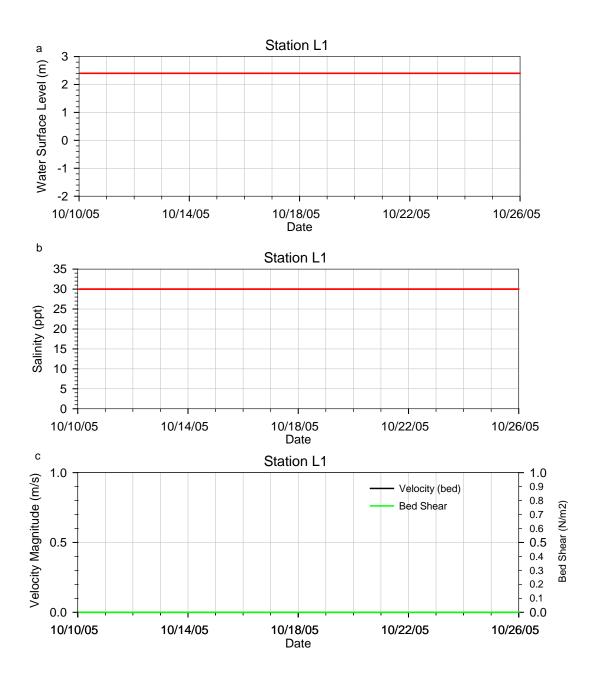
Figure C-5: Scenario 1 (Partial Restoration Leque) – Water-surface elevation, salinity, velocity magnitude, and bed shear stress at Leque Island restoration station L1, full bank conditions at 26,508 cfs river flow (tides and wind corresponding to October 2005)

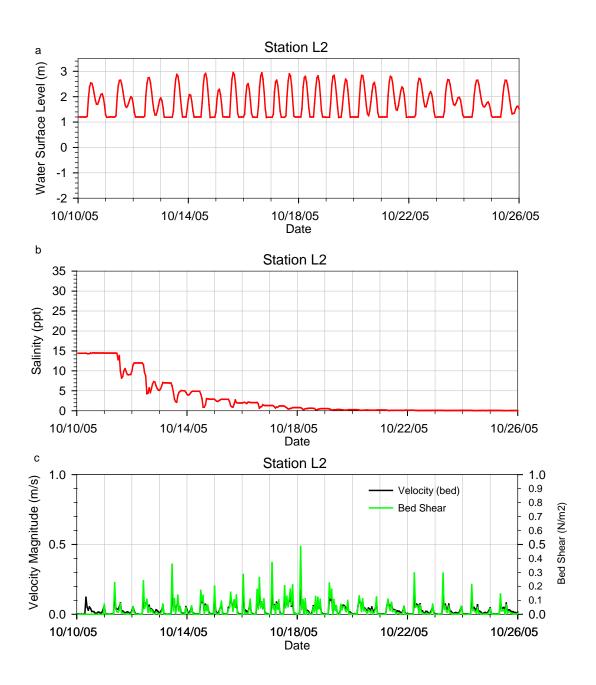
Figure C-6: Scenario 1 (Partial Restoration Leque) – Water-surface elevation, salinity, velocity magnitude, and bed shear stress at Leque Island restoration station L2, full bank conditions at 26,508 cfs river flow (tides and wind corresponding to October 2005)

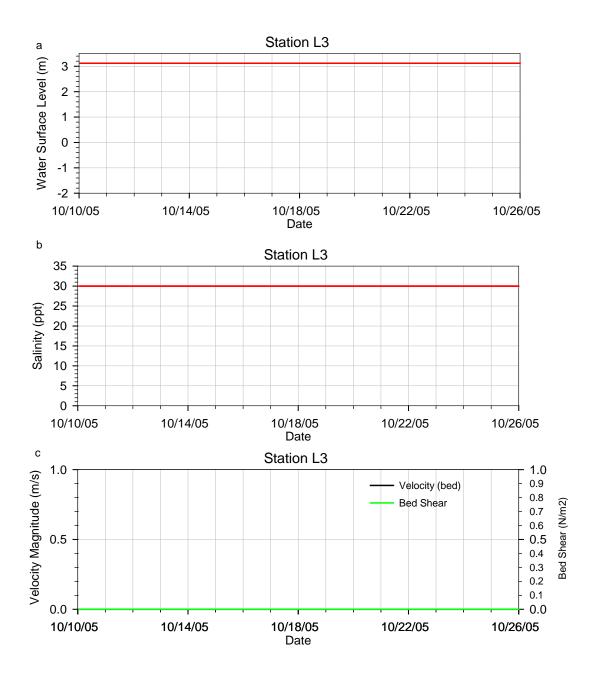
Figure C-7: Scenario 1 (Partial Restoration Leque) – Water-surface elevation, salinity, velocity magnitude, and bed shear stress at Leque Island restoration station L3, full bank conditions at 26,508 cfs river flow (tides and wind corresponding to October 2005)

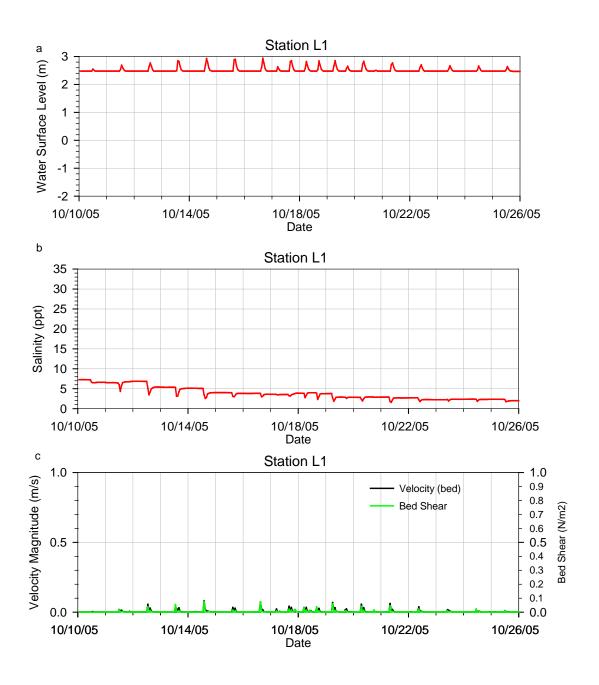
Figure C-8: Scenario 2 (4 Levee Breach Leque) – Water-surface elevation, salinity, velocity magnitude, and bed shear stress at Leque Island restoration station L1, full bank conditions at 26,508 cfs river flow (tides and wind corresponding to October 2005)

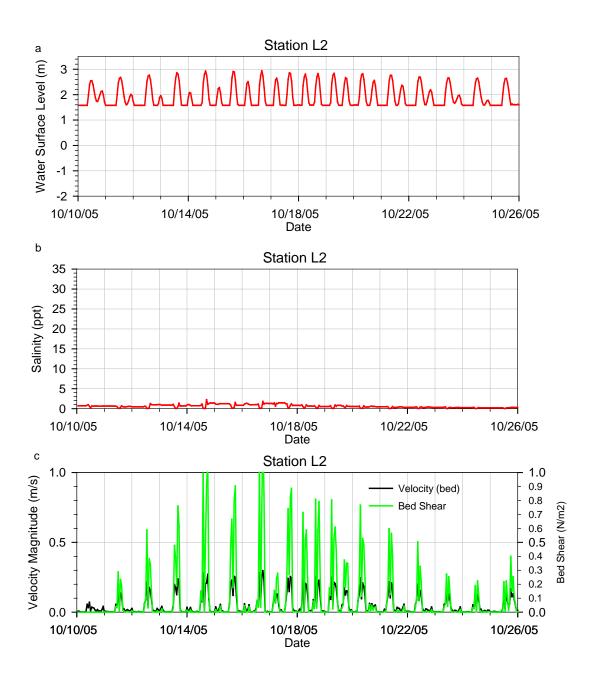
Figure C-9: Scenario 2 (4 Levee Breach Leque) – Water-surface elevation, salinity, velocity magnitude, and bed shear stress at Leque Island restoration station L2, full bank conditions at 26,508 cfs river flow (tides and wind corresponding to October 2005)

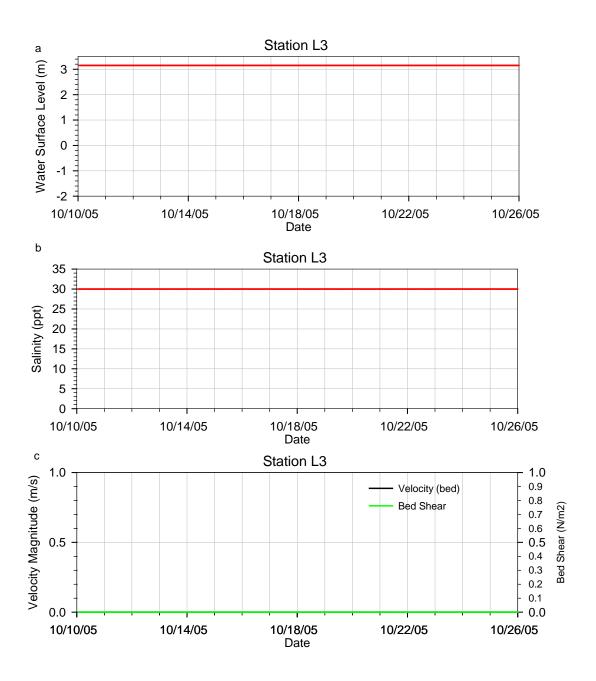
Figure C-10: Scenario 2 (4 Levee Breach Leque) – Water-surface elevation, salinity, velocity magnitude, and bed shear stress at Leque Island restoration station L3, full bank conditions at 26,508 cfs river flow (tides and wind corresponding to October 2005)

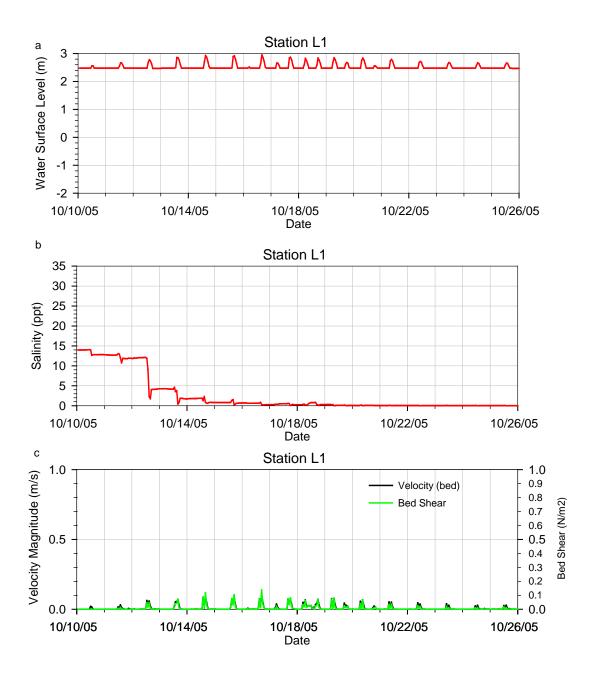
Figure C-11: Scenario 3 (Full Restoration Leque 1) – Water-surface elevation, salinity, velocity magnitude, and bed shear stress at Leque Island restoration station L1, full bank conditions at 26,508 cfs river flow (tides and wind corresponding to October 2005)

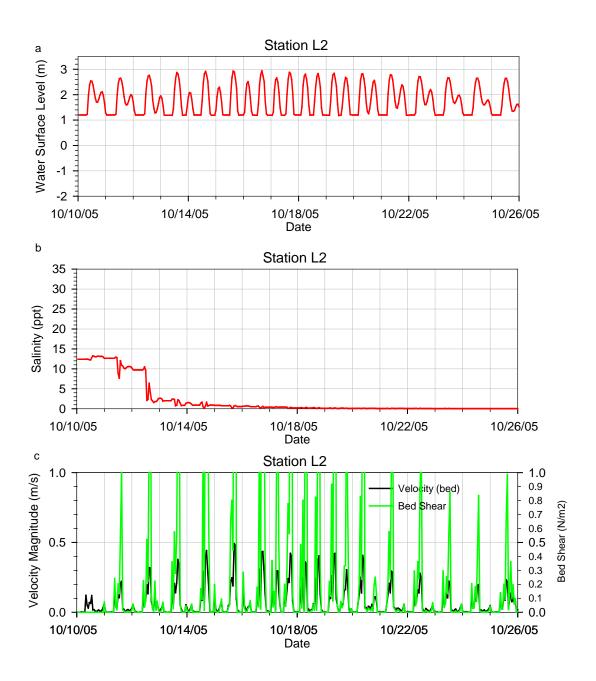
Figure C-12: Scenario 3 (Full Restoration Leque 1) – Water-surface elevation, salinity, velocity magnitude, and bed shear stress at Leque Island restoration station L2, full bank conditions at 26,508 cfs river flow (tides and wind corresponding to October 2005)

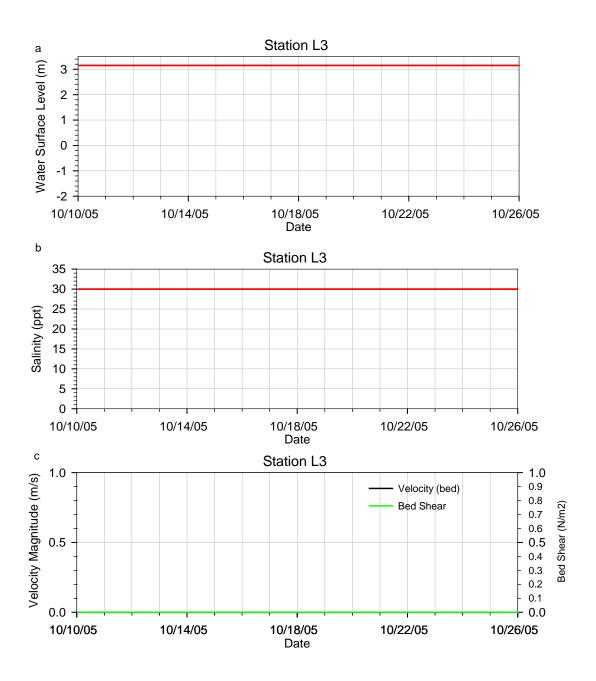
Figure C-13: Scenario 3 (Full Restoration Leque 1) – Water-surface elevation, salinity, velocity magnitude, and bed shear stress at Leque Island restoration station L3, full bank conditions at 26,508 cfs river flow (tides and wind corresponding to October 2005)

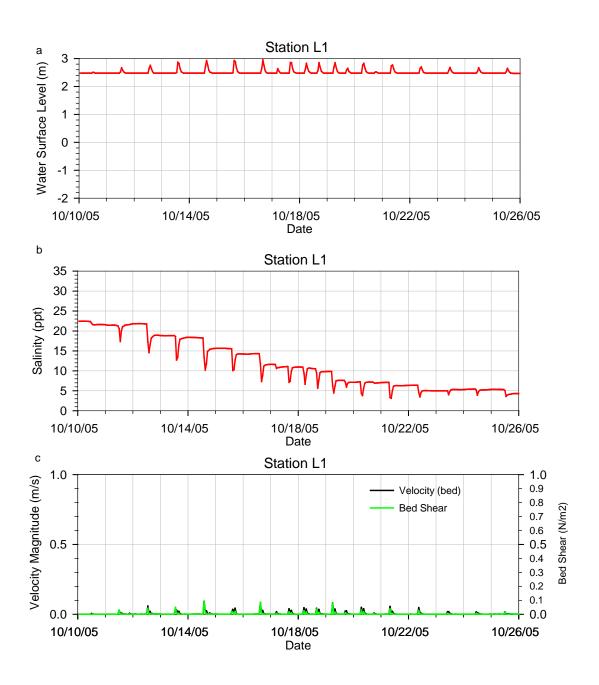
Figure C-14: Scenario 4 (Full Restoration Leque 2) – Water-surface elevation, salinity, velocity magnitude, and bed shear stress at Leque Island restoration station L1, full bank conditions at 26,508 cfs river flow (tides and wind corresponding to October 2005)

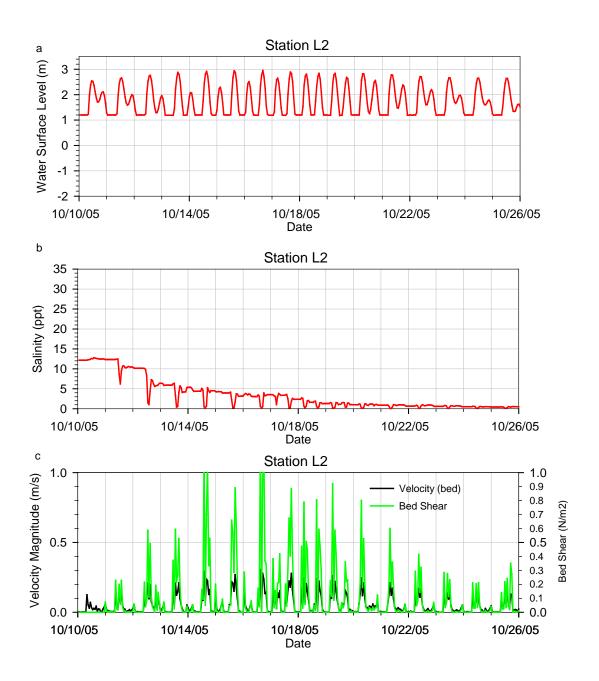
Figure C-15: Scenario 4 (Full Restoration Leque 2) – Water-surface elevation, salinity, velocity magnitude, and bed shear stress at Leque Island restoration station L2, full bank conditions at 26,508 cfs river flow (tides and wind corresponding to October 2005)

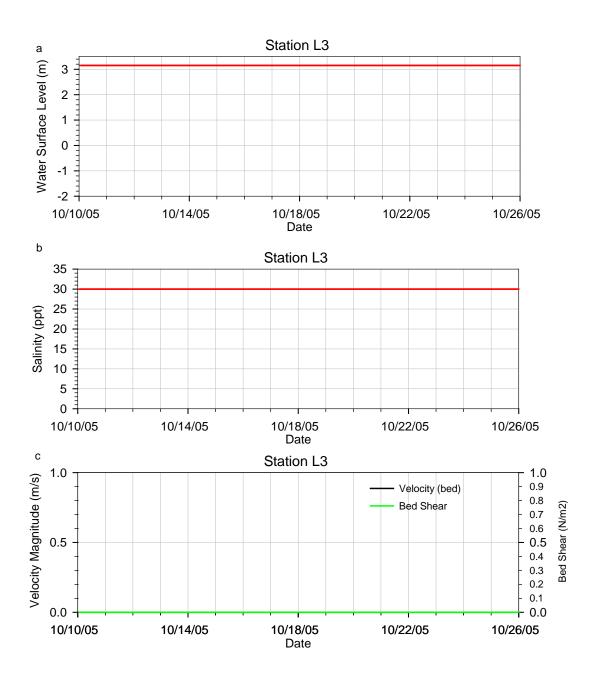
Figure C-16: Scenario 4 (Full Restoration Leque 2) – Water-surface elevation, salinity, velocity magnitude, and bed shear stress at Leque Island restoration station L3, full bank conditions at 26,508 cfs river flow (tides and wind corresponding to October 2005)

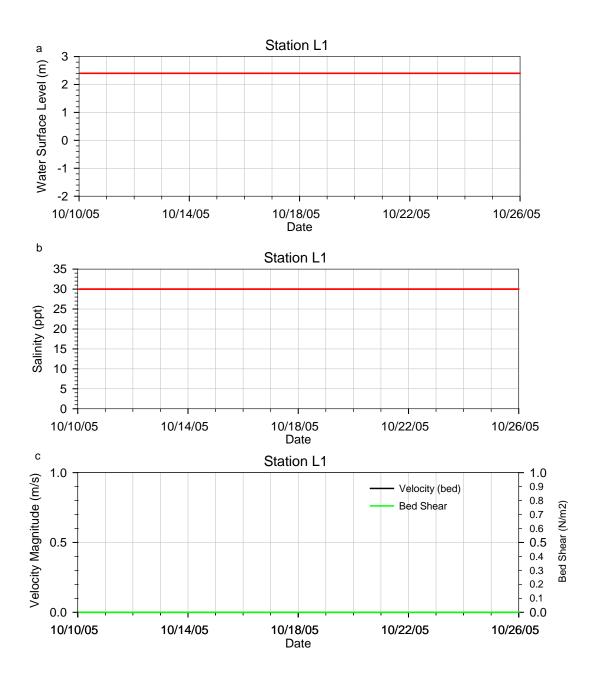
Figure C-17: Scenario 5 (Full Restoration zis a ba + SCN1) – Water-surface elevation, salinity, velocity magnitude, and bed shear stress at Leque Island restoration station L1, full bank conditions at 26,508 cfs river flow (tides and wind corresponding to October 2005)

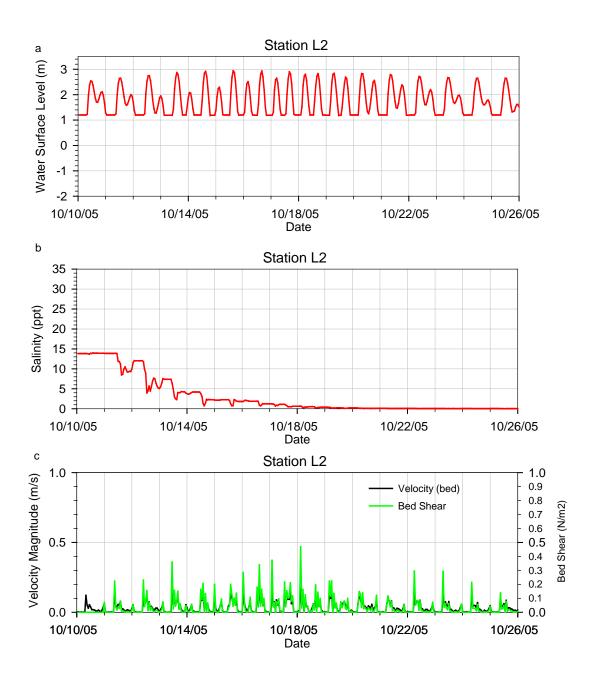
Figure C-18: Scenario 5 (Full Restoration zis a ba + SCN1) – Water-surface elevation, salinity, velocity magnitude, and bed shear stress at Leque Island restoration station L2, full bank conditions at 26,508 cfs river flow (tides and wind corresponding to October 2005)

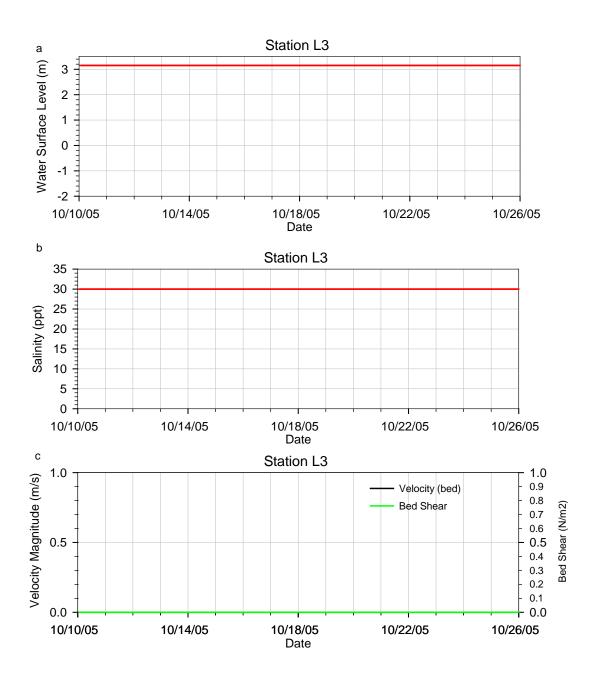
Figure C-19: Scenario 5 (Full Restoration zis a ba + SCN1) – Water-surface elevation, salinity, velocity magnitude, and bed shear stress at Leque Island restoration station L3, full bank conditions at 26,508 cfs river flow (tides and wind corresponding to October 2005)

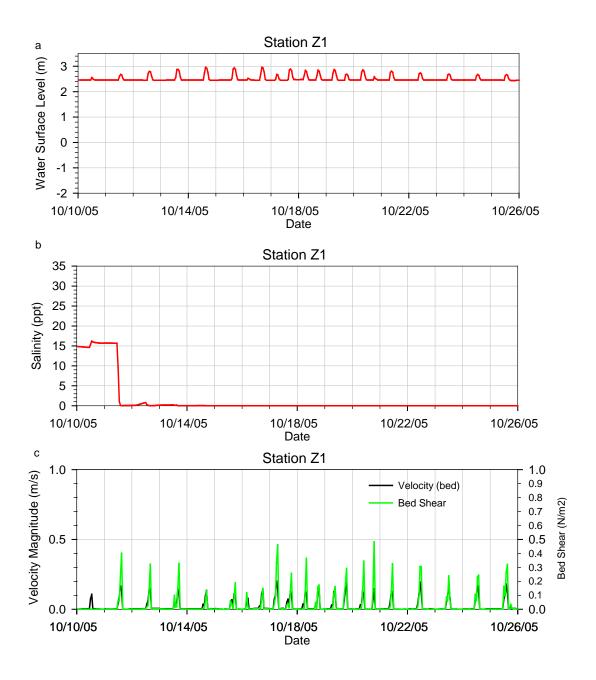
Figure C-20: Scenario 5 (Full Restoration zis a ba + SCN1) – Water-surface elevation, salinity, velocity magnitude, and bed shear stress at zis a ba restoration station Z1, full bank conditions at 26,508 cfs river flow (tides and wind corresponding to October 2005)

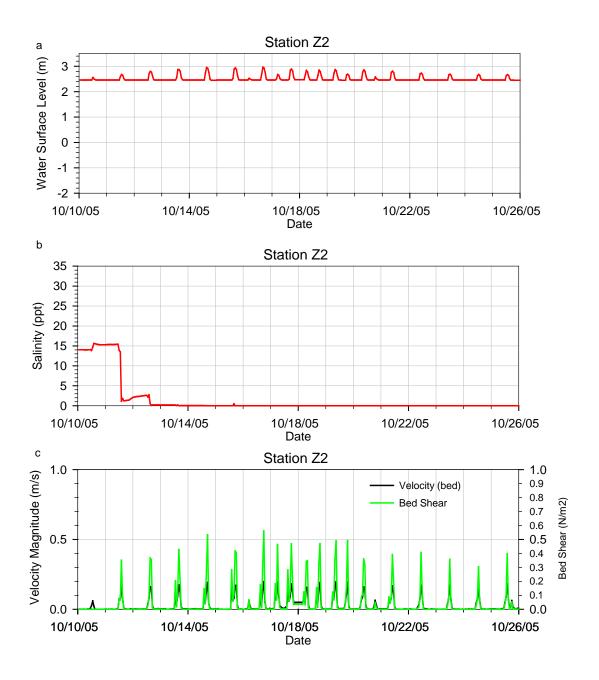
Figure C-21: Scenario 5 (Full Restoration zis a ba + SCN1) – Water-surface elevation, salinity, velocity magnitude, and bed shear stress at zis a ba restoration station Z2, full bank conditions at 26,508 cfs river flow (tides and wind corresponding to October 2005)

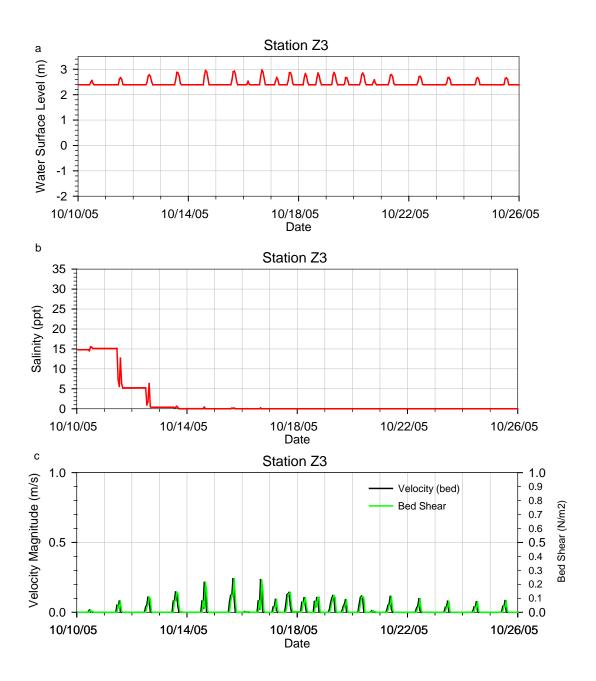
Figure C-22: Scenario 5 (Full Restoration zis a ba + SCN1) – Water-surface elevation, salinity, velocity magnitude, and bed shear stress at zis a ba restoration station Z3, full bank conditions at 26,508 cfs river flow (tides and wind corresponding to October 2005)

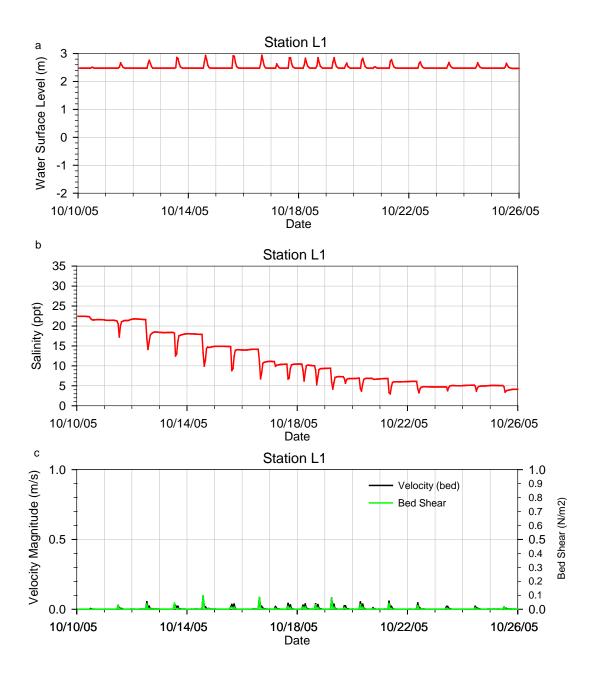
Figure C-23: Scenario 6 (Full Restoration zis a ba + SCN4) – Water-surface elevation, salinity, velocity magnitude, and bed shear stress at Leque Island restoration station L1, full bank conditions at 26,508 cfs river flow (tides and wind corresponding to October 2005)

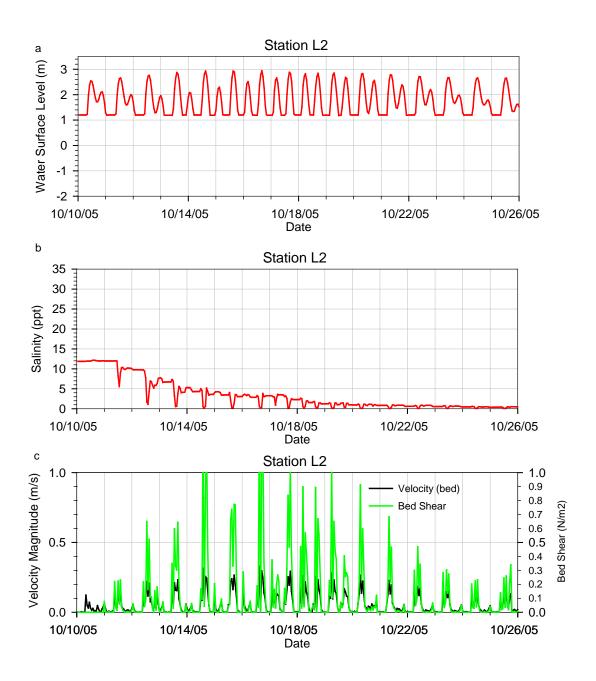
Figure C-24: Scenario 6 (Full Restoration zis a ba + SCN4) – Water-surface elevation, salinity, velocity magnitude, and bed shear stress at Leque Island restoration station L2, full bank conditions at 26,508 cfs river flow (tides and wind corresponding to October 2005)

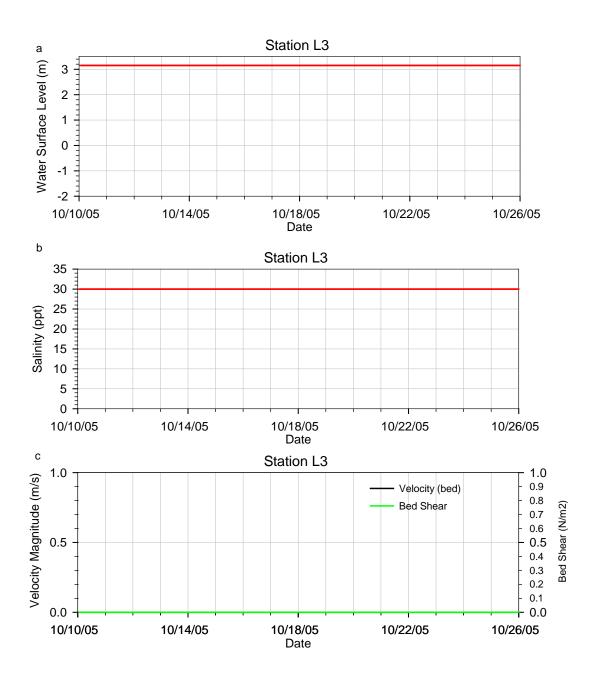
Figure C-25: Scenario 6 (Full Restoration zis a ba + SCN4) – Water-surface elevation, salinity, velocity magnitude, and bed shear stress at Leque Island restoration station L3, full bank conditions at 26,508 cfs river flow (tides and wind corresponding to October 2005)

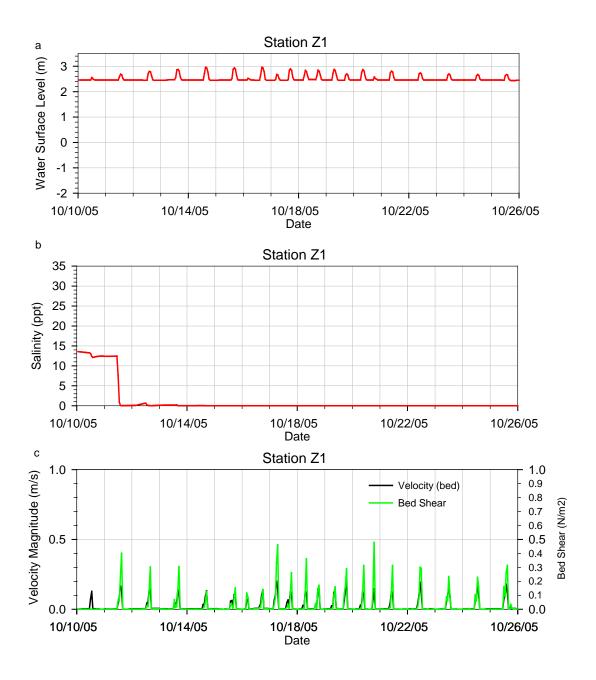
Figure C-26: Scenario 6 (Full Restoration zis a ba + SCN4) – Water-surface elevation, salinity, velocity magnitude, and bed shear stress at zis a ba restoration station Z1, full bank conditions at 26,508 cfs river flow (tides and wind corresponding to October 2005)

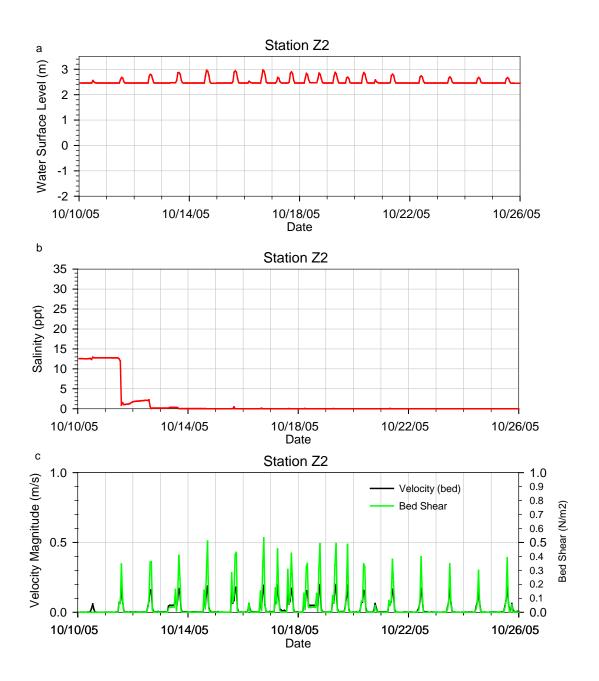
Figure C-27: Scenario 6 (Full Restoration zis a ba + SCN4) – Water-surface elevation, salinity, velocity magnitude, and bed shear stress at zis a ba restoration station Z2, full bank conditions at 26,508 cfs river flow (tides and wind corresponding to October 2005)

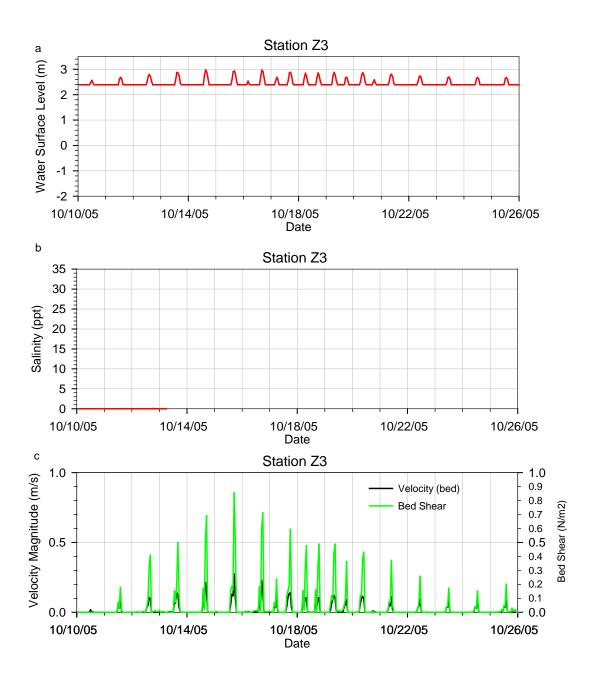
Figure C-28: Scenario 6 (Full Restoration zis a ba + SCN4) – Water-surface elevation, salinity, velocity magnitude, and bed shear stress at zis a ba restoration station Z3, full bank conditions at 26,508 cfs river flow (tides and wind corresponding to October 2005)

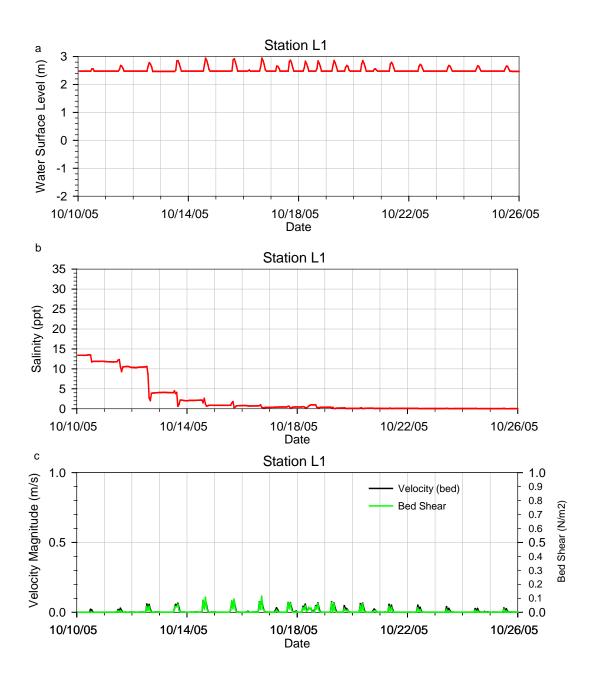
Figure C-29: Scenario 7 (Full Restoration zis a ba + SCN3) – Water-surface elevation, salinity, velocity magnitude, and bed shear stress at Leque Island restoration station L1, full bank conditions at 26,508 cfs river flow (tides and wind corresponding to October 2005)
