Prepared for Ducks Unlimited, Inc.

Hydrodynamic Modeling Analysis for Leque Island and zis a ba Restoration Feasibility Study

JM Whiting TP Khangaonkar

January 2015

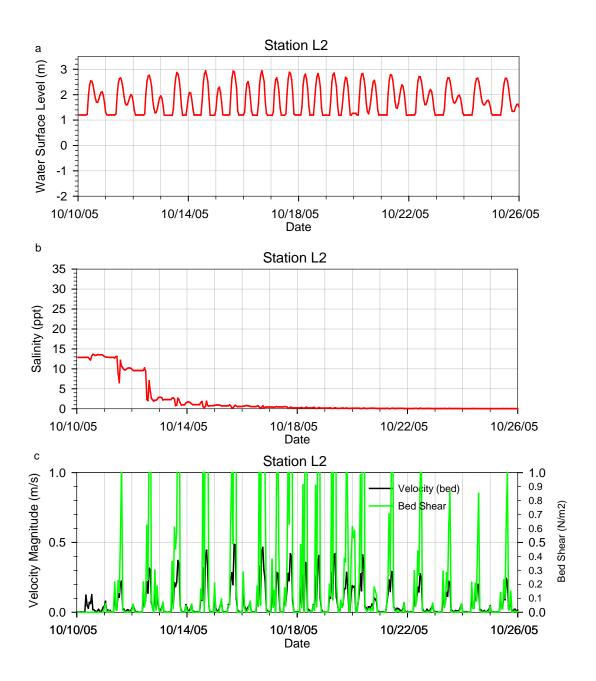
Figure C-30: Scenario 7 (Full Restoration zis a ba + SCN3) – Water-surface elevation, salinity, velocity magnitude, and bed shear stress at Leque Island restoration station L2, full bank conditions at 26,508 cfs river flow (tides and wind corresponding to October 2005)

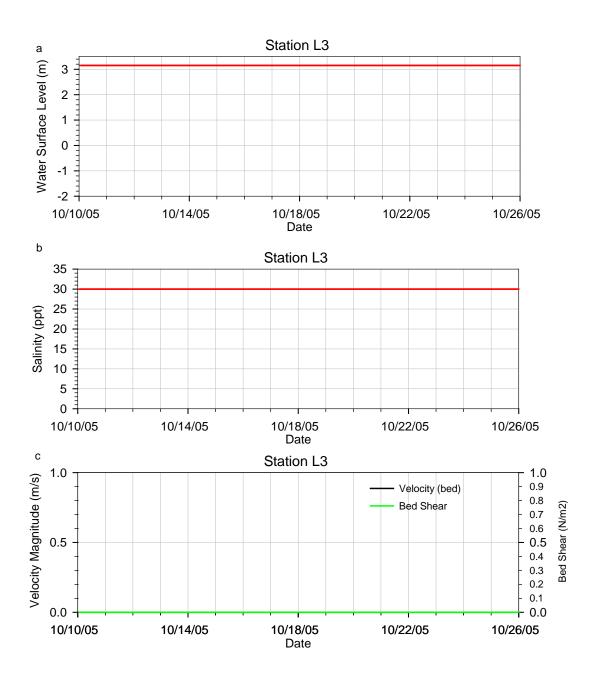
Figure C-31: Scenario 7 (Full Restoration zis a ba + SCN3) – Water-surface elevation, salinity, velocity magnitude, and bed shear stress at Leque Island restoration station L3, full bank conditions at 26,508 cfs river flow (tides and wind corresponding to October 2005)

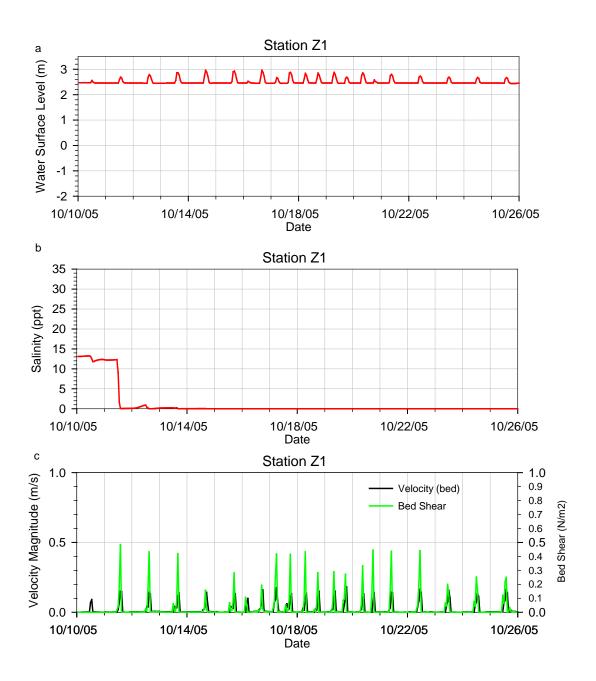
Figure C-32: Scenario 7 (Full Restoration zis a ba + SCN3) – Water-surface elevation, salinity, velocity magnitude, and bed shear stress at zis a ba restoration station Z1, full bank conditions at 26,508 cfs river flow (tides and wind corresponding to October 2005)

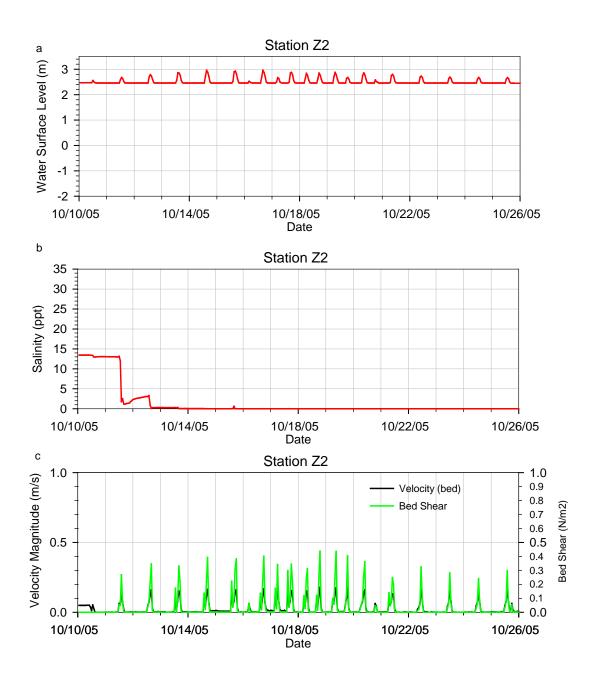
Figure C-33: Scenario 7 (Full Restoration zis a ba + SCN3) – Water-surface elevation, salinity, velocity magnitude, and bed shear stress at zis a ba restoration station Z2, full bank conditions at 26,508 cfs river flow (tides and wind corresponding to October 2005)

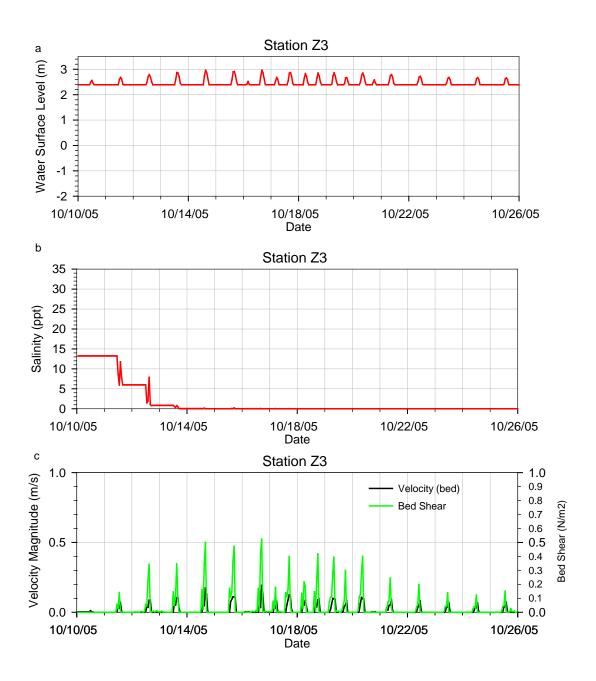
Figure C-34: Scenario 7 (Full Restoration zis a ba + SCN3) – Water-surface elevation, salinity, velocity magnitude, and bed shear stress at zis a ba restoration station Z3, full bank conditions at 26,508 cfs river flow (tides and wind corresponding to October 2005)

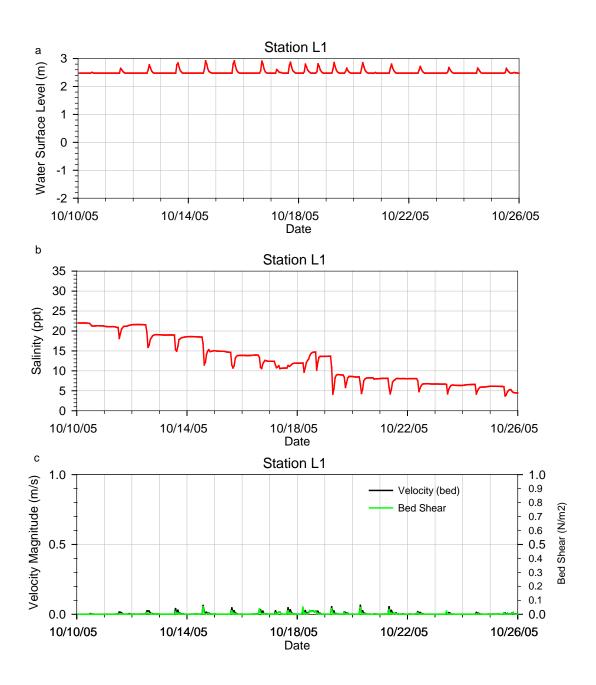
Figure C-35: Scenario 8 (3 Levee Breaches Leque) – Water-surface elevation, salinity, velocity magnitude, and bed shear stress at Leque Island restoration station L1, full bank conditions at 26,508 cfs river flow (tides and wind corresponding to October 2005)

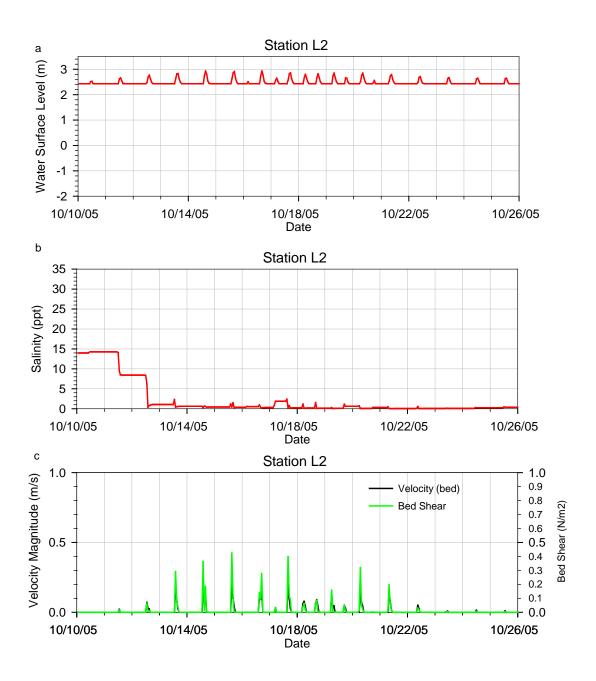
Figure C-36: Scenario 8 (3 Levee Breaches Leque) – Water-surface elevation, salinity, velocity magnitude, and bed shear stress at Leque Island restoration station L2, full bank conditions at 26,508 cfs river flow (tides and wind corresponding to October 2005)

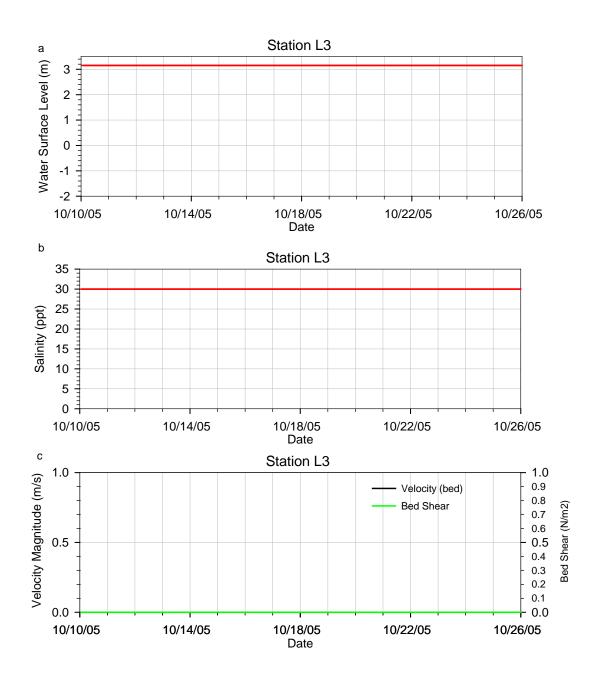
Figure C-37: Scenario 8 (3 Levee Breaches Leque) – Water-surface elevation, salinity, velocity magnitude, and bed shear stress at Leque Island restoration station L3, full bank conditions at 26,508 cfs river flow (tides and wind corresponding to October 2005)
